## ON-SITE SIDE IMPACT INFLATABLE OCCUPANT PROTECTION INVESTIGATION

CASE NUMBER - IN-05-025  
LOCATION - WISCONSIN  
VEHICLE - 2004 MAZDA 6S  
CRASH DATE - July 2005

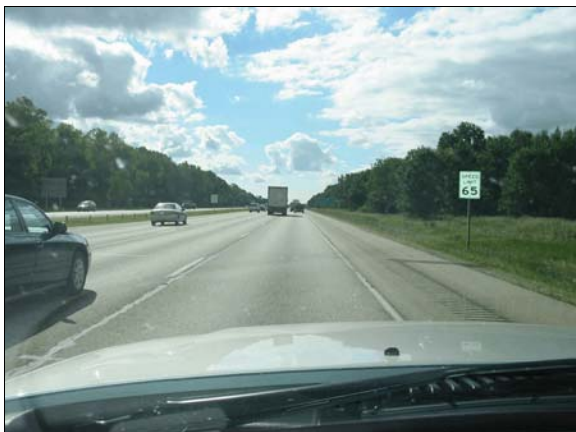
**Pre-Crash:** The case vehicle was traveling south in the outside lane (**Figure 1**) at a driver estimated speed of 97 km.p.h. (60 m.p.h.). The driver was intending to continue southbound in the outside lane. The driver stated that a car swerved into her lane from the middle lane. The case vehicle's driver steered right in an attempt to avoid a crash and the case vehicle traveled toward the outside shoulder and begin rotating clockwise. Based on the police reported measurements, the case vehicle produced 33.7 meters (110.6 feet) of tire marks on the roadway extending to the point where it entered the grass (**Figure 2** below). The police reported tire marks were not present at this contractor's scene inspection. The crash occurred on the west side of the roadway.

**Figure 1:** Approach of case vehicle southbound in outside lane to area of roadway departure
