Rollover/Electronic Stability Control Investigation/Vehicle to Vehicle
Dynamic Science, Inc./Case Number: DS05028
2005 Cadillac Escalade
Arizona
June 2005

1. Report No. DS05028		2. Government Accession No.		3. Recipient Catalog No.	
4. Title and Subtitle Rollover/Electronic Stability Control Investigation				5. Report Date May 15, 2006

Dynamic Science, Inc.
Crash Investigation
Case Number: DS05028

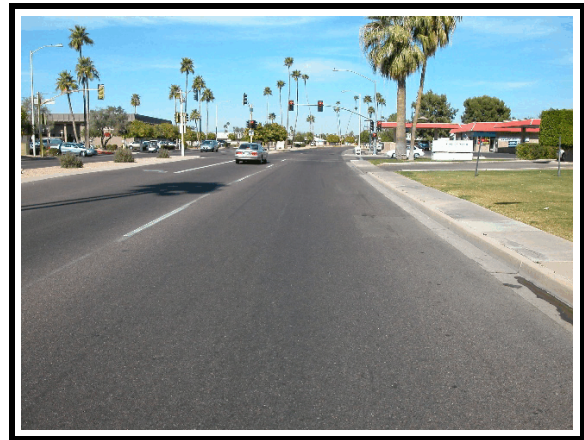
Figure 2. Case vehicle approach to area of impact

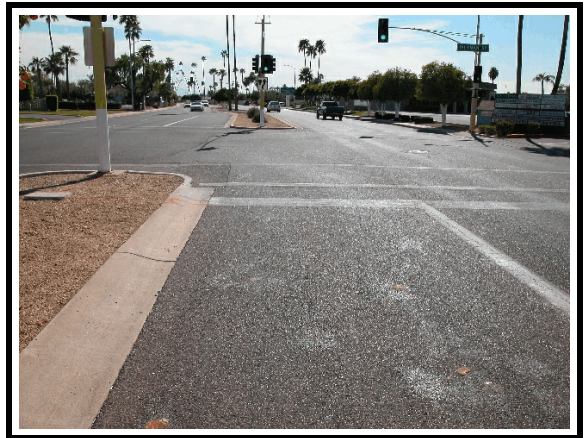
Figure 3. Other vehicle approach

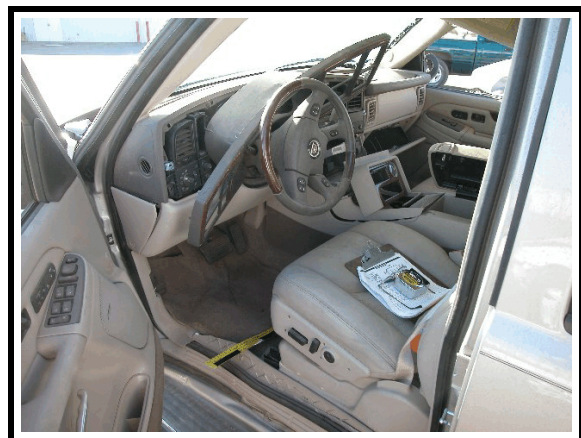
The 62-year-old male driver was seated in an upright posture. He was not wearing the manual 3-point lap and shoulder belt. The seat was adjusted to the rearmost track position and the seat back was slightly reclined at a 63 degree angle. The seat cushion had a 14 degree angle. He was wearing eyeglasses at the time of crash. Both hands were on the steering wheel at unknown o'clock positions. His left foot was on the floorboard. Just prior to impact, he began braking with his right foot. At the first impact, the driver pitched slightly forward and to the left. As the left rear tire was snagged, the vehicle began a sharp counterclockwise rotation. The unrestrained driver began moving to the right. At impact with the traffic signal pole, the driver came out of his seat and struck the center console with his hip and then struck the right side windshield with his head, causing the forehead laceration. As the vehicle rolled over onto its right side, the driver came to rest on the right side door. The driver was able to climb out of the side window unaided. Emergency personnel arrived on scene shortly after the crash. The driver sustained a forehead laceration that required three stitches, a small laceration on the right side of the forehead, and a contusion to the left forearm. He was transported by ambulance to a Level 1 trauma center where he was treated and released.

Figure 9. Driver's seated position

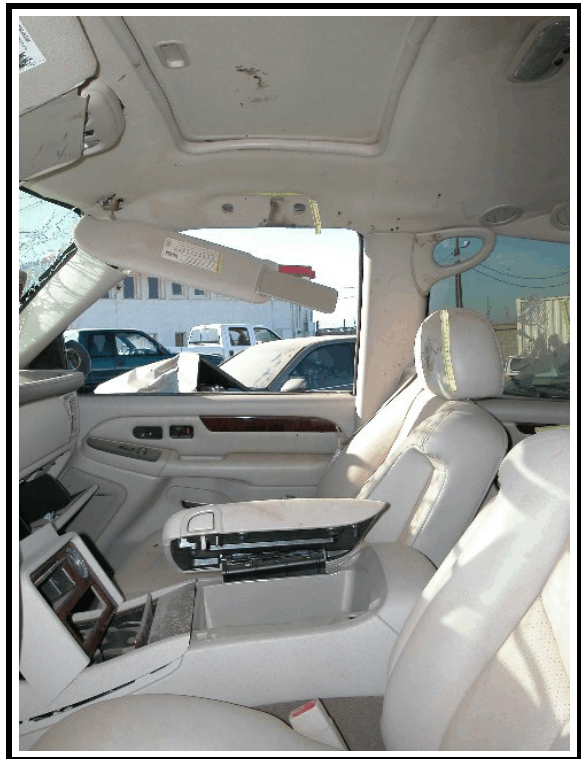
Figure 11. Driver path to final rest

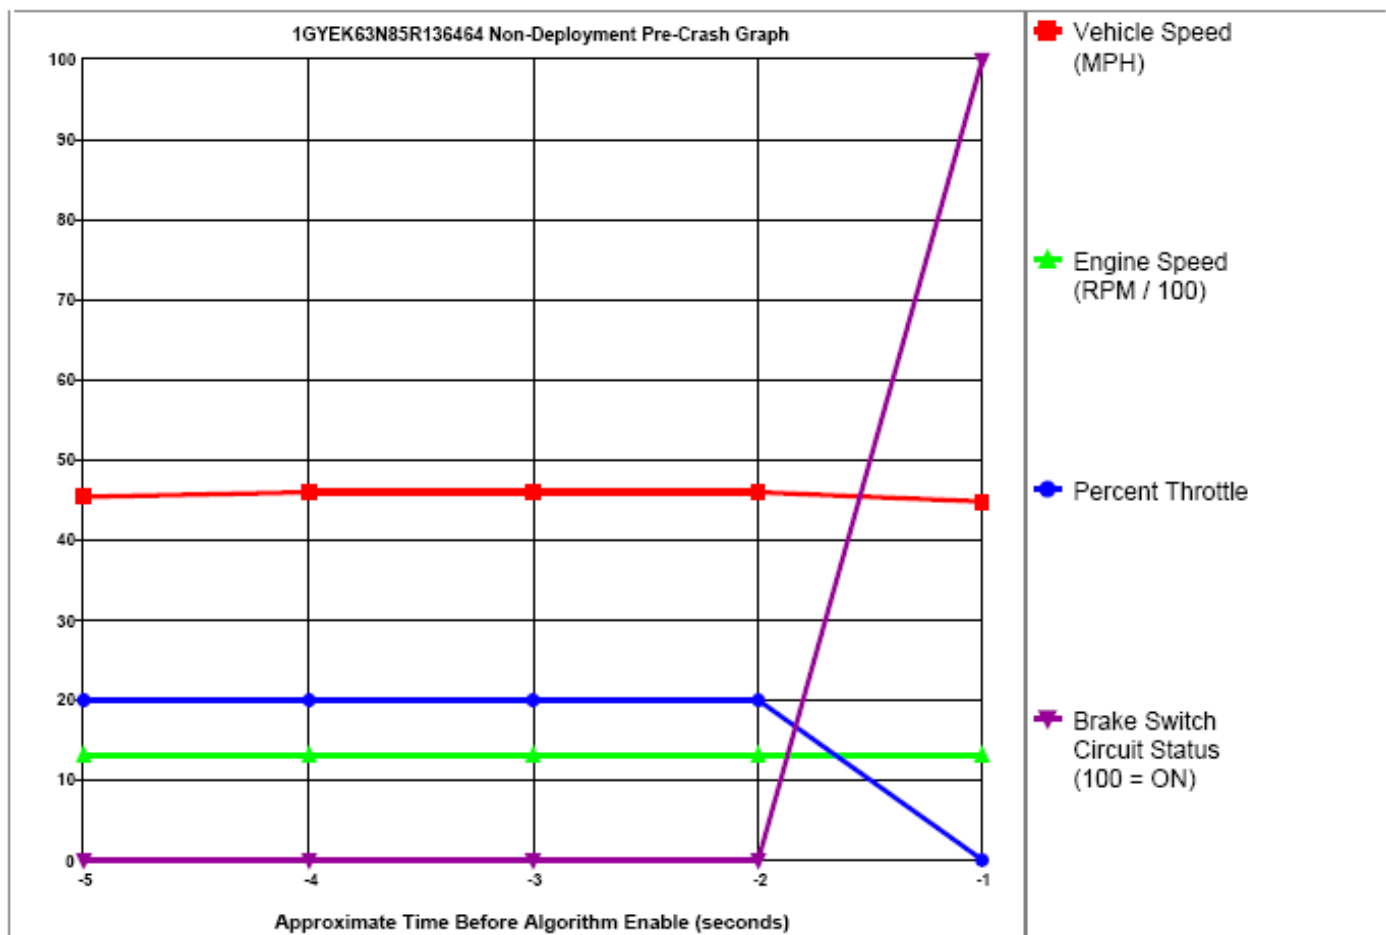
Attachment 2. Vetronix Report

SIR Warning Lamp Status	OFF
Driver's Belt Switch Circuit Status	UNBUCKLED
Passenger's Belt Switch Circuit Status	UNBUCKLED
Passenger Seat Position Switch Circuit Status	Rearward
Ignition Cycles At Non-Deployment	3173
Ignition Cycles At Investigation	3183
Maximum SDM Recorded Velocity Change (MPH)	-5.88
Algorithm Enable to Maximum SDM Recorded Velocity Change (msec)	220
Crash Record Locked	No
Event Recording Complete	Yes
Multiple Events Associated With This Record	No
One Or More Associated Events Not Recorded	No

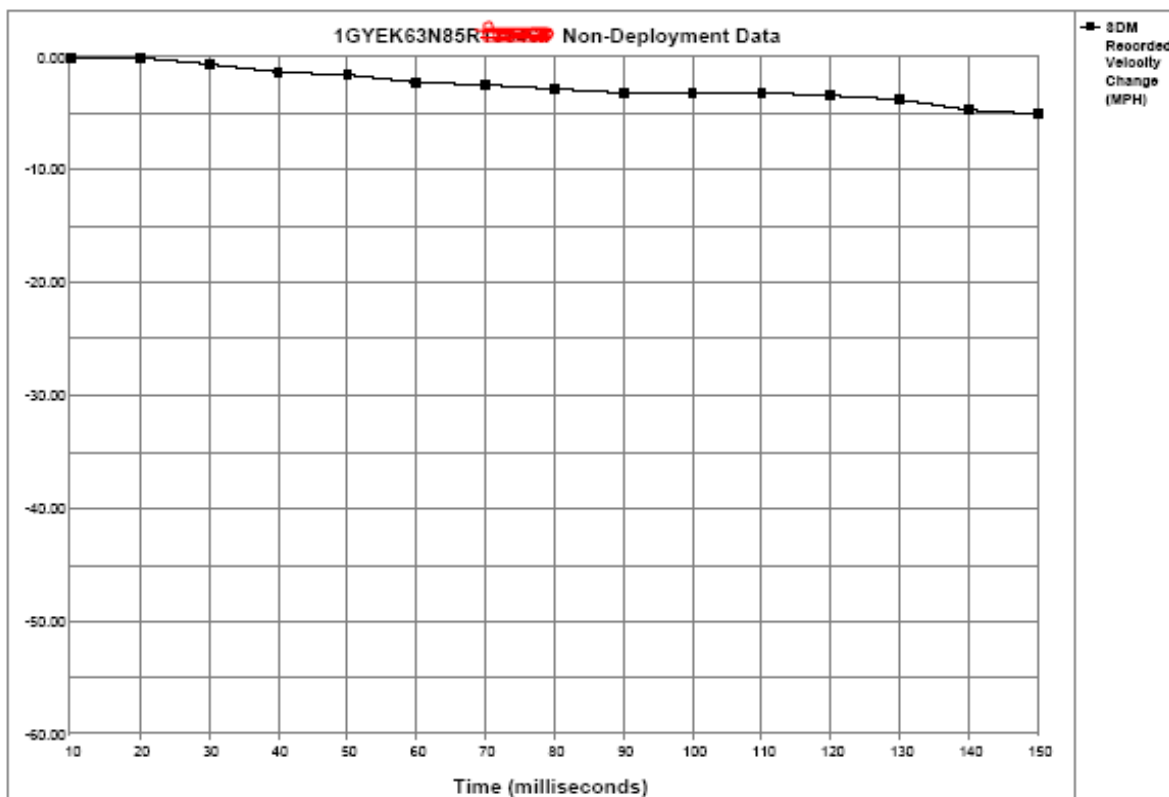
Seconds Before AE	Vehicle Speed (MPH)	Engine Speed (RPM)	Percent Throttle	Brake Switch Circuit Status
-5	45	1280	20	OFF
-4	46	1280	20	OFF
-3	46	1280	20	OFF
-2	46	1280	20	OFF
-1	45	1344	0	ON
