**CALSPAN ON-SITE CERTIFIED ADVANCED 208-COMPLIANT
VEHICLE CRASH INVESTIGATION**

SCI CASE NO: CA05-033

**VEHICLE: 2005 BUICK LACROSSE
LOCATION: PENNSYLVANIA
CRASH DATE: MAY 2005**

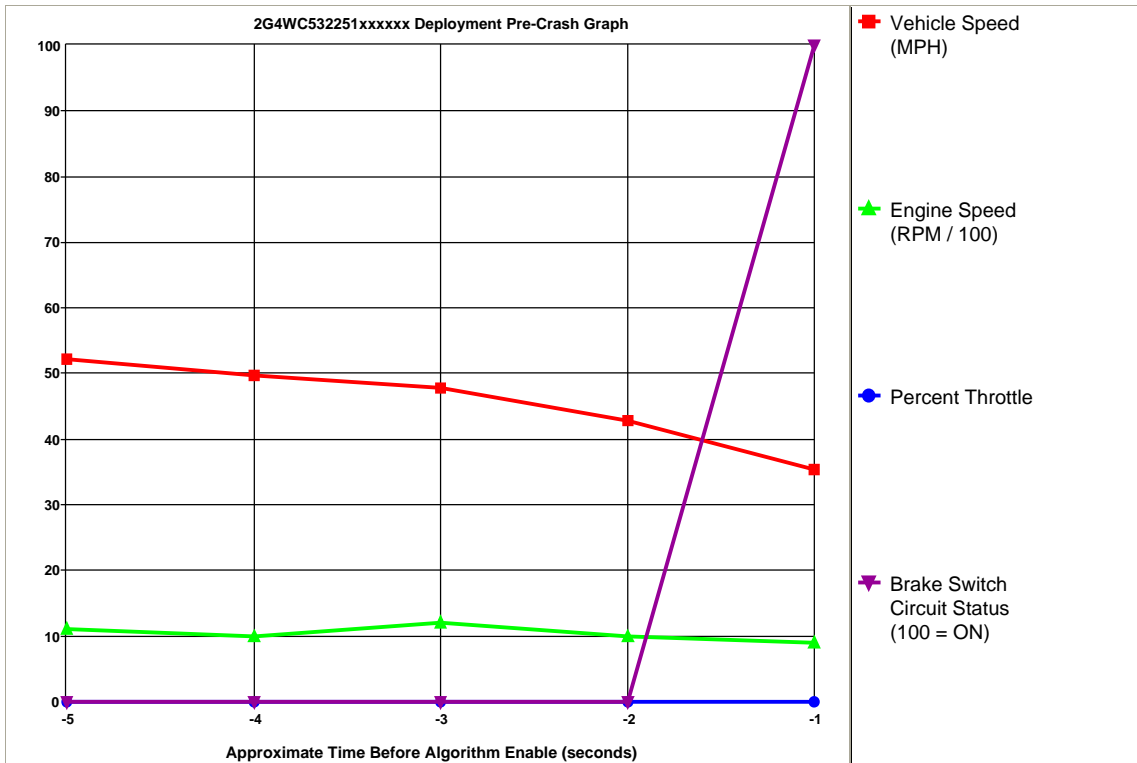
System Status At Deployment

SIR Warning Lamp Status	OFF
Driver's Belt Switch Circuit Status	UNBUCKLED
Ignition Cycles At Deployment	134
Ignition Cycles At Investigation	148
Maximum SDM Algorithm Forward Velocity Change (MPH)	-31.56
Algorithm Enable to Maximum SDM Recorded Velocity Change (msec)	347.5
Driver First Stage Time Algorithm Enabled to Deployment Command Criteria Met (msec)	255
Driver Second Stage Time Algorithm Enabled to Deployment Command Criteria Met (msec)	N/A
Passenger First Stage Time Algorithm Enabled to Deployment Command Criteria Met (msec)	255
Passenger Second Stage Time Algorithm Enabled to Deployment Command Criteria Met (msec)	N/A
Time Between Non-Deployment And Deployment Events (sec)	0
Event Recording Complete	Yes

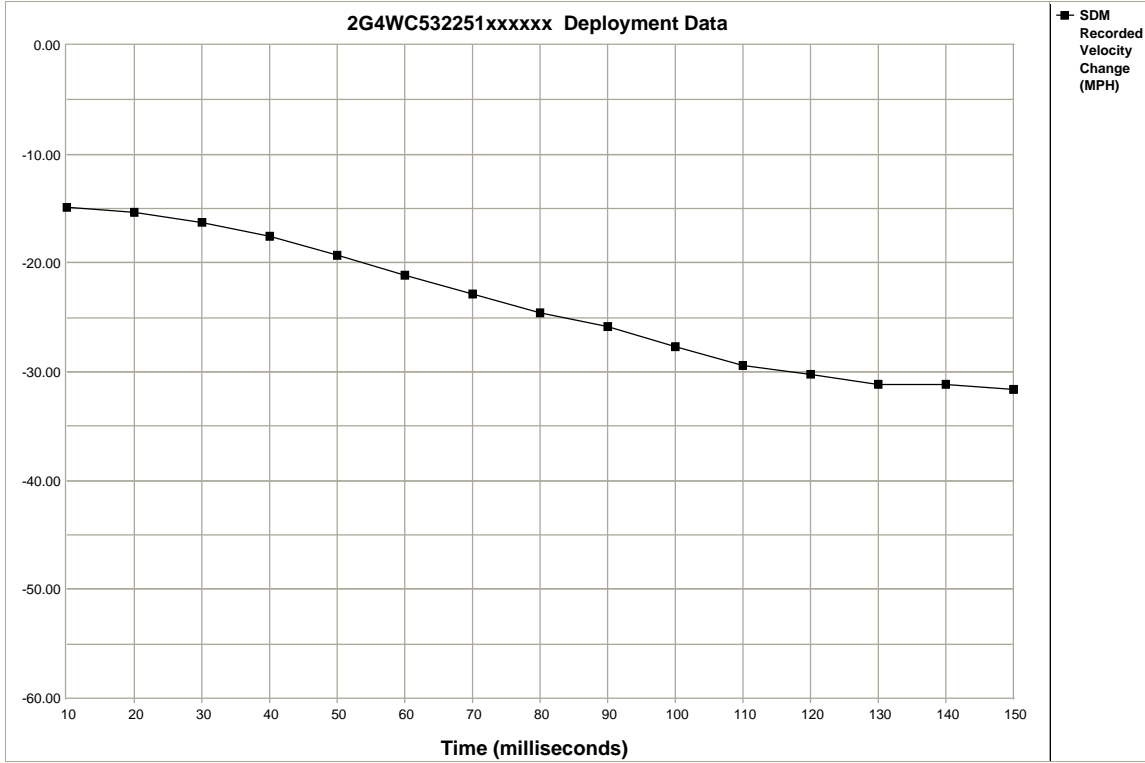
Seconds Before AE	Vehicle Speed (MPH)	Engine Speed (RPM)	Percent Throttle	Brake Switch Circuit Status
-5	52	1088	0	OFF
-4	50	1024	0	OFF
-3	48	1216	0	OFF
-2	43	1024	0	OFF
-1	35	896	0	ON

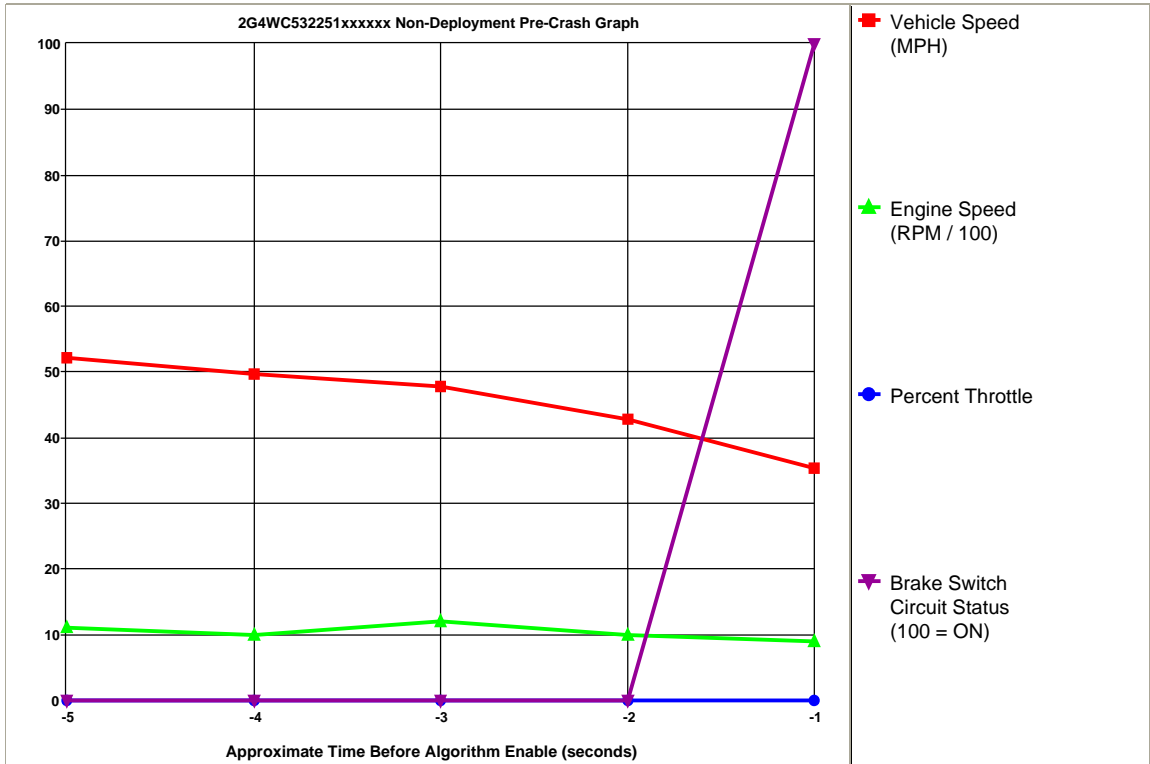
System Status At Non-Deployment

SIR Warning Lamp Status	OFF
Driver's Belt Switch Circuit Status	UNBUCKLED
Ignition Cycles At Non-Deployment	134
Ignition Cycles At Investigation	148
Maximum SDM Algorithm Forward Velocity Change (MPH)	-31.56
Algorithm Enable to Maximum SDM Recorded Velocity Change (msec)	347.5
A Deployment was Commanded Prior to this Event	No

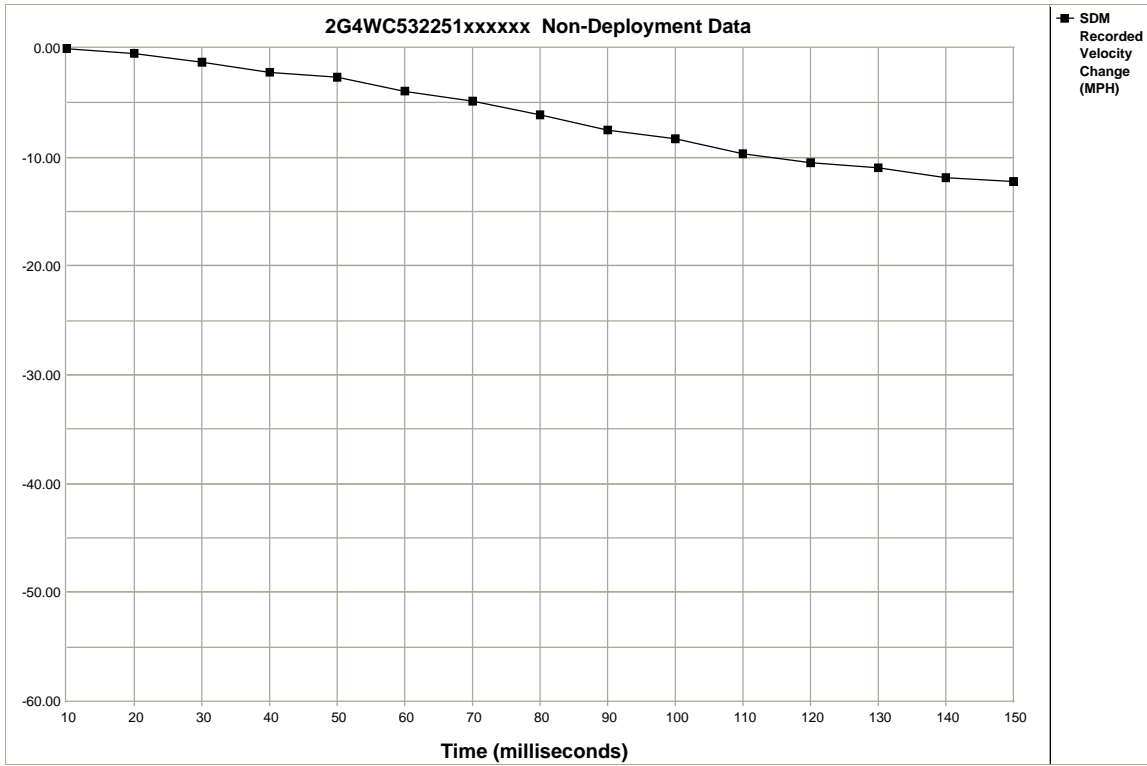
Seconds Before AE	Vehicle Speed (MPH)	Engine Speed (RPM)	Percent Throttle	Brake Switch Circuit Status
-5	52	1088	0	OFF
-4	50	1024	0	OFF
-3	48	1216	0	OFF
-2	43	1024	0	OFF
-1	35	896	0	ON
