**ON-SITE CERTIFIED ADVANCED 208-COMPLIANT
VEHICLE CRASH INVESTIGATION**

CALSPAN CASE NO: CA05-042

**VEHICLE: 2005 VOLKSWAGEN NEW BEETLE CONVERTIBLE
LOCATION: VIRGINIA
CRASH DATE: JUNE 2005**

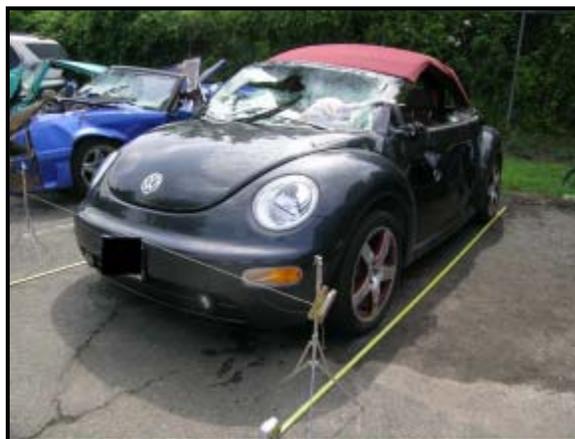
This investigation focused on the performance of the Certified Advanced 208-Compliant (CAC) safety system in a 2005 Volkswagen New Beetle Convertible, **Figure 1**. The vehicle was certified by the manufacturer that the CAC system met the requirements of the advanced FMVSS 208 ruling. This advanced occupant protection system was comprised of dual-stage frontal air bags, driver seat track position sensor, front safety belt buckle switch sensors, front seat belt pretensioners, and a front right occupant detection sensor. The vehicle was also equipped with head/thorax side impact air bags, active front seat head restraints and automatic rollover protection. The automatic rollover protection was integrated into the rear seat head restraints and deploys vertically in the event of a rollover.

Figure 1: 2005 VW Beetle.

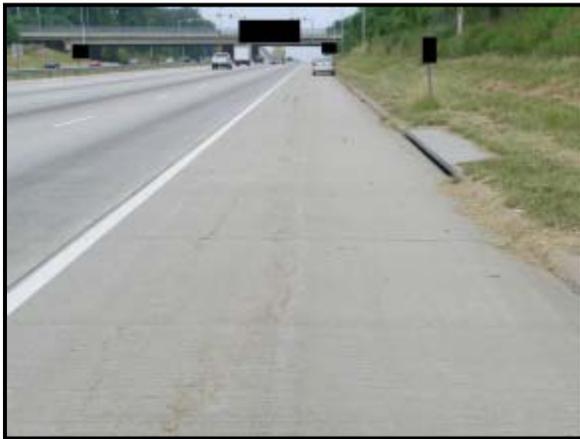
This crash occurred during the daylight hours in June 2005. At the time of the crash it was daylight and the weather was not a factor. The crash occurred on the eastbound lanes of a three-lane divided interstate highway. The south side of the traffic lanes was bordered by a 3.7 m (12.0 ft) wide breakdown lane and a 10 cm (4 in) concrete curb. Beyond the curb, there was an earth embankment. The embankment had a 35 degree positive slope, measured 4.6 m (15.0 ft) south of the curb line. The highway speed limit in the area of the crash was 89 km/h (55 mph). **Figure 2** is an eastbound view of the roadway configuration in the area of the crash. **Figure 3** is a trajectory view of the Volkswagen at the point of road side departure.

Figure 2: Eastbound view of the roadway.

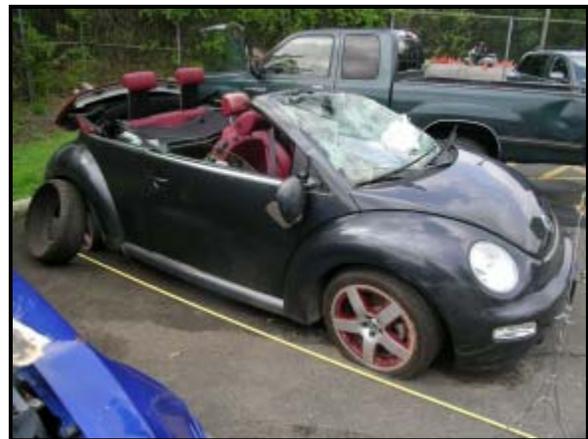
The 2005 Volkswagen New Beetle Convertible, **Figure 5**, was identified by the Vehicle Identification Number (VIN): 3VWCM31Y45M (production sequence deleted). The two door, four passenger front wheel drive convertible was equipped with a 2.0 liter/I4 engine linked to a six-speed automatic transmission. The service brakes were a power-assisted front/rear disc system with

Figure 5: Right side view of the Volkswagen.

An inspection of the Volkswagen revealed direct damage indicators of a four-quarter turn rollover. The direct damage consisted of abrasions and minor deformation to the body panels and minor residual vertical deformation of the reinforced windshield frame consistent with the rollover dynamics. The rake angle of the left side windshield frame was deflected down 7 degrees due to ground contact. The deflection reduced the height of the upper left corner of the windshield frame 8 cm (3.3 in). The rake angle of the right side windshield frame was unchanged. There was no change in the overall vehicle length. The left wheelbase dimension was unchanged. The right wheelbase dimension increased 6 cm (2.3 in). The increased dimension was attributed to damage to the right rear suspension at a result of the crash and reported damage that occurred during towing. The left door was jammed shut and exhibited indications of attempted extrication. The right door was operational. The windshield was completely fractured. All the side window glazings were disintegrated except for the partially open front right. The CDC of the rollover event was 00-TDDO1.

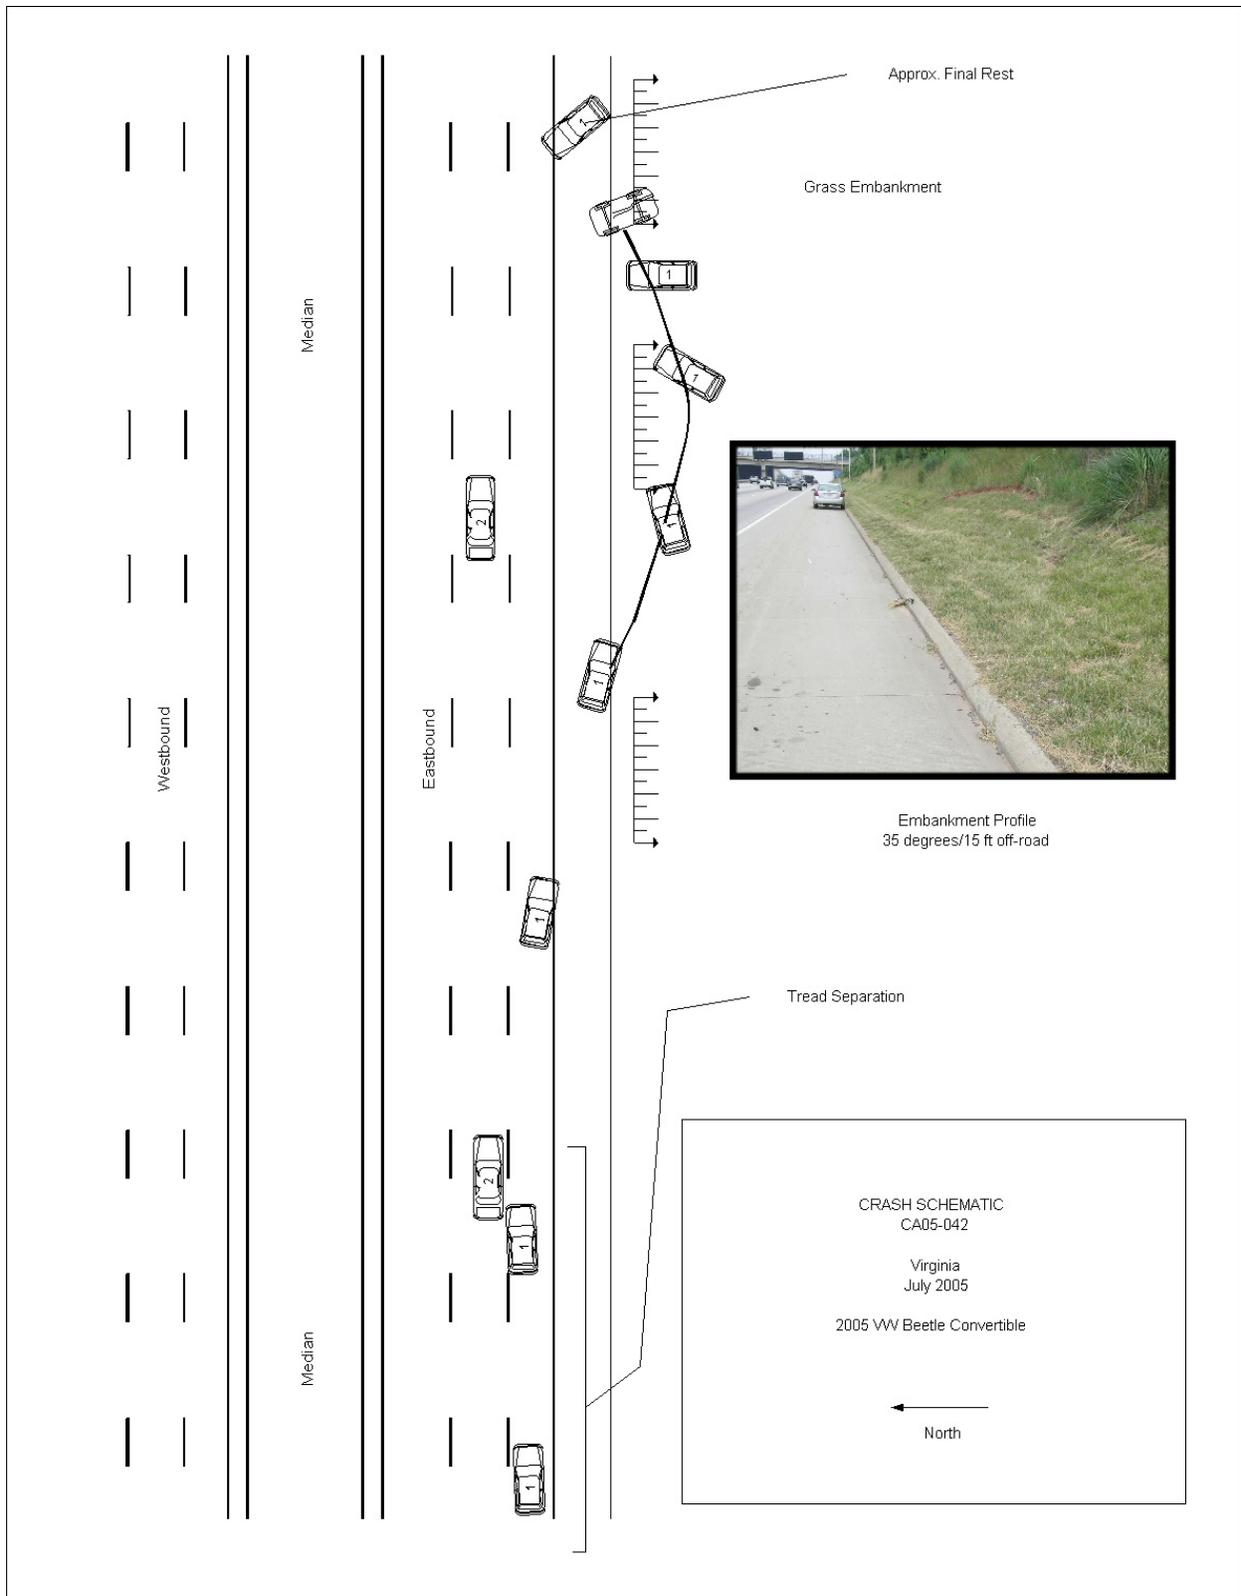
The Volkswagen overrode the curb bordering the breakdown lane and began climbing the roadside embankment. The SCI inspection of the scene identified tire marks attributed to the right side tires of the Volkswagen. These marks indicated a parabolic arcing trajectory along the embankment. The trajectory indicated the vehicle was rotating counterclockwise (resultant to the late left steer input). At the peak of its trajectory, the right front tire of the vehicle was located 4.6 m (15.2 ft) south of the curb line and the slope of the embankment at that location measured 35 degrees. As the vehicle's trajectory transitioned to the northeast and it began to descend the slope, the vehicle tripped over the right front wheel into a right side leading roll. During the roll sequence, the right side impact air bag and the automatic rollover protection deployed. The vehicle rolled onto its top causing the backlight to fracture and disintegrate. A pool of tempered glazing was identified. The disintegrated glazing was located 27.9 m (91.5 ft) east and 0.6 m (2.0 ft) south of the point of roadway departure. The Volkswagen rolled a total of four quarter turns coming to rest on its wheels in the breakdown lane of the roadway. **Figure 12** at the end of this report is a schematic of the crash.

Figure 12: Crash Schematic.
