**CALSPAN ON-SITE REAR OCCUPANT PROTECTION PROGRAM CRASH  
INVESTIGATION**

**CASE NO. – CA05-063**

**VEHICLE – 2004 CHEVROLET TRAILBLAZER**

**CRASH DATE – DECEMBER 2005**

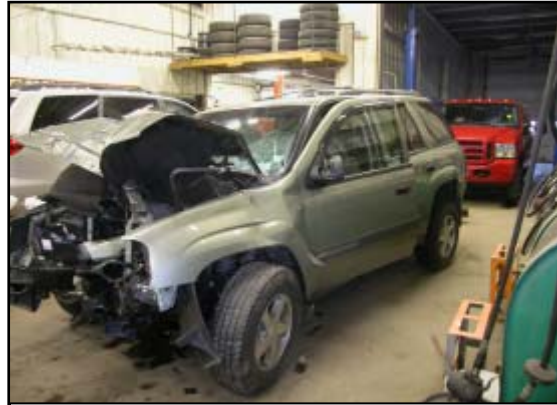
This on-site investigation focused on the severity of the crash and the 3-point lap and shoulder safety belt system for the rear right passenger of a 2004 Chevrolet TrailBlazer. The TrailBlazer (**Figure 1**) was involved in a severe frontal crash with a large diameter tree that resulted in the death of the 17-year old female rear right passenger. In addition to the rear right passenger, the TrailBlazer was driven by a 17-year old female with a 15-year old female in the front right position and a 14-year old male in the rear left position. The 14-year old was the only unrestrained occupant in the vehicle. The

**Figure 1. Subject vehicle 2004 Chevrolet TrailBlazer.**

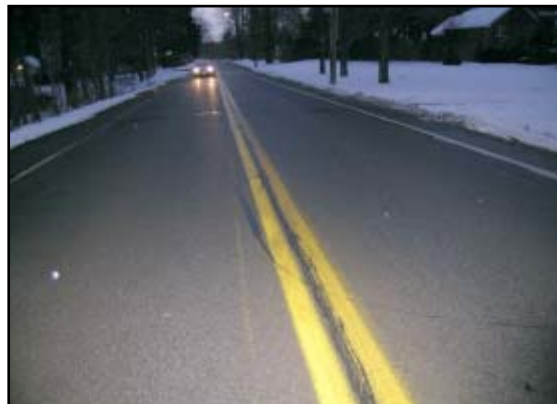
The crash occurred on a two-lane, north/south roadway (**Figure 2**) in a residential area during dark, evening hours. The roadway was surfaced with asphalt and was delineated with double yellow centerlines and white edge lines. The travel lanes were 3.2 m (10.5') in width and were bordered by 1.2 m (4.0') paved shoulders. At the time of the crash, the road surface was wet. Immediately following the crash, the weather changed to a light snowfall. The TrailBlazer was traveling in a northerly direction on a straight segment of road with a downgrade of 1.5 percent that transitioned

**Figure 2. Overall view of the north/south roadway.**

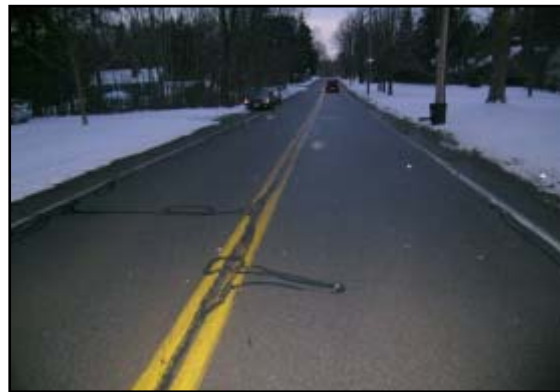
The 17-year old female driver of Chevrolet TrailBlazer was traveling in a northerly direction on the two-lane roadway (**Figure 3**). As she entered the residential village area, the roadway speed limit reduced from 64 km/h (40 mph) to 48 km/h (30 mph). The TrailBlazer was equipped with an Event Data Recorder (EDR) that was downloaded during

**Figure 3. Chevrolet's northbound trajectory.**

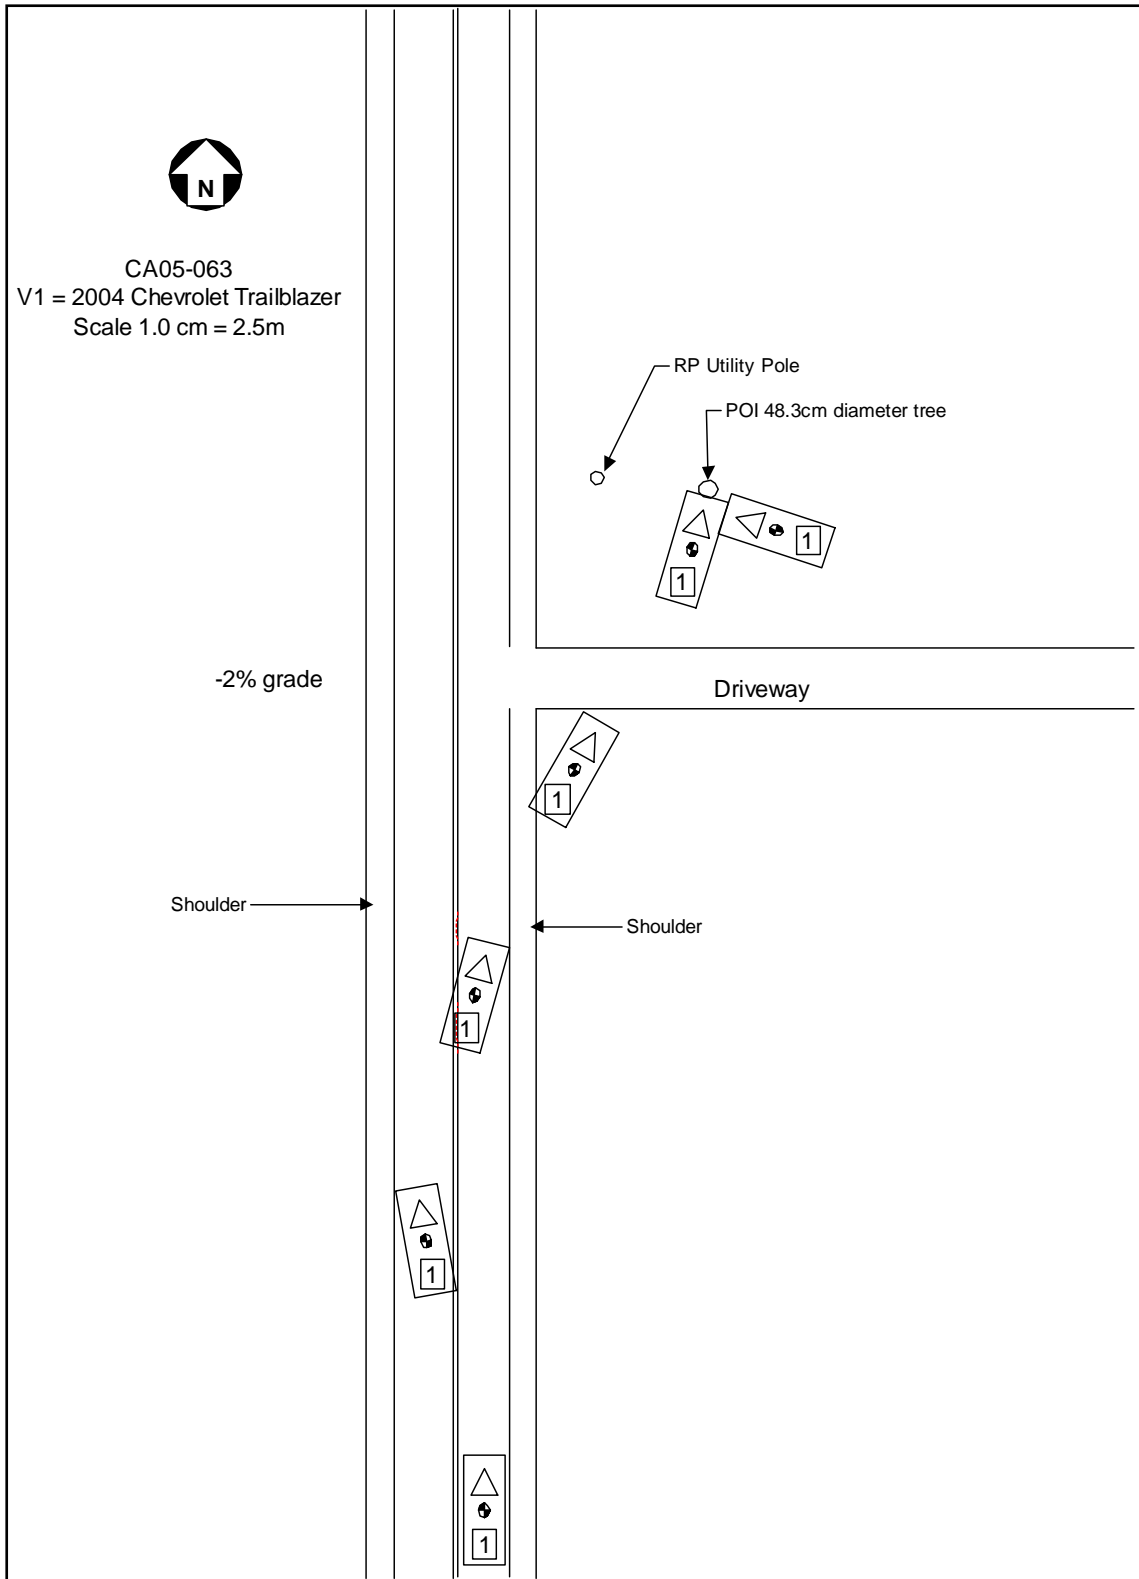
**Figure 16: Scene Schematic**

to a sag at the crash site. The speed limit was posted at 64 km/h (40 mph) and reduced to 48 km/h (30 mph) approximately 0.8 km (0.5 mile) south of the crash site. Single family residences were located on both sides of the roadway. In the vicinity of the crash site, several large diameter trees were located 5.2 m (17.0') outboard of the east edge line. A wooden utility pole was located 2.7 m (8.8') outboard of the edge line with the struck tree located directly east of the pole. The struck hardwood tree measured 48 cm (19") in diameter. The Crash Site Schematic is included as **Figure 16** at the end of this summary.

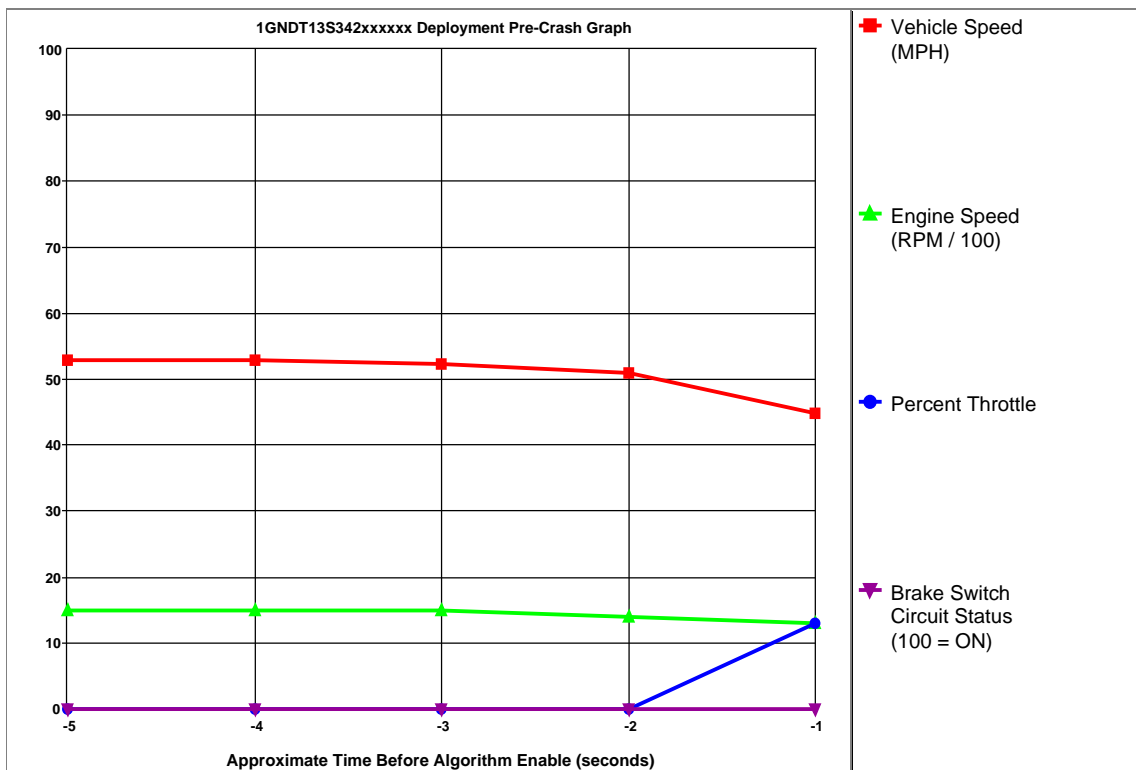
Seconds Before AE	Vehicle Speed (MPH)	Engine Speed (RPM)	Percent Throttle	Brake Switch Circuit Status
-5	53	1536	0	OFF
-4	53	1472	0	OFF
-3	52	1472	0	OFF
-2	51	1408	0	OFF
-1	45	1280	13	OFF

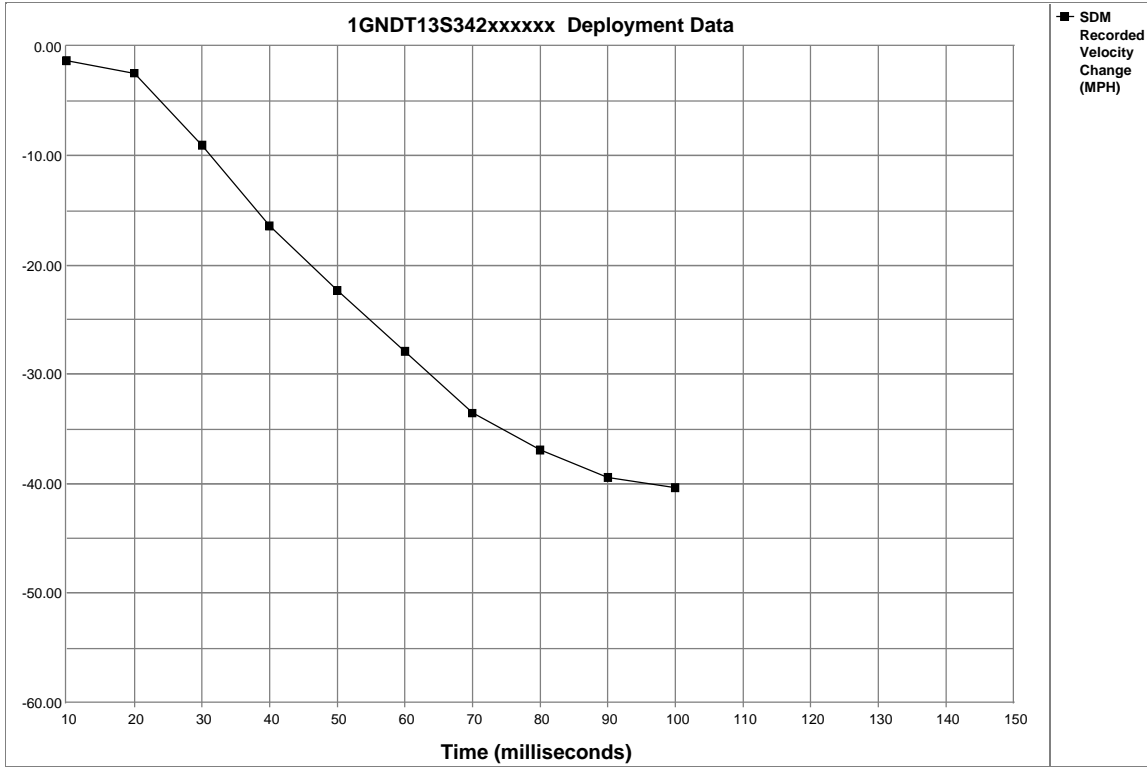
Time (milliseconds)	10	20	30	40	50	60	70	80	90	100	110	120	130	140	150
Recorded Velocity Change (MPH)	-1.24	-2.48	-8.99	-16.43	-22.32	-27.90	-33.48	-36.89	-39.37	-40.30	N/A	N/A	N/A	N/A	N/A
