**CALSPAN ON-SITE CHILD AIR BAG RELATED FATALITY  
INVESTIGATION**

**CALSPAN CASE NO: CA06-004**

**VEHICLE: 1996 PLYMOUTH VOYAGER**

**CRASH DATE: FEBRUARY 2006**

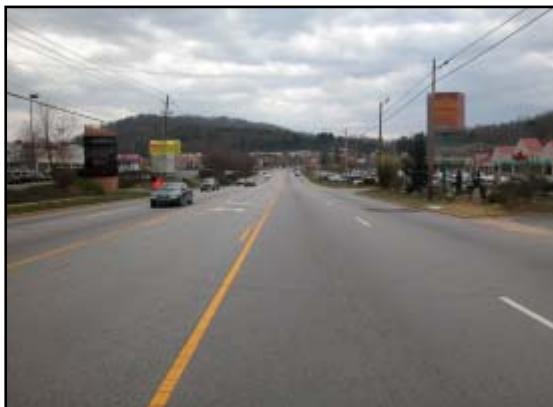
**Figure 2. Plymouth's southbound approach.**

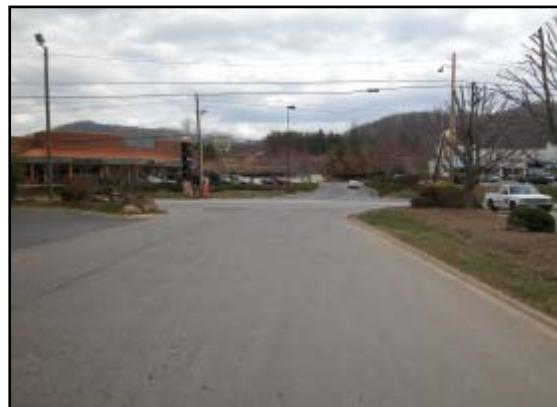
**Figure 3. Jeep's eastbound pre-crash travel.**

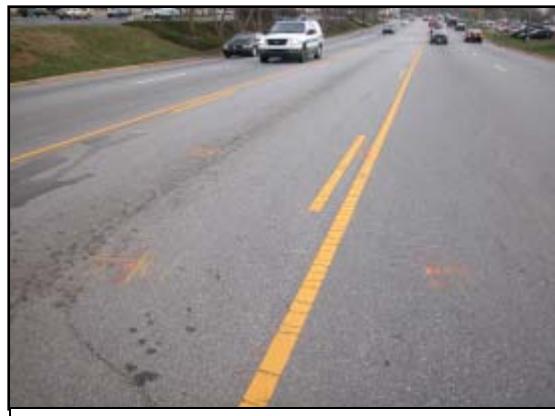
The Voyager continued its forward and slight left travel and came to final rest approximately 10 m (33 feet) south of the driveway straddling the center two-way left turn lane and the inboard southbound lane (**Figure 5**). The driver of the Jeep did not stop post-crash and fled the crash site. Police stopped the Jeep approximately 10 minutes post-crash on an interstate where it struck a sign post with the front right corner.

**Figure 5. Plymouth's final rest.**

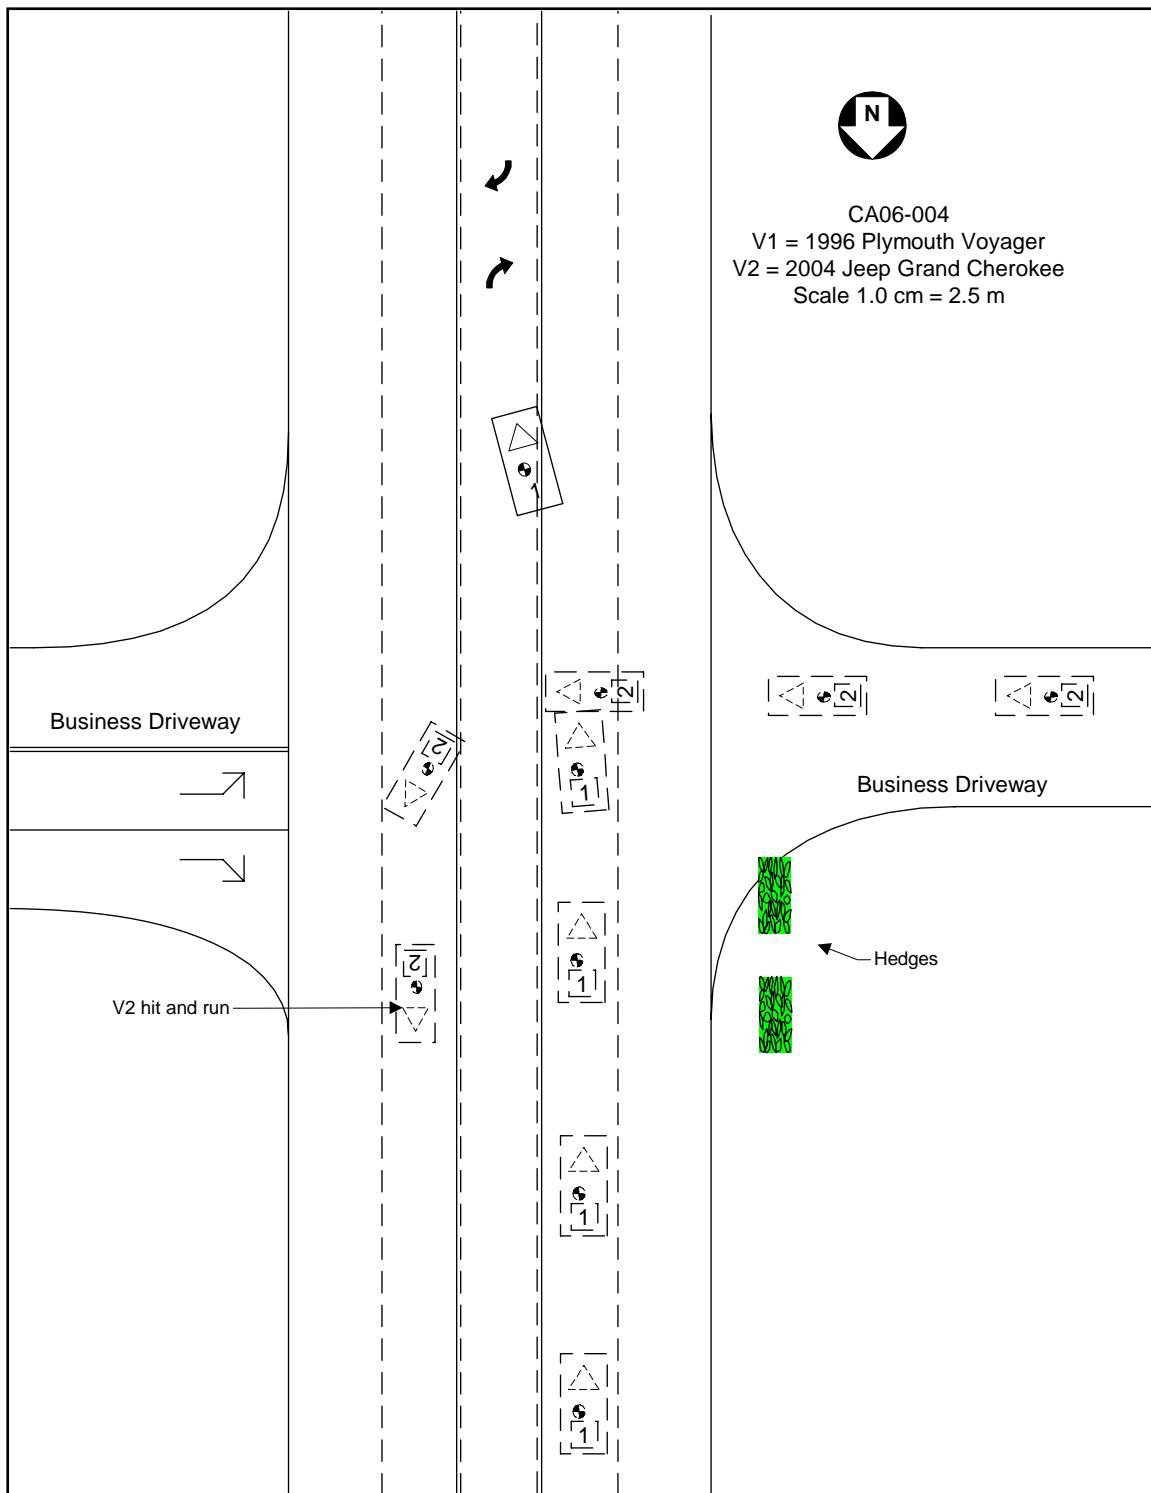
**Figure 15: Scene Schematic**

The crash occurred on a five-lane 19.9 m (65.3 ft) wide north/south roadway that was intersected by two business driveways at the east and west road edges. The north/south roadway consisted of two travel lanes in each direction with a center two-way left turn lane. A solid yellow line with a broken yellow line adjacent delineated the turn lane. The 12.3 m (40.4 ft) wide driveway that intersected the roadway from the east roadside was configured with three lanes; a single westbound lane, a left turn lane, and a right turn only lane. The 7.5 m (24.6 ft) wide driveway on the west road edge consisted single lane for two-way traffic. There were no traffic control devices for the west driveway. The posted speed limit was 72 km/h (45 mph) for the north/south roadway. The scene schematic is included as **Figure 15** of this report.
