Electronic Stability Control and Knee Air Bag Investigation/Vehicle to Vehicle  
Dynamic Science, Inc./Case Number: DS06005  
2005 Lexus RX330  
California  
December 2005

1. Report No. DS06005		2. Government Accession No.		3. Recipient Catalog No.	
4. Title and Subtitle  Electronic Stability Control and Knee Air Bag Investigation				5. Report Date August 17, 2006

**Dynamic Science, Inc.**  
**Crash Investigation**  
**Case Number: DS06005**

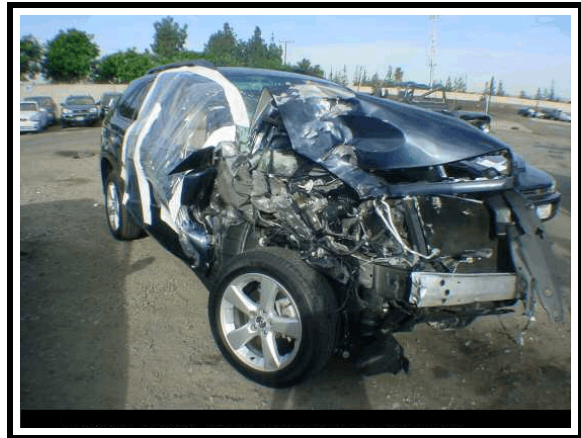
**Figure 1.** Front right, 2005 Lexus RX330

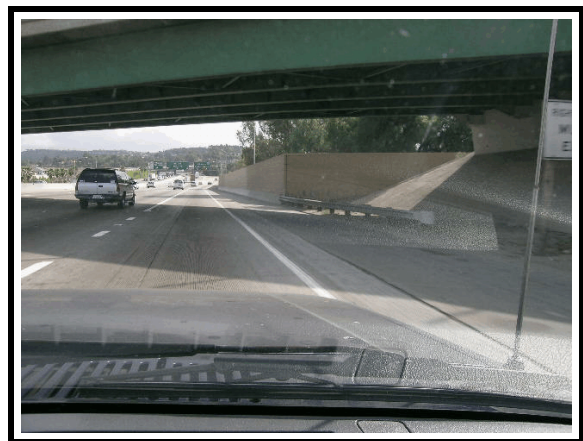
**Figure 2.** Approach of both vehicles to crash location - east

The Lexus RX330 was traveling east in lane one of four at an EDR reported speed 88.0 km/h (54.7 mph) approximately 5 seconds prior to impact. The other vehicle was a 1998 Dodge Ram pickup being driven by a 37-year-old female. The pickup was traveling east in the right lane, ahead of the case vehicle. According to the police report, the driver of the Lexus had missed her freeway exit and was “looking at signs trying to determine where she was”. When she refocused her attention on traffic ahead of her, she realized that traffic had slowed and she was only one to two car lengths behind the Dodge Ram.

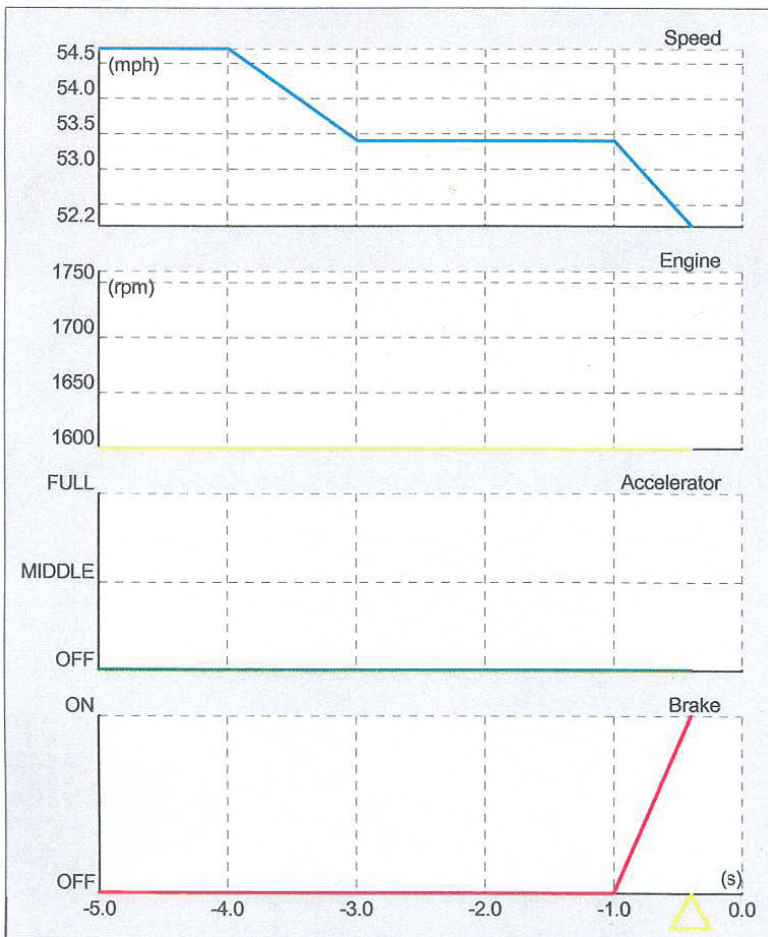
Pre-Crash Data

s	Speed	Engine	Accelerator	Brake
-5.0	54.7	1600	OFF	OFF
-4.0	54.7	1600	OFF	OFF
-3.0	53.4	1600	OFF	OFF
-2.0	53.4	1600	OFF	OFF
-1.0	53.4	1600	OFF	OFF
-0.4	52.2	1600	OFF	ON

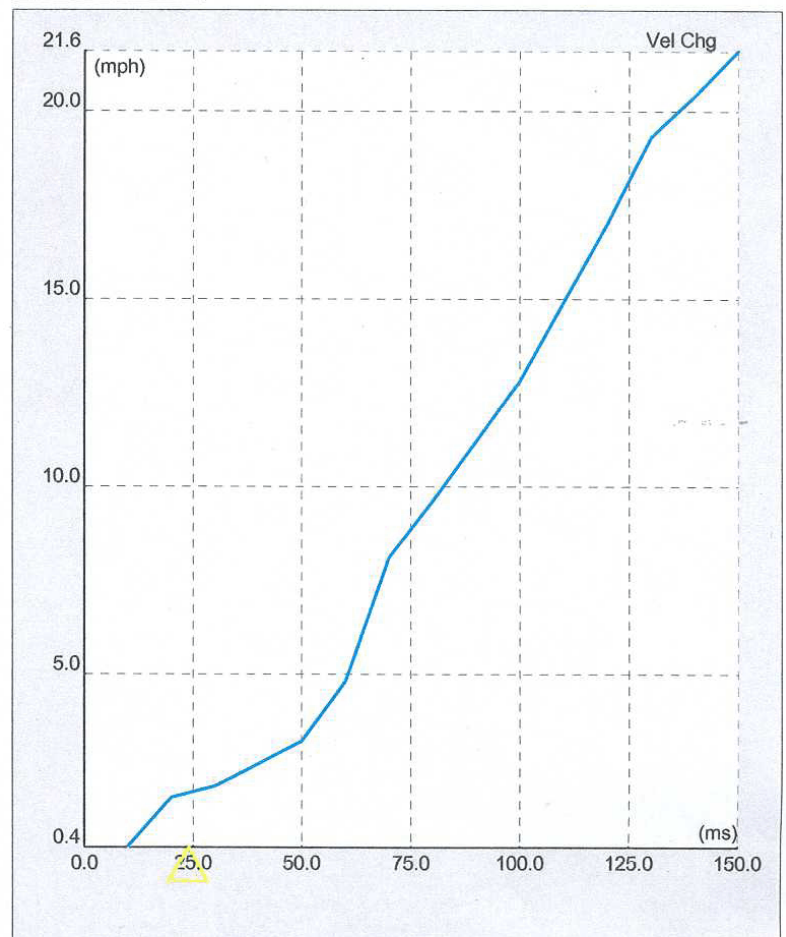
Post-Crash Data

ms	Vel Chg	ms	Vel Chg	ms	Vel Chg
10.0	0.4	70.0	8.1	130.0	19.3
20.0	1.7	80.0	9.6	140.0	20.4
30.0	2.0	90.0	11.2	150.0	21.6
40.0	2.6	100.0	12.8		
50.0	3.2	110.0	14.9		
60.0	4.8	120.0	17.0
