**CALSPAN ON-SITE CERTIFIED ADVANCED-208 COMPLIANT VEHICLE
CRASH INVESTIGATION**

SCI CASE NO. – CA06-006

SUBJECT VEHICLE – 2006 PONTIAC G6

CRASH DATE – FEBRUARY 2006

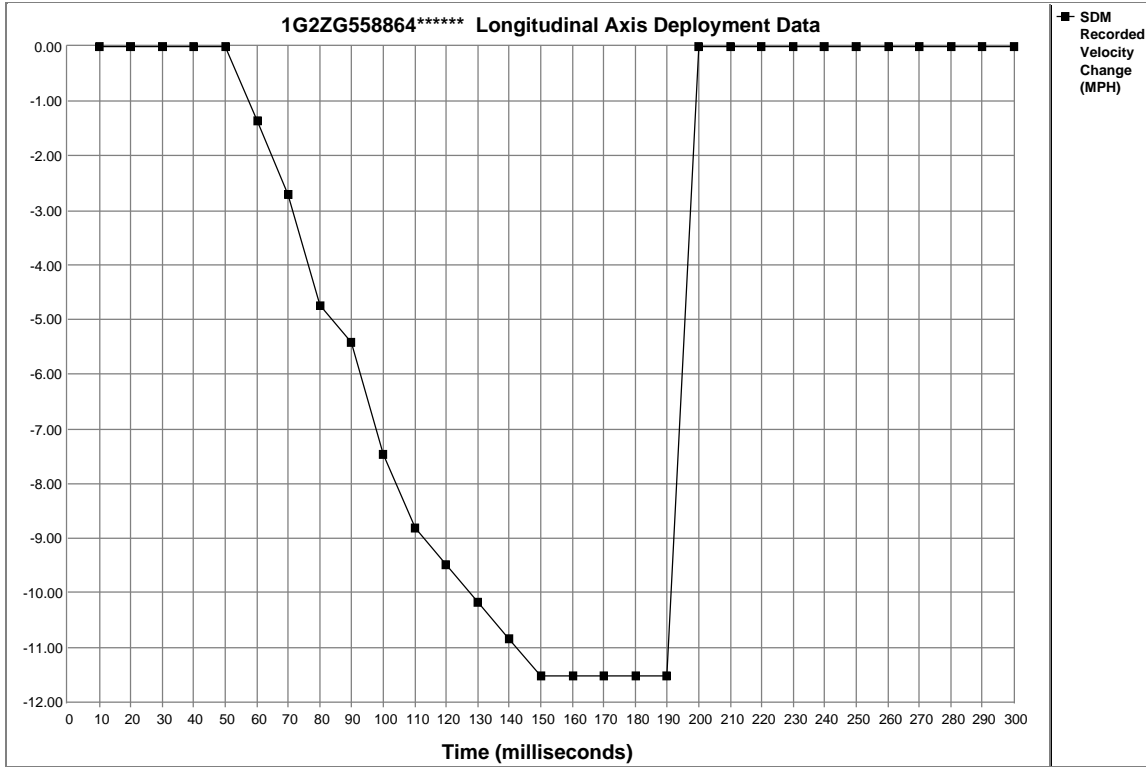
Time (milliseconds)	10	20	30	40	50	60	70	80	90	100	110	120	130	140	150
Longitudinal Axis Recorded Velocity	0.00	0.00	0.00	0.00	0.00	-1.36	-2.71	-4.74	-5.42	-7.46	-8.81	-9.49	-10.17	-10.85	-11.52
Time (milliseconds)	160	170	180	190	200	210	220	230	240	250	260	270	280	290	300
Longitudinal Axis Recorded Velocity	-11.52	-11.52	-11.52	-11.52	0.00	0.00	0.00	0.00	0.00	0.00	0.00	0.00	0.00	0.00	0.00

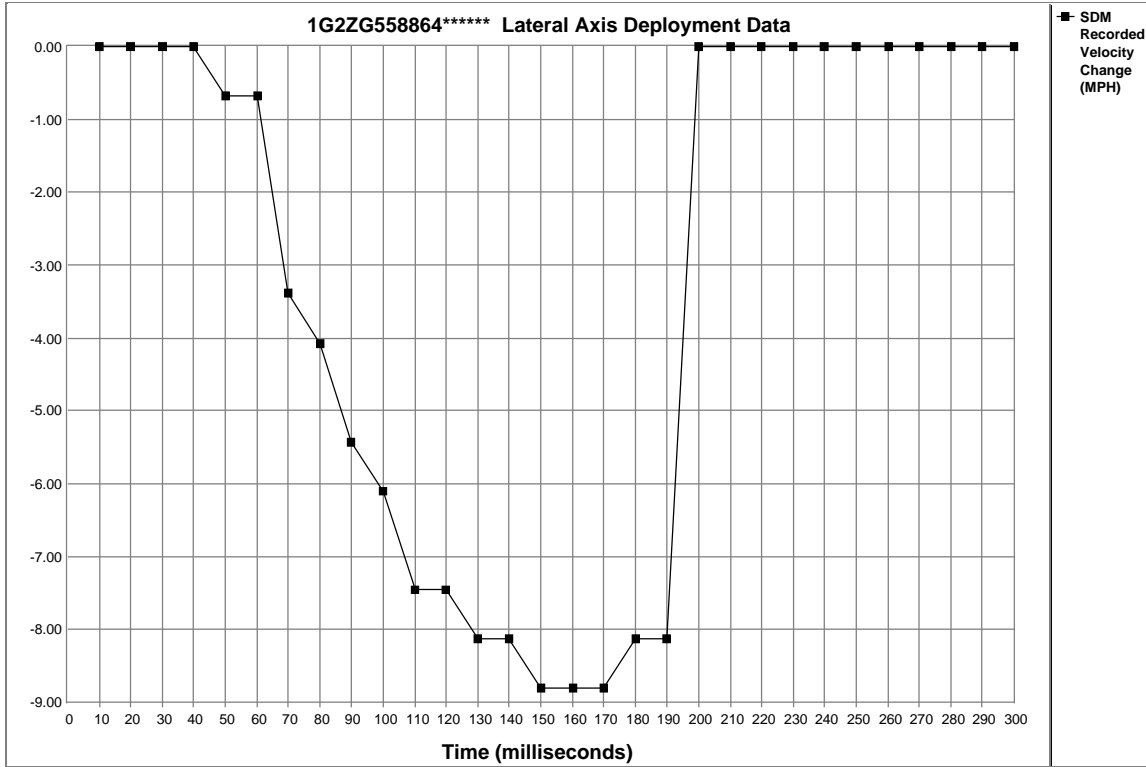
Time (milliseconds)	10	20	30	40	50	60	70	80	90	100	110	120	130	140	150
Lateral Axis Recorded Velocity Change (MPH)	0.00	0.00	0.00	0.00	-0.68	-0.68	-3.39	-4.07	-5.42	-6.10	-7.46	-7.46	-8.13	-8.13	-8.81
Time (milliseconds)	160	170	180	190	200	210	220	230	240	250	260	270	280	290	300
Lateral Axis Recorded Velocity Change (MPH)	-8.81	-8.81	-8.13	-8.13	0.00	0.00	0.00	0.00	0.00	0.00	0.00	0.00	0.00	0.00	0.00
