ON-SITE CHILD AIR BAG-RELATED FATALITY INVESTIGATION

CASE NUMBER - IN-06-011

VEHICLE - 1995 FORD WINDSTAR GL

CRASH DATE - May 2006

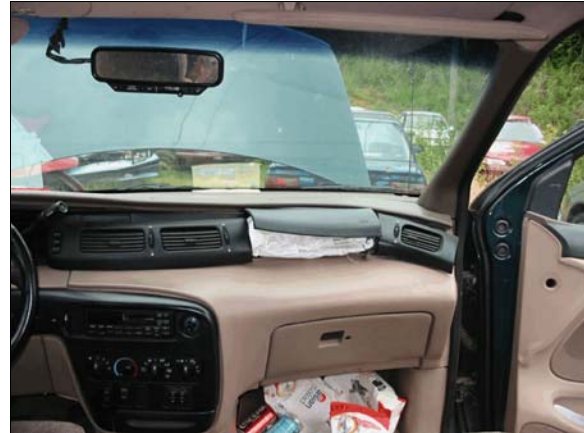
The front right passenger air bag was located in the middle of the instrument panel (Figure 14 below). The air bag module cover consisted of a single rectangular cover flap constructed of medium thickness, pliable vinyl. The cover flap was 33.5 centimeters (13.1 inches) in width and 12.5 centimeters (4.9 inches) in height. Inspection of the air bag module cover flap and the air bag fabric revealed that the cover flap opened at the designated tear points. There was no damage due to deployment to the cover flap or the air bag. The front right passenger air bag (Figure 15) was rectangular in shape and was approximately 71 centimeters (27.9 inches) in width and 64 centimeters (25.2 inches) in height. The air bag was designed without tethers had two vent ports, each 4.5 centimeters (1.8 inches) in diameter located at the 9:30 and 2:30 o'clock positions.

Figure 14: Overview of case vehicle's front right passenger air bag located in middle of right instrument panel

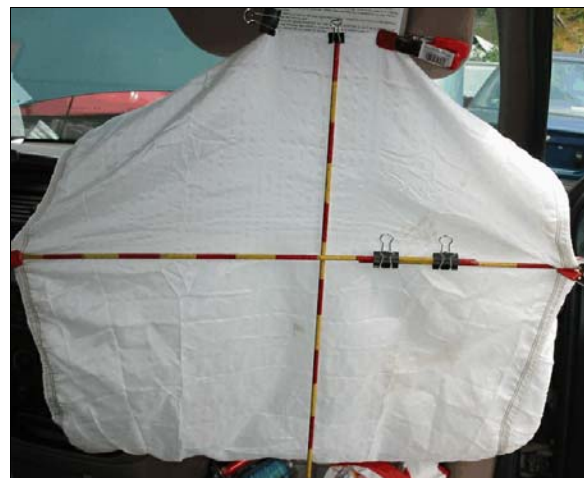
Figure 15: Case vehicle's front right passenger air bag
