**CALSPAN ON-SITE SIDE IMPACT PROTECTION SYSTEM CRASH  
INVESTIGATION**

**CASE NO: CA06-011**

**VEHICLE: 2006 HONDA CR-V**

1. Report No. CA06-011		2. Government Accession No.		3. Recipient's Catalog No.	
4. Title and Subtitle Calspan On-Site Certified Advanced 208-Compliant Vehicle Crash Investigation Vehicle: 2006 Honda CRV Location: State of New York				5. Report Date: October 2006

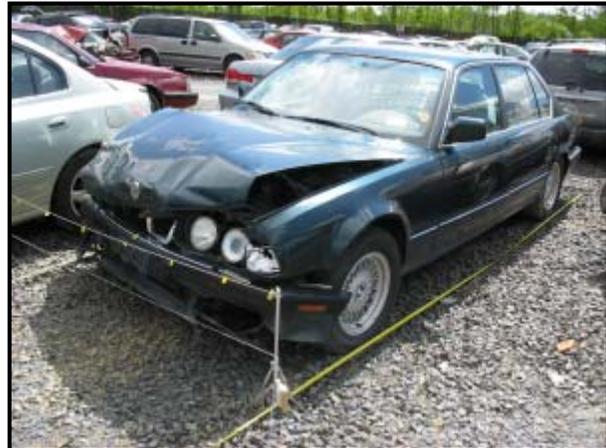
**Figure 3: Left front view of the BMW 740i.**

The BMW was equipped with air bags for the driver and front right passenger that deployed as a result of the crash. The BMW was equipped with Fuzion HRI P225/60R15 tires on OEM alloy wheels. The recommended tire pressure was 241 kPa (35 PSI) front and 269 kPa (39 PSI) rear. The specific measured tire data at the time of the SCI inspection was as follows:

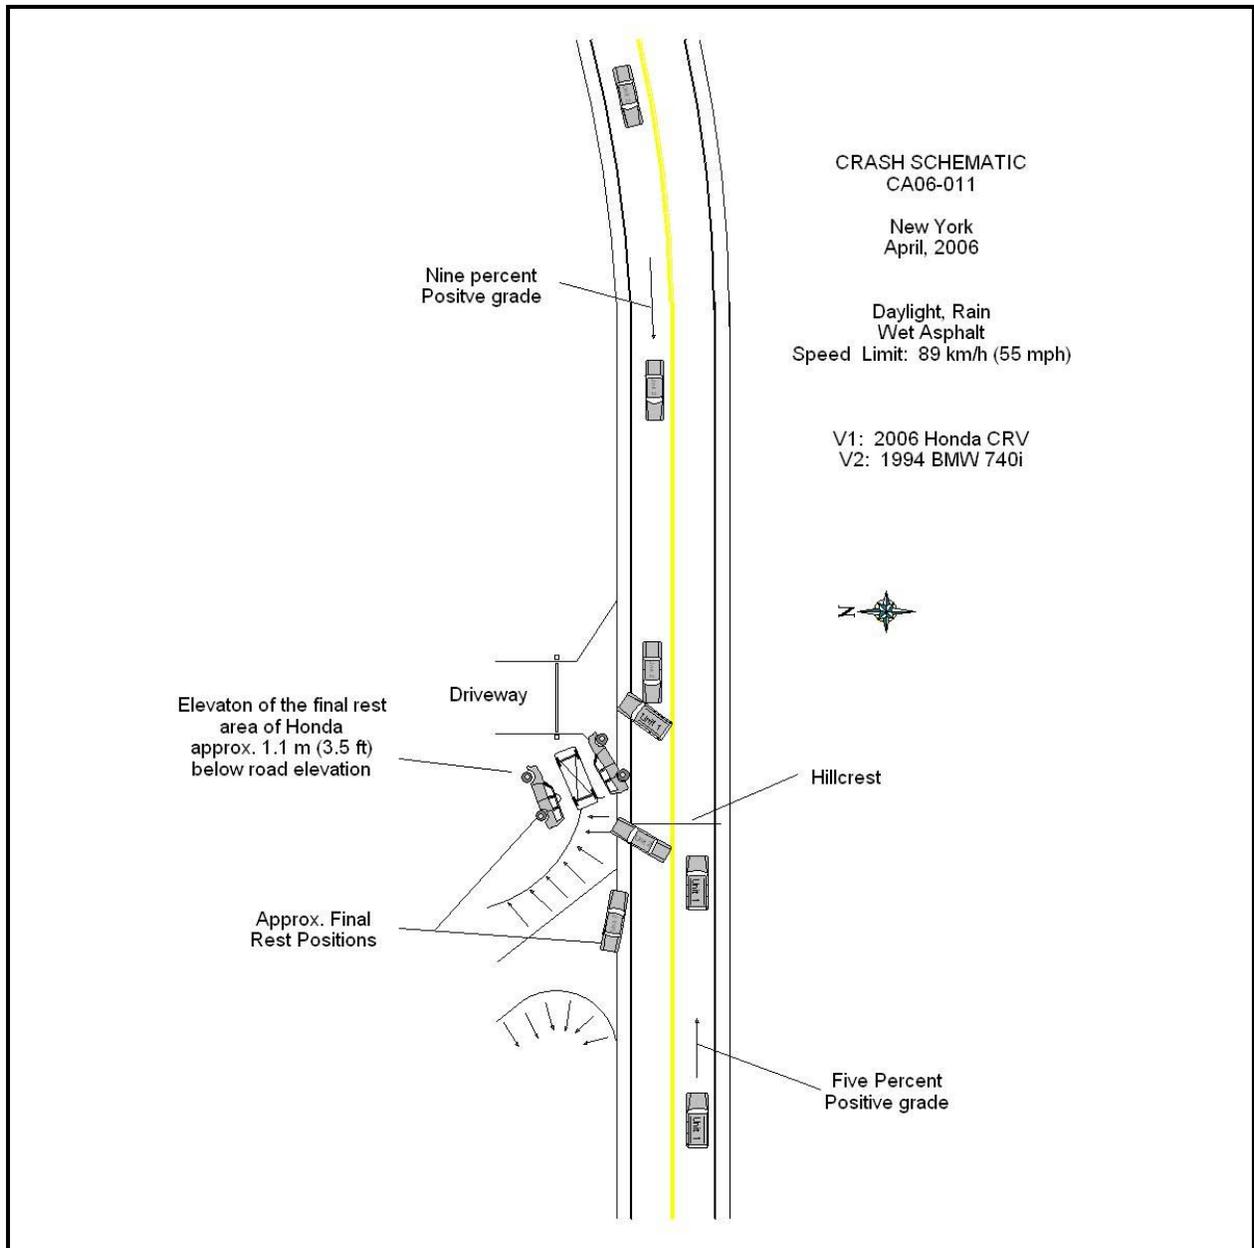
Figure 17 - Crash Schematic

The front plane of the BMW struck the right side plane of the Honda in an 11/2 o'clock impact configuration. The right front window glazing disintegrated in the impact. The westbound momentum of the BMW displaced the vehicles to the northeast and both vehicles began to rotate clockwise. The impact force caused the Honda's front safety belt pretensioners to fire and deployed the vehicle's inflatable right side occupant protection system. This protection system included a front seatback mounted thorax bag and a right side curtain mounted in the right roof rail. The force of the impact also caused the frontal air bags in the BMW to deploy. The severity (delta V) of the impact was calculated using the Damage Algorithm of the WINSMASH collision model. The total delta V of the Honda was 24 km/h (15.0 mph) with an estimated 50 degree Principle Direction of Force (PDOF). The Honda's longitudinal and lateral delta V components were -16 km/h (-9.6 mph) and -18 km/h (-11.4 mph), respectively. The total delta V of the BMW was 20 km/h (12.5 mph) with an estimated 340 degree PDOF. Its corresponding longitudinal and lateral components were -19 km/h (-11.7 mph) and 7 km/h (4.3 mph), respectively.

The Honda separated from the BMW sliding to the northwest and rotating counterclockwise. The Honda traveled across the mouth of the driveway and departed the north side of the road 4.3 m (14.1 ft) from the impact. Due to the negative slope of the roadside, the Honda began to fall over its left side. The Honda's rollover sensor assessed the change in the vehicle's roll rate and attitude and deployed the left side curtain. The weight shift to the left rear of the vehicle overloaded the left rear tire and caused the tire to air out. The Honda rolled three-quarter turns over its left side and came to rest on its right side approximately 10.6 m (35 ft) northeast of the impact. Two pools of disintegrated window glazing were identified along the vehicle's roll trajectory and established the area of the Honda's final rest. These two defined areas related to the disintegrated glazing of the left front and right rear windows, respectively. The BMW rotated approximately 190 degrees clockwise and slid to rest on the north shoulder of the road approximately 21 m (69 ft) from the impact.
