ON-SITE SIDE IMPACT INFLATABLE OCCUPANT PROTECTION INVESTIGATION

CASE NUMBER - IN-06-018

VEHICLE - 2006 MINI COOPER

CRASH DATE - May 2006

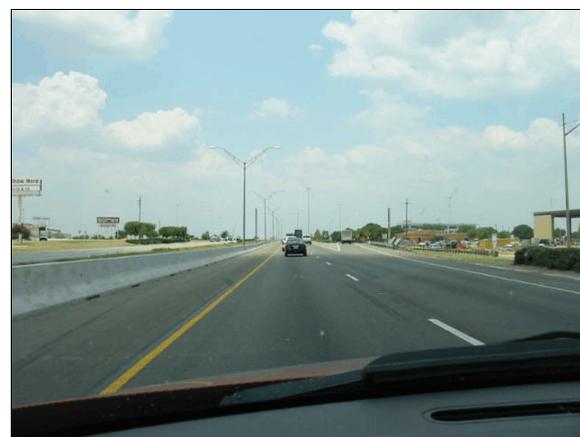
Figure 1: Overview of approach of case vehicle, Buick and Subaru in inside westbound lane to area of impact

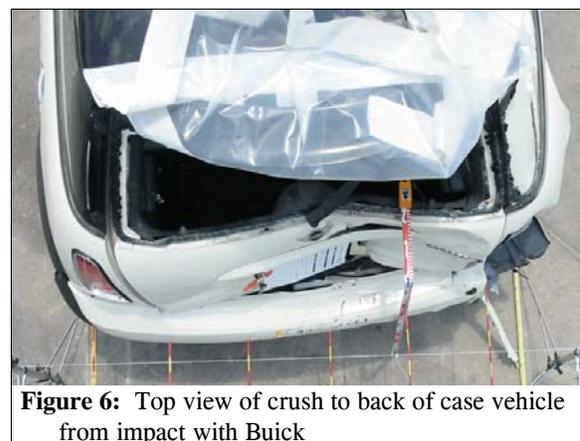
Exterior Damage: The case vehicle's impact with the Buick (event 1) involved approximately the right half of the case vehicle's back end. The back bumper, hatch and back of the right quarter panel were directly damaged and crushed forward. The direct damage began at the back right bumper corner and extended 68 centimeters (26.8 inches) across the back bumper. The residual maximum crush was measured as 11 centimeters (4.3 inches) occurring at C₅ (**Figure 6**). The table below shows the case vehicle's back crush profile.
