Child Safety Seat Fatality Investigation / Vehicle to Pole
Dynamic Science, Inc. / Case Number: DS06020
2006 Toyota Matrix
California
September 2006

1. Report No. DS06020	2. Government Accession No.		3. Recipient Catalog No.	
4. Title and Subtitle Child Safety Seat Fatality Investigation			5. Report Date February 10, 2007

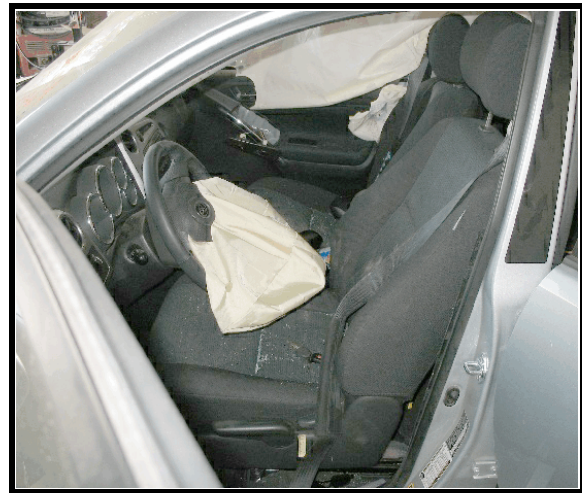
Figure 17. Driver's seated position

The 23-year-old female driver was likely seated in an upright posture. She was wearing the 3-point manual lap and shoulder belt. The shoulder belt anchorage was in the full down position. The fabric covered bucket seat was in the fully forward track position. The seat back was at a 30 degree angle from the vertical; the seat bottom was at a 13 degree angle from the horizontal. She likely had both hands on the steering wheel and was actively steering to the left and braking prior to impact. The driver was likely leaning to the right to some degree in response to centrifugal forces. At impact, the frontal air bag deployed and the seat belt pretensioner actuated. The female driver initiated a forward and slightly right lateral trajectory. She likely loaded the seat belt to some degree as she pitched forward and to the right. Her right hip likely came into contact with the center console. She complained of pain to her neck, right shoulder, back and right hip and groin. She was transported by ground ambulance for treatment.
