Rollover and Child Safety Seat Investigation / Rollover
Dynamic Science, Inc. / Case Number: DS06021
2006 Ford Freestar
Arizona
May 2006

1. Report No. DS06021		2. Government Accession No.		3. Recipient Catalog No.	
4. Title and Subtitle Rollover and Child Safety Seat Investigation				5. Report Date April 13, 2007

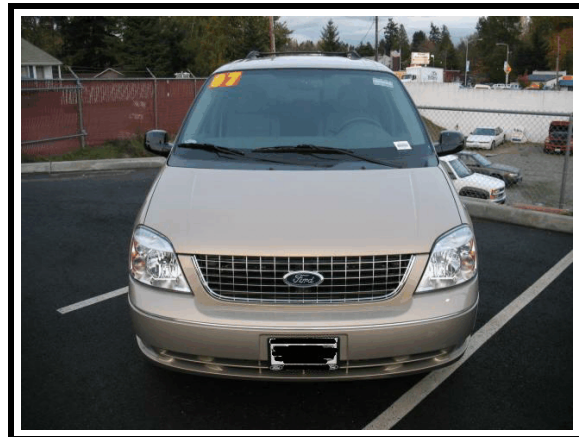
Figure 2. Front, exemplar vehicle (2007 Ford Freestar; 2006 model not available)

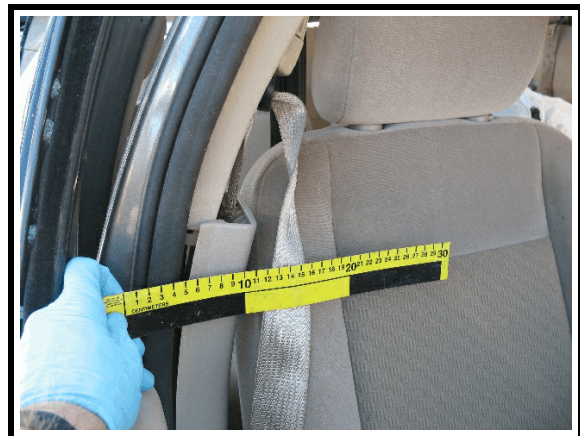
The driver's seat belt was equipped with a sliding latchplate and an Emergency Locking Retractor (ELR). The seat belt exhibited signs of usage during the crash; no failures were noted (see Figure 20). The remaining six passenger belts were equipped with sliding latchplates and switchable ELR/Automatic Locking Retractors (ALR). There was blood found on the right front seat belt webbing. This belt showed signs of being used during the crash and was found locked in the D-ring (see Figure 21). The second row left seat belt showed no visible signs of loading that would have been consistent with its having been used during the crash. The second row right seat belt showed signs of occupant loading and blood was found on both the lap and shoulder portions. The distance between the seat belt stop button and the evidence of occupant loading to this belt was 51.0 cm (20.1 in).

Figure 20. Driver's seat belt

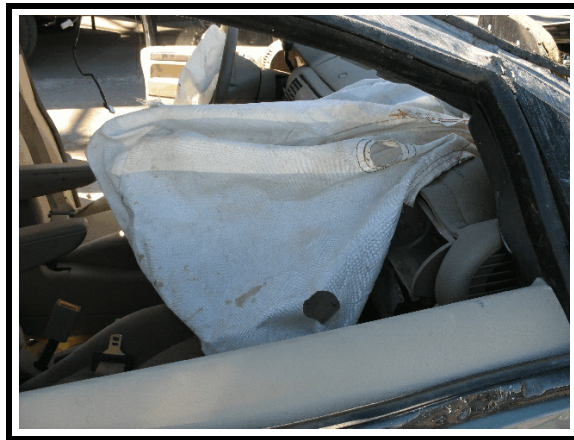
During the crash sequence, the driver and right front passenger air bags deployed. The driver’s air bag deployed from the center of the steering wheel hub through I-configuration cover flaps (see Figure 23). There was a third flap located at the top of the side flaps that measured 13.5 cm (5.3 in) wide by 6.0 cm (2.4 in) high. The top and bottom sections of the left and right cover flaps measured 8.0 cm (3.1 in) wide and both flaps were 9.5 cm (3.7 in) high. The deployed driver air bag measured 42.0 cm (16.5 in) in diameter in its deflated state. The air bag was tethered by a single internal strap and there were two circular vent ports located at the 11 and 1 o’clock positions on the rear of the air bag. There was blood on the lower center section of the back of the air bag which may have been a result of post-crash contact by one or more of the vehicle occupants (see Figure 24). There was no damage or occupant contact visible on the cover flaps.

Figure 24. Blood on back/lower section of the driver's deployed front air bag

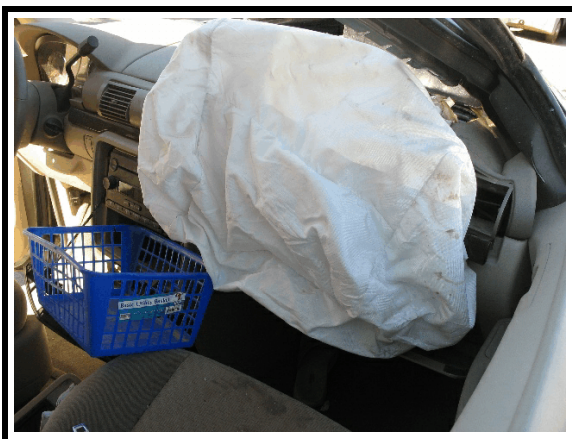
Figure 25. Location of right vent ports

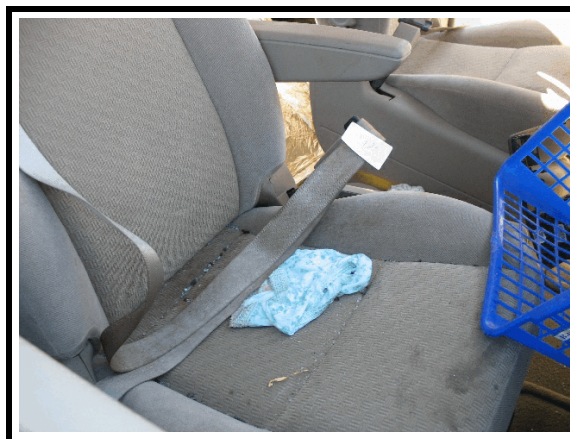
Figure 30. Right front seat belt

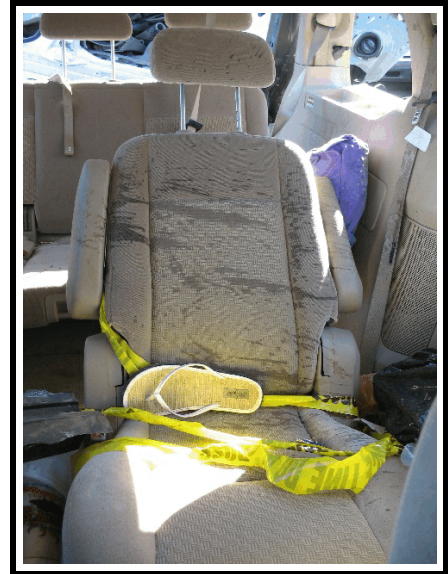
Figure 32. Second row left seat

As the Freestar continued to rollover, this occupant was thrown around inside the passenger compartment. During the rollover event, this pregnant occupant was fully ejected from the vehicle. It is likely that she was ejected through the second row right window glazing, which had disintegrated during the crash. There was blood found on the right rear window frame and to the top outer portion of the right rear door and roof side rail.

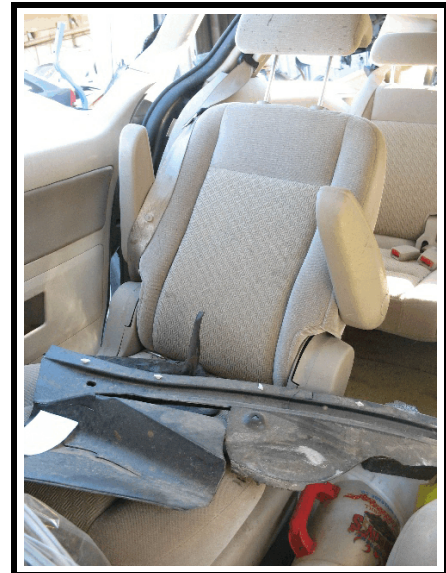
Figure 34. Second row right seat

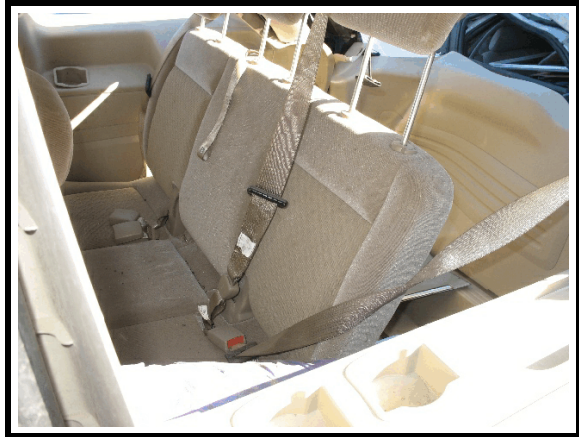
When the Freestar departed the freeway to the left, the driver began to actively steer to the right but overcorrected, causing the vehicle to go into a clockwise rotation. This passenger was likely leaning to the left in response to centrifugal forces. As the vehicle rolled with the left side leading, her body pitched even further to the left. As the Freestar continued to rollover, this passenger likely came in contact with the child safety seat that was secured in the third row center seating area.

Figure 35. Third row left seating area

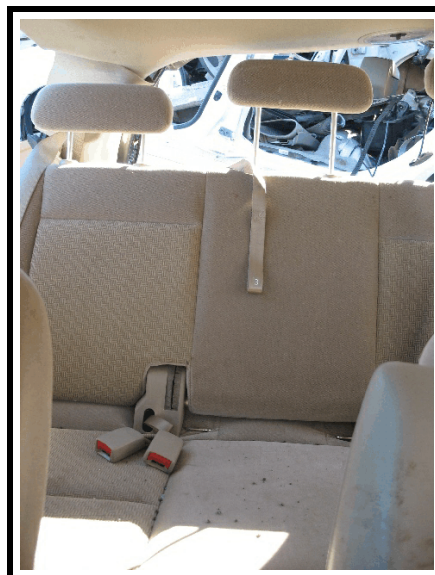
As the vehicle rolled with the left side leading, this passenger's body pitched even further to the left, likely coming in contact with the padding on the inside of the safety seat. As the Freestar continued to rollover, this passenger remained within her child safety seat, but it is not known how she was restrained. She was removed from the vehicle by the driver and was transported by ambulance to the hospital where she was hospitalized for three days with contusions to her upper chest, right pelvis, left leg and left arm.

Figure 36. Third row center seating area

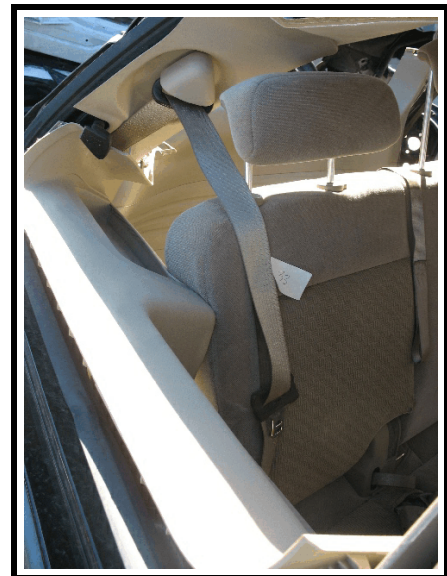
Figure 37. Third row right seating area

As the vehicle rolled with the left side leading, this unrestrained 3-year-old passenger pitched even further to the left and likely came in contact with the right side of the child safety seat that was secured in the seat to his left.
