Certified Advanced 208-Compliant Air Bag Investigation / Multiple Vehicles
Dynamic Science, Inc. / Case Number: DS06028
2005 Chevrolet Trailblazer LS
Washington
October 2006

1. Report No. DS06028	2. Government Accession No.		3. Recipient Catalog No.	
4. Title and Subtitle Certified Advanced 208-Compliant Air Bag Investigation			5. Report Date May 7, 2007

Background

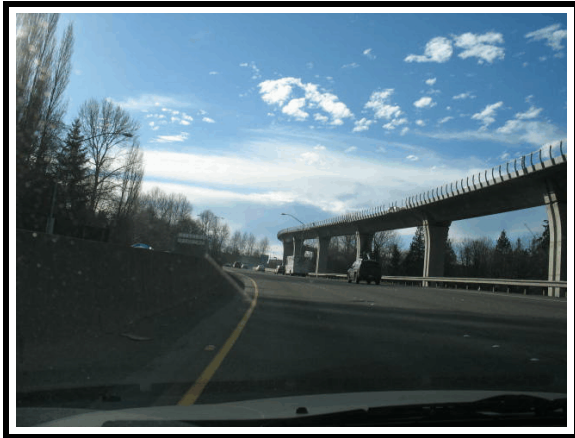
Figure 4. Approach of case vehicle to crash area (west)

All three vehicles were traveling in the westbound lanes of a divided state freeway. The Chevrolet Trailblazer was traveling in the inside westbound lane, the Acura was traveling in the right lane, and the tractor-trailer was traveling in the center lane.

According to the police report, the driver of the tractor-trailer began to slow due to a collision that had occurred in front of him. According to the driver of the case vehicle, as the semi was braking, a non-contact vehicle that had been traveling immediately behind the semi swerved into the Trailblazer's path of travel. The driver of the Trailblazer braked and swerved right to avoid striking the non-contact vehicle.

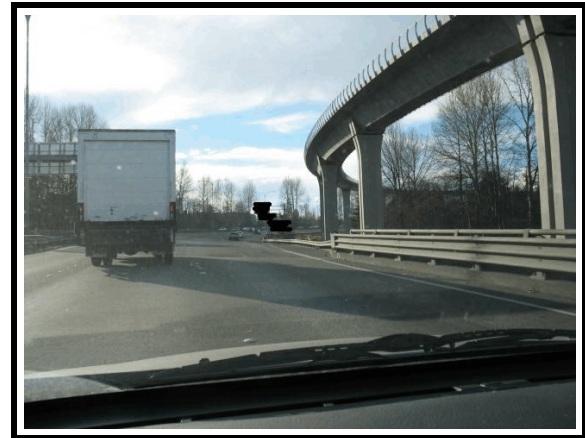
Figure 6. Approximate area of impact between the case vehicle & the Acura 3.2TL

After the initial impact, the Trailblazer rotated counterclockwise and its back right bumper corner impacted (06BREN1) the left side of the Acura. All three vehicles came to final rest near the points of impact.

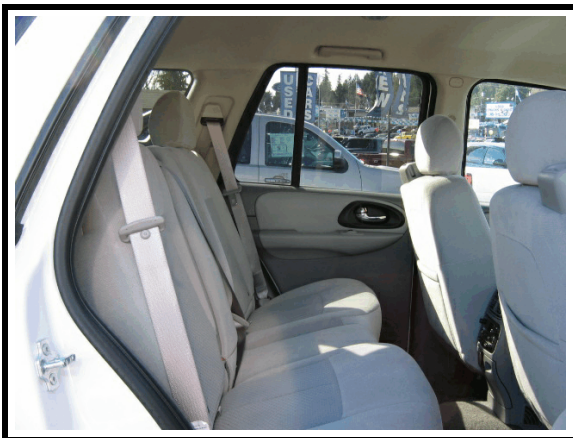
Figure 15. 2nd row seatbacks - exemplar vehicle

The second row seatback was damaged and had intruded longitudinally into the second row seating area. The damage was caused by contact from subwoofers that had been installed behind the seat backs.

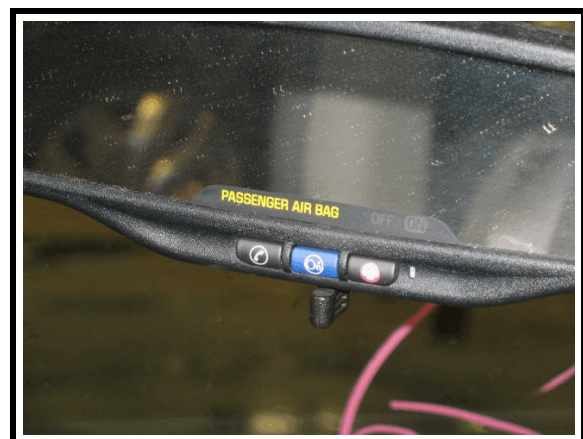
The PSS works with sensors located in the front right passenger seat and safety belt. These sensors are designed to detect the presence of a properly seated occupant and under certain conditions, the PSS will turn off the passenger front air bag. Some of these conditions include: when the front right passenger seat is unoccupied, when the PSS determines that an infant is present in a rear-facing infant seat, and when the right front seat is occupied by a smaller person. There is a passenger air bag status indicator located in the rearview mirror which displays “ON” or “OFF” when the vehicle is running. Whenever the PSS has turned off the right front air bag, the “OFF” indicator located on the rearview mirror will illuminate.

Figure 17. Passenger Air Bag On/Off indicator (on rearview mirror)

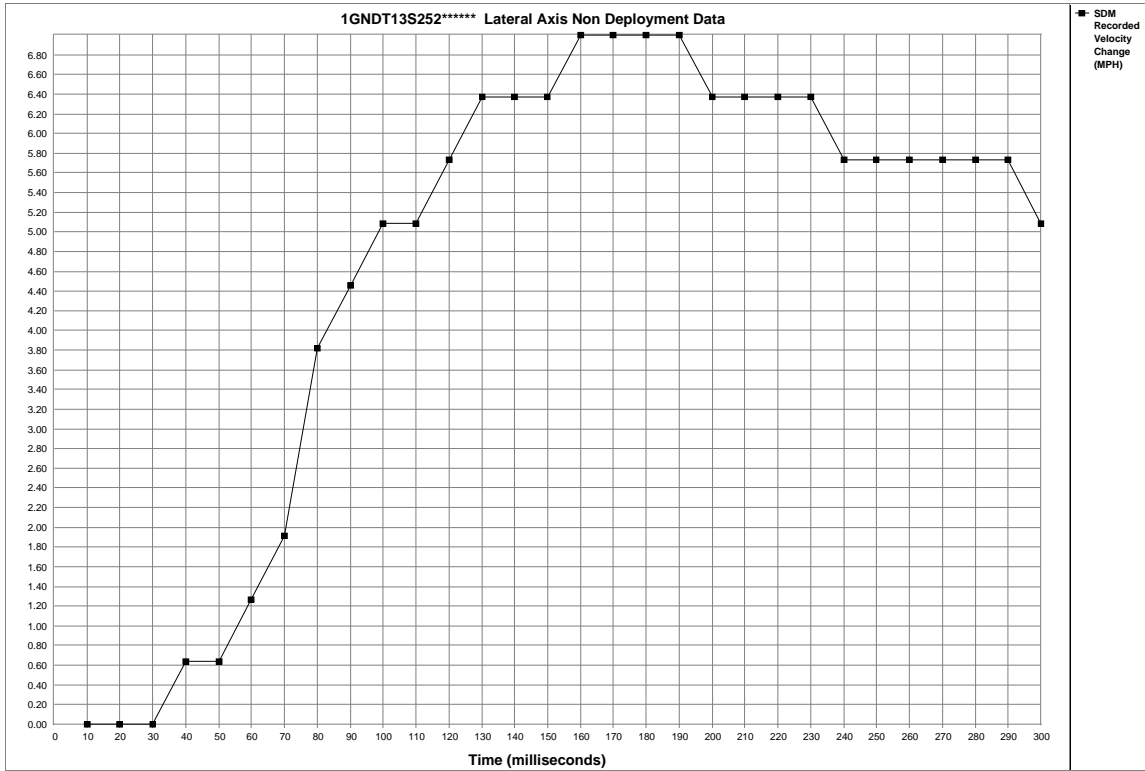
Time (milliseconds)	10	20	30	40	50	60	70	80	90	100	110	120	130	140	150
Longitudinal Axis Recorded Velocity	0.00	0.00	-1.27	-1.91	-2.55	-4.46	-7.00	-11.46	-14.01	-15.28	-19.10	-22.29	-25.47	-29.29	-30.56
Time (milliseconds)	160	170	180	190	200	210	220	230	240	250	260	270	280	290	300
Longitudinal Axis Recorded Velocity	-31.20	-32.47	-32.47	-32.47	-32.47	-32.47	-32.47	-32.47	-31.84	-31.84	-31.84	-31.84	-31.20	-31.20	-31.20

Time (milliseconds)	10	20	30	40	50	60	70	80	90	100	110	120	130	140	150
Lateral Axis Recorded Velocity Change (MPH)	0.00	0.00	0.00	0.64	0.64	1.27	1.91	3.82	4.46	5.09	5.09	5.73	6.37	6.37	6.37
Time (milliseconds)	160	170	180	190	200	210	220	230	240	250	260	270	280	290	300
Lateral Axis Recorded Velocity Change (MPH)	7.00	7.00	7.00	7.00	6.37	6.37	6.37	6.37	5.73	5.73	5.73	5.73	5.73	5.73	5.09
