ON-SITE CHILD SAFETY SEAT INVESTIGATION

CASE NUMBER - IN-06-034

VEHICLE - 2003 HYUNDAI ELANTRA XD

CRASH DATE - November 2006

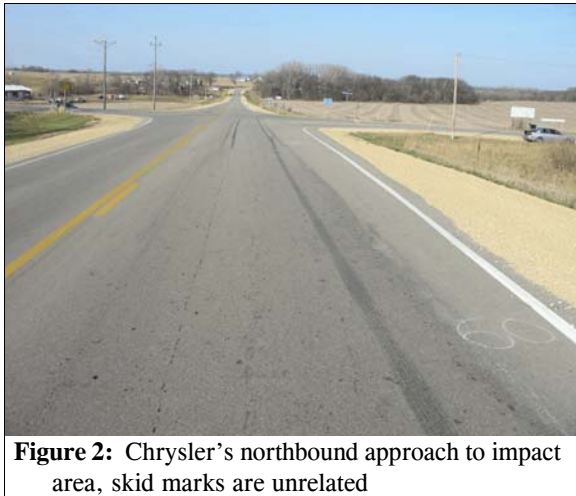
Pre-Crash: The case vehicle was traveling east in the eastbound lane (**Figure 1** above) approaching the stop sign at the intersection. The case vehicle's driver was intending to proceed straight ahead through the intersection. The sheriff's department crash report indicated that the case vehicle's driver failed to yield the right-of-way and entered the intersection. The Chrysler was traveling north in the northbound lane (**Figure 2**) also approaching the intersection. The Chrysler's driver was intending to continue northbound through the intersection. The case vehicle's driver made no avoidance maneuvers prior to the crash. The crash occurred in the four-leg intersection of the two trafficways (**Figure 3**).
