Remote Combination ODI Passenger Air Bag Deployment Investigation  
Dynamic Science, Inc. (DSI), Case Number 2007-75-135J  
2007 Dodge Charger  
Colorado  
November 2007

1. Report No. 2007-75-135J	2. Government Accession No.		3. Recipient Catalog No.	
4. Title and Subtitle  Remote Combination ODI Passenger Air Bag Deployment Investigation			5. Report Date November 12, 2008

**Dynamic Science, Inc.**  
**Crash Investigation**  
**Case Number: 2007-75-135J**

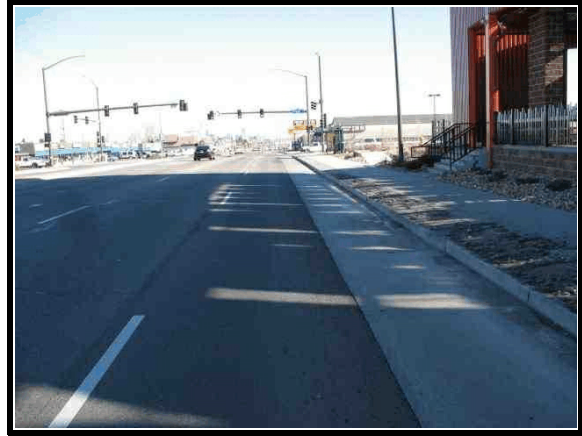
**Figure 2.** Eastbound approach for 2007 Dodge Charger

The Dodge Charger was traveling eastbound in the outboard lane (**Figure 2**) at a police reported speed of 113 km/h (70 mph). The Ontario bus was being driven by a 41-year-old male (**Figure 3**). The driver of the bus had brought the vehicle to a controlled stop just west of the bus shelter in the outboard travel lane. The door of the bus was open and passengers were entering and exiting the bus. A total of 30 passengers were on the bus. The driver of the Charger applied the brakes prior to impact; there was no evidence of lockup.

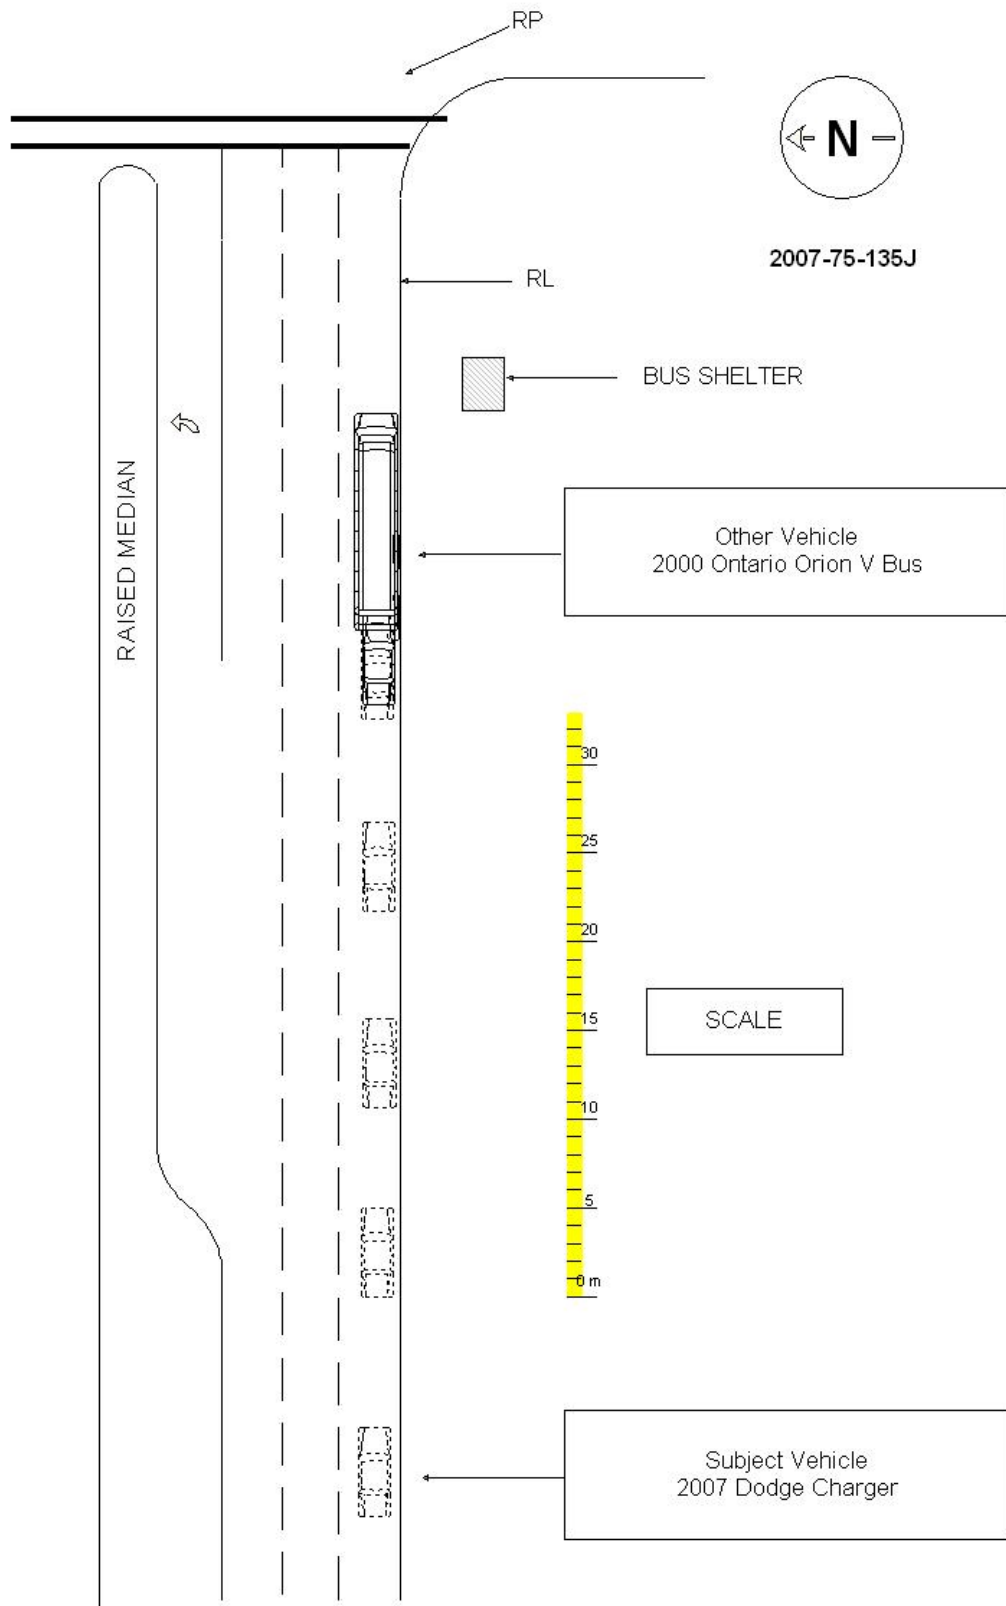
**Attachment 1. Scene Diagram**

The front of the Dodge Charger struck the rear of the Ontario Orion bus (**Figure 4**). The impact was severe, and resulted in the deployment of the frontal air bag system in the Charger. The Barrier algorithm of the WinSmash program computed a total delta V of 51 km/h (31.6 mph), based on the Charger's front end crush profile. The Charger came to rest at approximately the same location as the impact.
