**CALSPAN ON-SITE CHILD SAFETY SEAT CRASH INVESTIGATION  
CALSPAN CASE NO.: CA07-007**

**LOCATION: NEW JERSEY**

**VEHICLE: 1998 NISSAN QUEST**

**CRASH DATE: JANUARY 2007**

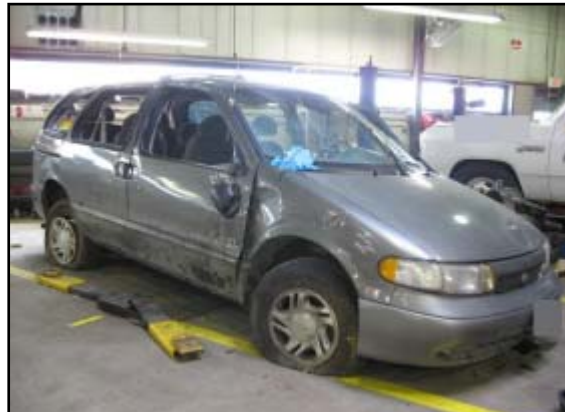
This on-site investigative effort focused on a Rear Facing Child Safety Seat (RFCSS), the injury sources for an 11-month-old female passenger, and the ejection of the RFCSS and the infant passenger. The infant passenger was restrained in the RFCSS in the second row left position of a 1998 Nissan Quest (**Figure 1**). Additionally, the Nissan was occupied by a 21-year-old male driver, a 17-year-old female front right passenger, and a 23-year-old female second row right passenger. The Quest was involved in a moderate severity run-off-road rollover

**Figure 1. Subject vehicle 1998 Nissan Quest.**

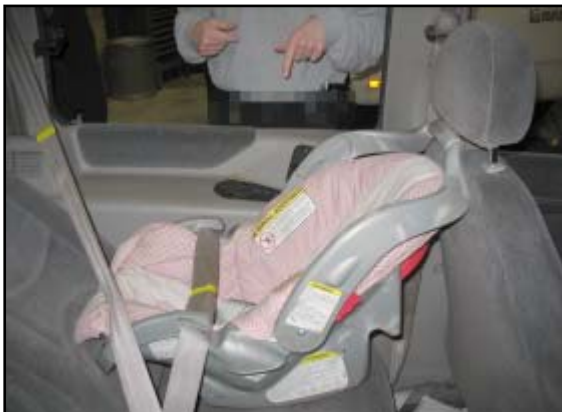
The exposed portion of the webbing in the buckled position at the time of the crash was approximately 140 cm (50"). The RFCSS was repositioned on the left rear seat (**Figure 11**) to determine the position of the safety belt. The amount of exposed webbing was not sufficient to install the RFCSS using the belt path. To install the RFCSS, the SCI investigator unbuckled the safety belt and rerouted the lap belt through the belt path (**Figure 12**). In **Figure 11**, the yellow markings on the webbing indicate the location of the webbing in the post-crash position. Inspection of the safety belt webbing and the components revealed no crash related evidence (i.e., frictional abrasions on the hard points or loading of the webbing).

**Figure 11. Reinstalled RFCSS using the belt path.**
