Rollover/Child Safety Seat Investigation / Vehicle to Object  
Dynamic Science, Inc. / Case Number: DS07011  
1996 Jeep Grand Cherokee  
Utah  
February 2007

1. Report No. DS07011	2. Government Accession No.		3. Recipient Catalog No.	
4. Title and Subtitle Rollover/Child Safety Seat Investigation			5. Report Date June 10, 2007

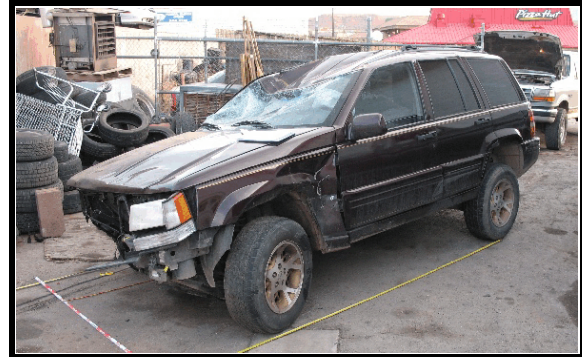
This on site investigation focused on the dynamics of a 1996 Jeep Grand Cherokee during a rollover crash, and on the performance of two child safety seats installed in the rear of the Jeep (**Figure 1**). A forward facing Graco CarGo booster seat was positioned in the second row left of the Jeep Grand Cherokee, and a rear-facing Evenflo Embrace infant seat was positioned in the second row right. This single vehicle crash occurred in February 2007 at 1047 hours. The crash occurred on a two lane local roadway, with a posted speed limit of 48 km/h (30 mph). The vehicle was driven by a 22-year-old female, and there were three child occupants in the second row, ages 6 months, 6 years, and 2 years. The 6-month-old was restrained in a rear facing infant seat; the 2-year-old was restrained in a forward facing child safety seat. The case vehicle was traveling westbound when the driver departed the roadway on the right side in a curve. The front of the Jeep struck an outcropping of rocks. The vehicle rotated in a clockwise direction and rolled over onto its roof. All of the occupants were transported to a local hospital where they were treated and released. The vehicle was towed from the scene due to damage.

**Figure 1.** Case vehicle, 1996 Jeep Grand Cherokee

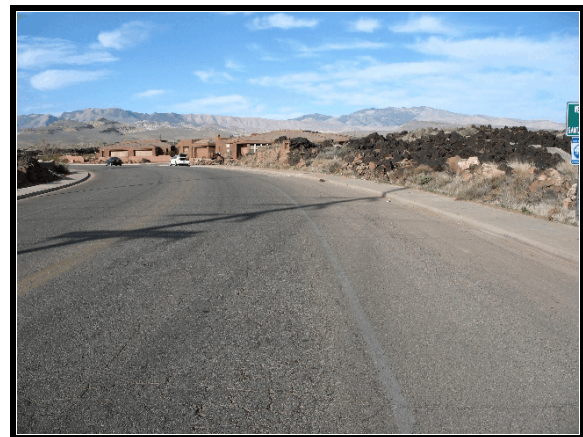
This single vehicle crash occurred while the vehicle was negotiating a left hand curve in February 2007 (**Figure 2**). At the time of the crash, there were no adverse weather conditions and the asphalt roadway surface was dry. The east/west roadway was configured with a single lane in each direction that were separated by a double-yellow painted centerline. Each travel lane was bordered on the outside by a wide paved shoulder that was marked with a single white fog line. Adjacent to the shoulder was a concrete curb and concrete sidewalk. Adjacent to the sidewalk was an outcropping of rocks. The roadway had a radius of 166 m (544 ft) near the point of departure. The speed limit for this location was 48 km/h (30 mph).

**Figure 2.** Approach to area of roadway departure (west)

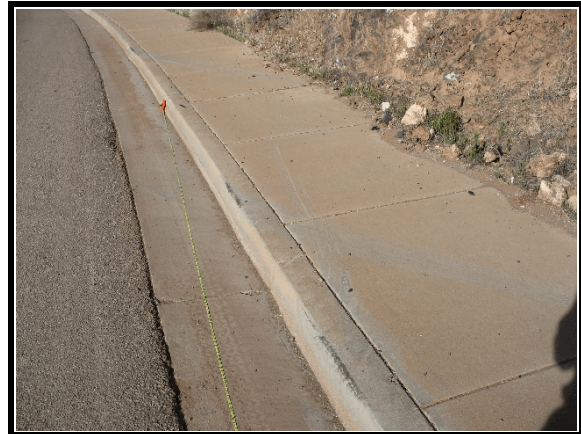
As the vehicle entered the left hand curve, the 22-year-old driver lost control of the vehicle and the vehicle departed the right side of the roadway (**Figure 3**).

**Figure 3.** Area of roadway departure

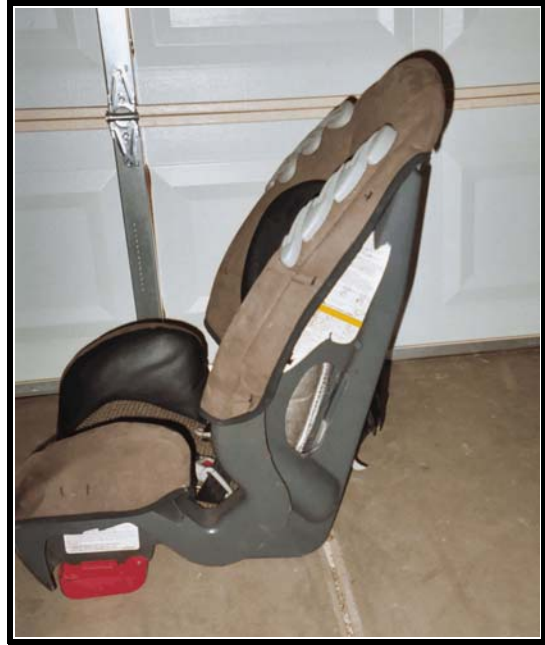
In this crash, the child was using the internal harness. The child's height was 94 cm (37 in) and her weight was 16 kg (35 lbs), which was within the manufacturer's recommended height and weight guidelines.

**Figure 13.** Side view, Graco CarGo booster seat

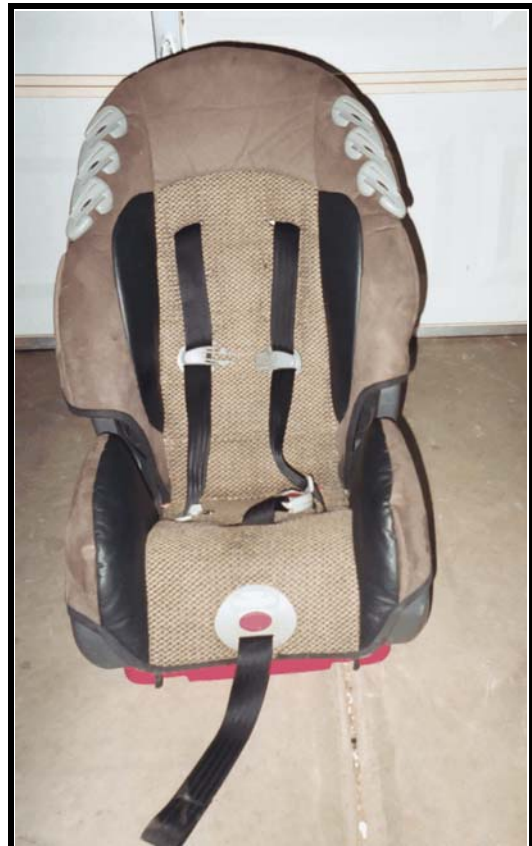
**Figure 14.** Graco CarGo booster seat

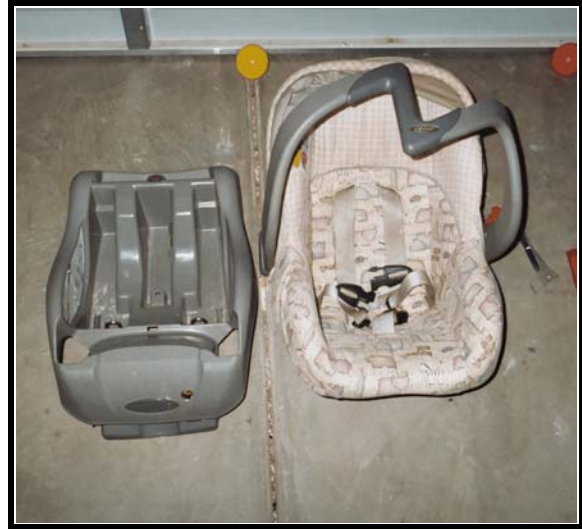
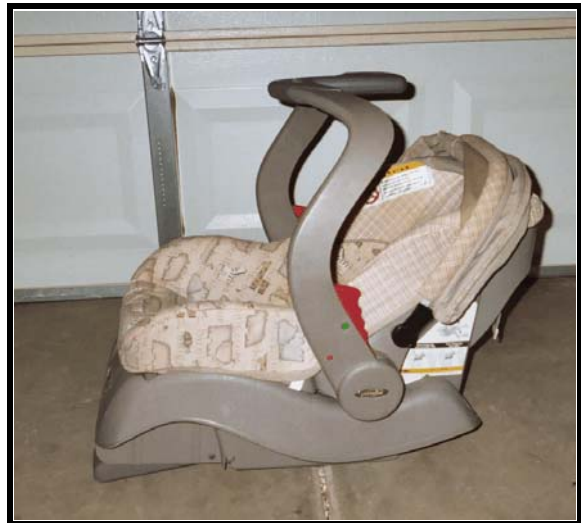
A rear-facing Evenflo Embrace infant safety seat (ISS) was secured in the second row right seat position of the Jeep Grand Cherokee (**Figures 15-16**). The model number of the seat was 5481586 and the date of manufacture was November 3, 2005. The infant seat was configured with a 5-point internal harness system and a two-piece locking harness retainer clip. The seat was designed with three shoulder harness positions. At the time of the crash, the harness was in the top position. The seat was designed to be used with a stay-in-vehicle base. The base was in use at the time of the crash. The infant seat carrying handle was in the down position. The ISS handle was the subject of a recall in 2007. The recall involved the ISS when it was being carried, and had no impact in this crash. The seat base was designed to be used with a LATCH strap, which was not used. The manufacturer recommends that the seat be used for infants weighing between 2.3-10 kg (5-22 lbs) and between 48-66 cm (19-26 in) in height. The child's weight was 7 kg (15 lbs), which was within the manufacturer's recommended weight guidelines. Her height was 69 cm (27 in), which put her just above the recommended height guideline.

The infant seat was secured in the rear-facing configuration using the vehicle's lap and shoulder belt by the driver. The seat belt was configured with a lightweight/cinching locking latch plate. The seat belt was routed through the rear facing slots of the stay-in-vehicle base. According to the driver, the seat base was installed tightly. The seat belt was cut during the extrication of the child. There were no other indications of usage.

**Figure 15.** Evenflo Embrace infant seat and seat base

**Figure 16.** Evenflo infant seat and seat base (assembled)
