**CALSPAN ON-SITE SIDE IMPACT INFLATABLE OCCUPANT PROTECTION
SYSTEM INVESTIGATION**

SCI CASE NO. – CA07-013

SUBJECT VEHICLE – 2005 FORD FREESTYLE

CRASH DATE – MARCH 2007

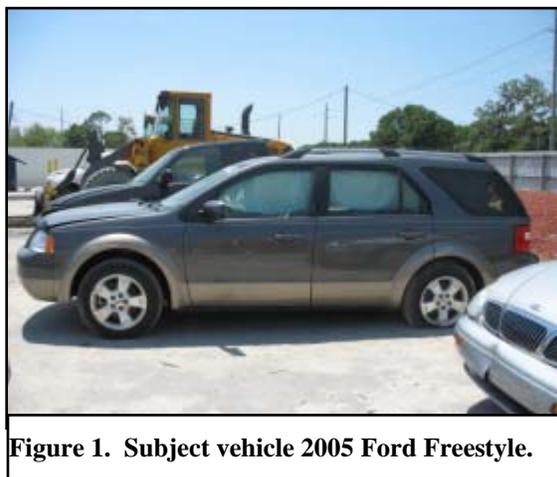
Figure 1. Subject vehicle 2005 Ford Freestyle.

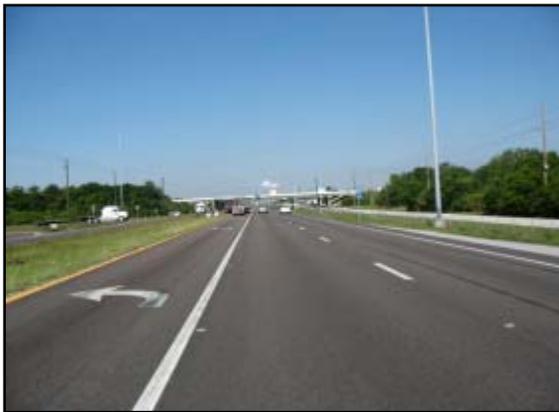
A restrained 37-year-old female driver was operating the Ford westbound on the inboard through lane (**Figure 2**) approaching the intersection. As the vehicle approached the intersection, the driver initiated a left turn maneuver across the left turn lane. There were two non-contact vehicles stopped in the left turn lane waiting for traffic to clear. The drivers of the non-contact vehicles witnessed the pre-crash travel of the Ford and the impact. Reportedly, the driver of the Ford was visiting from another state and was unfamiliar with the roadway. A 35-year-old male was operating the Freightliner eastbound on the outboard lane approaching the intersection. As the Freightliner neared the intersection, the Ford traversed the inboard eastbound lane and entered the outboard lane. The driver of the Freightliner observed the Ford and applied the brakes in an attempt to avoid the crash. The brake application locked the Freightliner's rear tires and resulted in approximately 40 meters (130 feet) of skid marks leading to the intersection. The police on-scene images of the Freightliner's approach depict the skid marks (**Figure 3**). Due to the heavy traffic pattern and the passage of time between the crash date and SCI investigation, the pre-impact skid marks from the Freightliner had eroded and were not present on the roadway at the time of the SCI inspection.

Figure 2. Ford's westbound approach to the intersection.

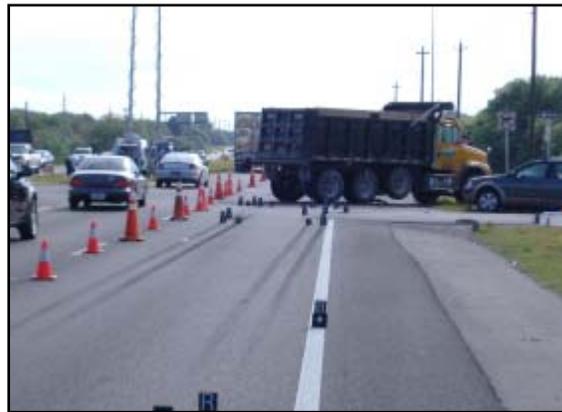
Figure 3. Freightliner's pre-impact skid marks.

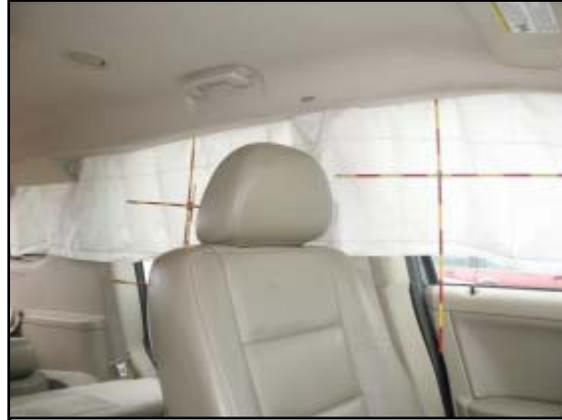
Figure 9. Deployed left canopy air bag.

In the subject crash, the right and left canopy air bags deployed. The canopy air bags deployed as a result of the right side impact and were commanded by the side impact sensor.

The canopy air bags were rectangular in shape and measured 41 cm (16") vertically from the roof side rail and 239 cm (94") in length. The air bags were tethered by a sail-panel at the A-pillar and a rope-type tether at the C-pillar. The sail-panel at the A-pillar measured 32 cm (12.75") in height and 38 cm (15") in length. The tether at the C-pillar measured 18 cm (7") in length. No occupant contacts were noted to the left canopy air bag. **Figure 9** is an overall view of the deployed left canopy air bag.

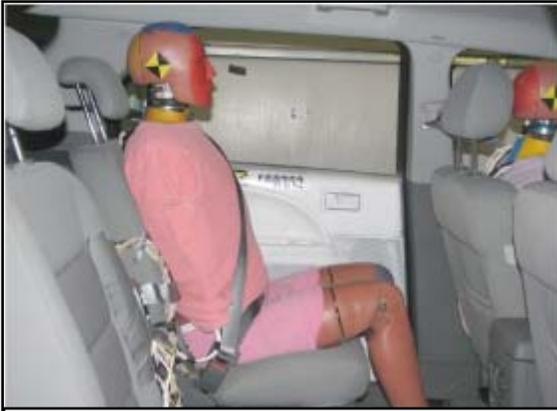
In a side impact crash test conducted by Karco on August 18, 2006 for NHTSA's SNCAP, Test number 5829, the left canopy air bag deployed in a similar pattern. The test video shows the impeded deployment of the canopy air bag. As the air bag reached its fully deployed status, the C-pillar trim panel was dislodged from its top mounting points and the membrane inflated behind the panel. **Figures 13 and 14** are images of the second row left side canopy air bag system pre- and post-test. In the post-test image the canopy air bag was captured behind the C-pillar trim panel.

Figure 13. Pre-test view of the left side.

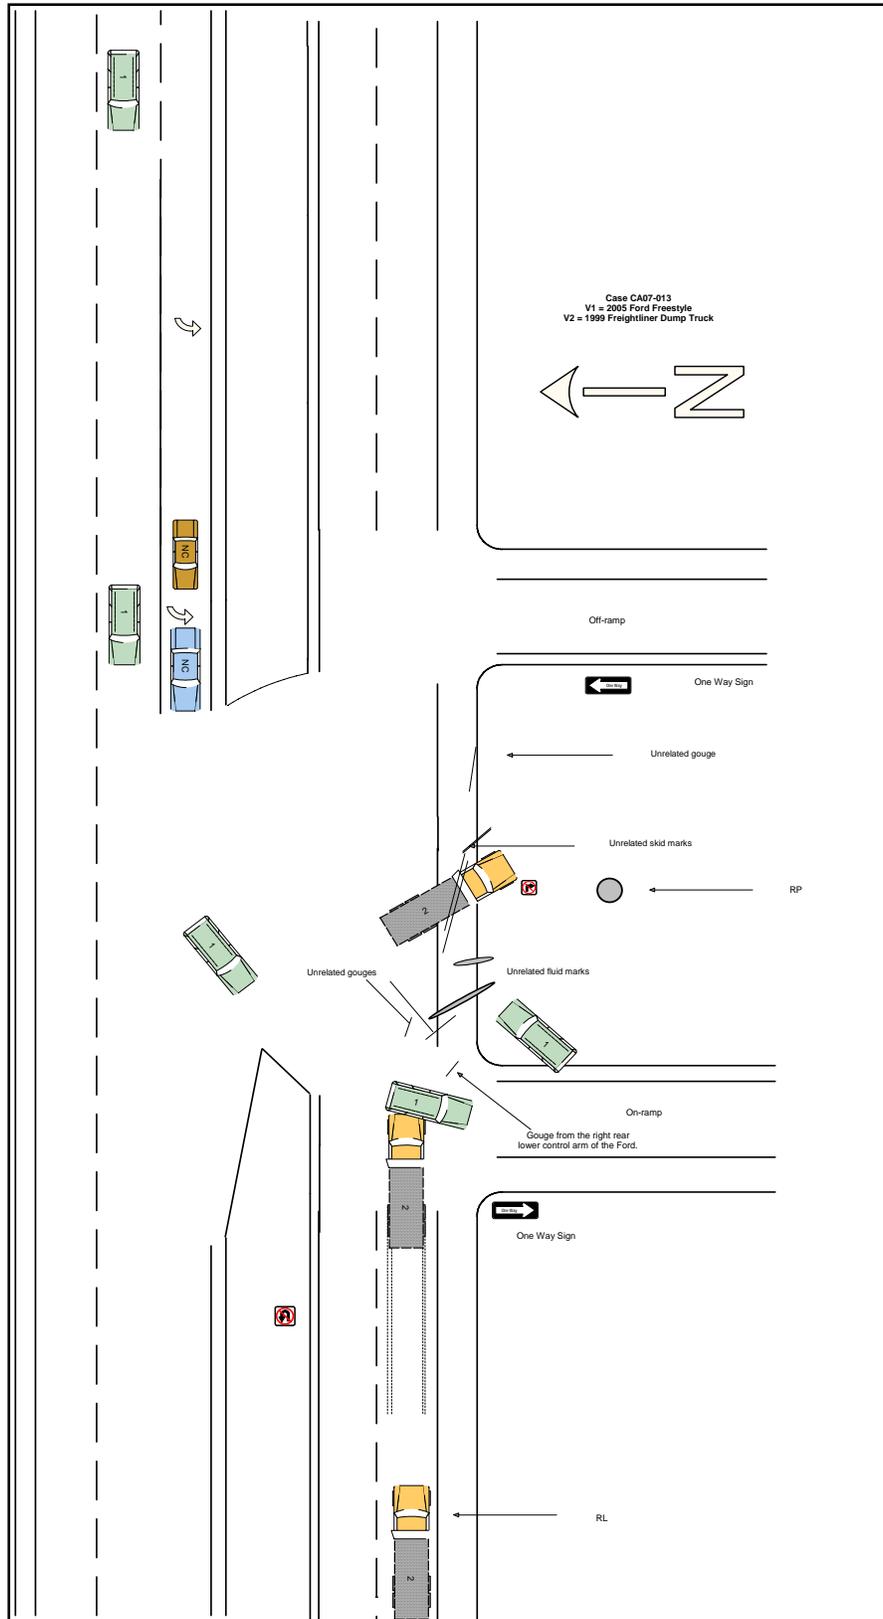
Figure 17: Crash Schematic

This intersection crash occurred during the morning hours of March 2007. At the time of the crash, the weather was clear with no adverse conditions. The crash occurred at the intersection of a five-lane east/west roadway and an interstate on-ramp. The eastbound lanes measured 3.7 meters (12.1 feet) wide and were configured with two through traffic lanes and center left turn lane. The westbound direction consisted of two through traffic lanes that measured 3.5 meters (11.5 feet) in width. The east/westbound lanes were separated by a 7.9 meter (25.9 feet) wide grass median that was bordered by concrete curbs. The east/westbound lanes were bordered by white fog lines with asphalt shoulders that extended beyond the fog lines. Grass roadsides were located adjacent to the shoulders. The south roadside at the intersection contained numerous street signs and a utility pole. The interstate on-ramp was located at the southern aspect of the intersection. The off-ramp was located 22 meters (72 feet) east of the on-ramp. The posted speed limit for the east/west roadway was 89 km/h (55 mph). The Crash Schematic is included as **(Figure 17)** of this report.
