**NOT-IN-TRAFFIC SURVEILLANCE
CALSPAN ON-SITE BACKOVER FATALITY INVESTIGATION**

SCI CASE NO.: CA07-014

VEHICLE: 2007 CHRYSLER 300C

CRASH DATE: APRIL 2007

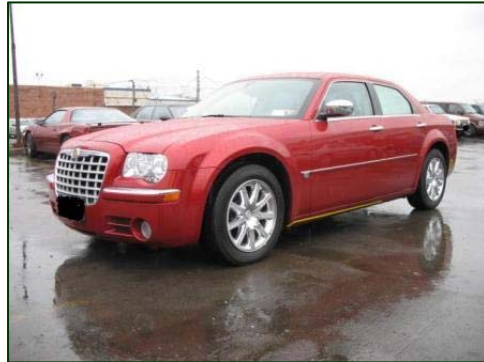
Figure 1. Involved 2007 Chrysler 300C.

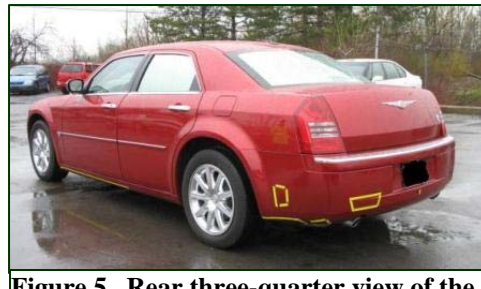
The exterior of the vehicle was finished in a red color with matching bumper fascias. The window glazing was AS1 for the windshield and AS2 for the side and backlight glass with OEM solar tint. An aftermarket mirror tint film was applied to the rear door and backlight glazing (**Figures 4 and 5**). This film prevented viewing through the glass from the exterior, but provided a deep tint view from the interior of the vehicle.

Figure 5. Rear three-quarter view of the 300C.

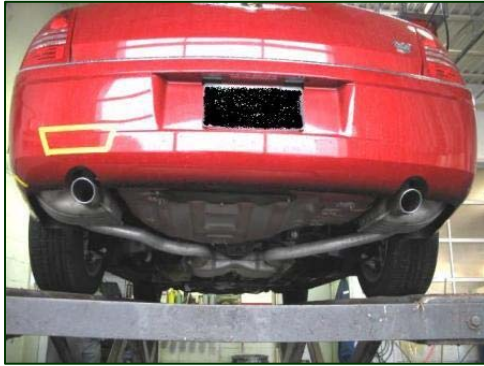
The vertical measurements from the ground to the major rear components of the vehicle (**Figures 6 and 7**) were documented and are listed in the following table:

Figure 6. Rear view of the undercarriage components.

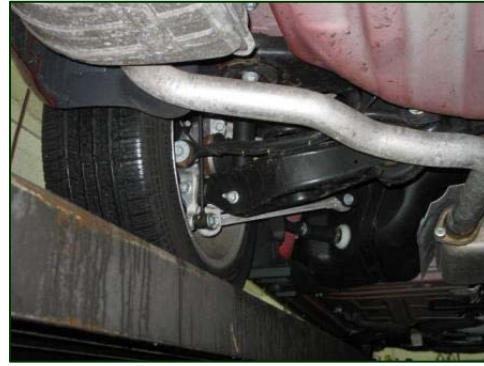
Figure 7. Left rear muffler and suspension components.
