Rollover Investigation
Dynamic Science, Inc. / Case Number: DS07014
2006 Mitsubishi Raider
California
March 2007

1. Report No. DS07014	2. Government Accession No.		3. Recipient Catalog No.	
4. Title and Subtitle Rollover Investigation			5. Report Date October 16, 2007

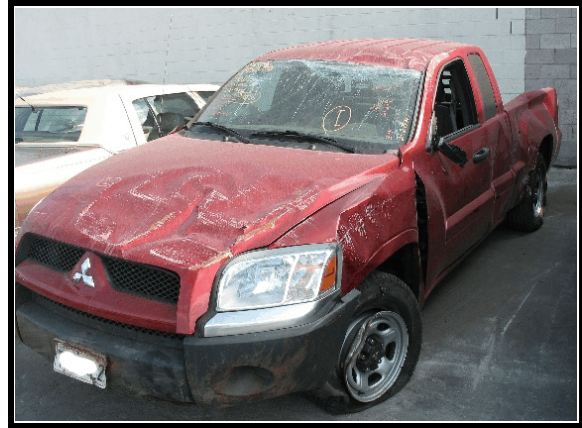
This on-site investigation focused on a 2006 Mitsubishi Raider that was involved in a rollover crash (**Figure 1**). This two vehicle crash occurred in March 2007 at 2100 hours. The crash occurred on a three-lane divided state highway near the approach to an interstate on-ramp/transition road. The speed limit at this location is 89 km/h (55 mph). The case vehicle is a 2006 Mitsubishi Raider extended cab pickup that was being driven by a restrained 52-year-old male. The front right seat was occupied by a restrained 48-year-old female. The other vehicle was a 2001 Freightliner tractor-trailer that was being driven by a 37-year-old male. The Mitsubishi Raider was traveling westbound on the state highway in the first lane from the right at a police reported speed of 97 km/h (60 mph). The other vehicle was traveling westbound in the second lane from the right at a police reported speed of 72 km/h (45 mph). The driver of the other vehicle changed lanes to the right. The front right of the other vehicle struck the left side of Raider. The driver of Raider lost control of his vehicle. The Raider rotated out in a clockwise direction and struck a curb with its left front tire. The Raider continued on out of control onto an embankment where the vehicle overturned. The Raider came to rest on its roof. There were no indications of any injuries to any of the parties involved, but an ambulance did respond to the scene. The Mitsubishi Raider was towed from the scene due to damage. It was later declared to be a total loss by the insurance company. The Freightliner was driven from the scene.

Figure 1. 2006 Mitsubishi Raider
