Child Safety Seat/Rollover Investigation
Dynamic Science, Inc. / Case Number: DS07016
2005 Toyota Tundra
Arizona
February 2007

1. Report No. DS07016	2. Government Accession No.		3. Recipient Catalog No.	
4. Title and Subtitle Child Safety Seat/Rollover Investigation			5. Report Date February 10, 2008

BACKGROUND

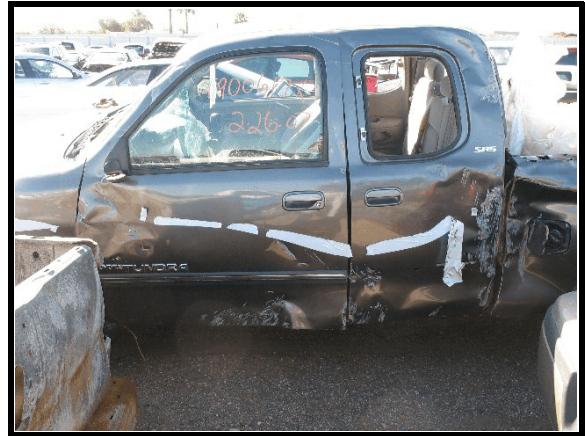
Figure 1. 2005 Toyota Tundra

This on site investigation focused on a 2005 Toyota Tundra (**Figure 1**) during a rollover crash and a booster safety seat that was installed in the second row right seat. This single vehicle crash occurred in February 2007 at 1436 hours. The crash occurred on a curved two-lane state highway. It was snowing at the time of the crash. The speed limit at this location was 89 km/h (55 mph). The case vehicle was a 2005 Toyota Tundra access cab pickup that was being driven by a restrained 37-year-old male. There were three additional occupants in the vehicle. The front right seat was occupied by a restrained 36-year-old female. The second row middle seat was occupied by a 6-year-old female. The second row right seat was occupied by a 3-year-old male who was seated in a booster safety seat. The Toyota Tundra was traveling northbound at a police reported speed of 89 km/h (55 mph) and was entering a left hand curve. The driver lost control of the vehicle due to the slippery road conditions. The Toyota Tundra departed the roadway on the right side and began traveling down an embankment. The right front of the Tundra probably contacted a juniper tree on the embankment. The Tundra began a clockwise rotation and the vehicle tripped and rolled over onto its left side. The driver indicated that no one sustained any injuries. The Toyota Tundra was towed from the scene due to damage. It was later declared to be a total loss by the insurance company.

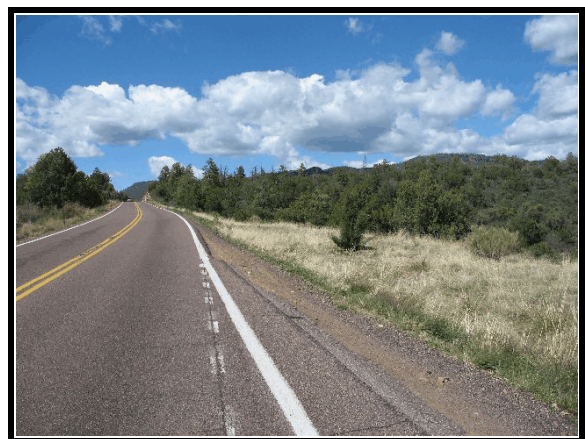
Figure 2. Approach to area of roadway departure (north)

This single vehicle crash occurred in February 2007 at 1436 hours. The crash occurred on a curved portion of a two-lane state highway (**Figure 2**). At the time of the crash, it was snowing and the asphalt roadway was snow and slush covered. There was a slight uphill grade in the area of the roadway departure.

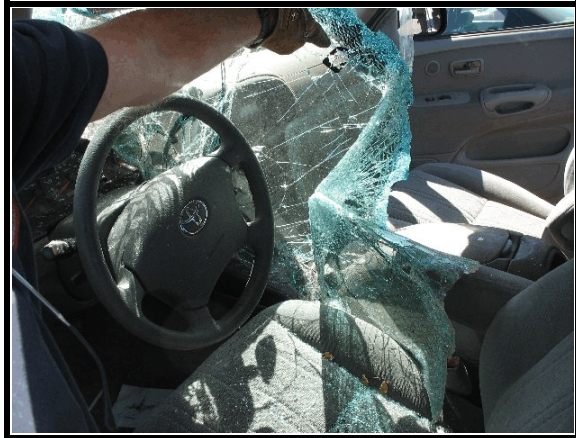
Figure 7. Overview of front row seating

The 2005 Toyota Tundra sustained minor interior damage as a result of passenger compartment intrusion. The C-pillar intruded 4 cm (1.6 in) into the passenger compartment laterally. The windshield was cracked from impact damage and was removed to aid in extrication. Both right side windows and the left rear window were disintegrated. The outboard portions of the three part backlight were also disintegrated. All the doors remained closed and operational.
