Rollover Investigation
Dynamic Science, Inc. / Case Number: DS07017
2005 Chevrolet Trailblazer
Arizona
February 2007

1. Report No. DS07017		2. Government Accession No.		3. Recipient Catalog No.	
4. Title and Subtitle Child Safety Seat/Rollover Investigation				5. Report Date February 22, 2008

Dynamic Science, Inc.
Crash Investigation
Case Number: DS07017

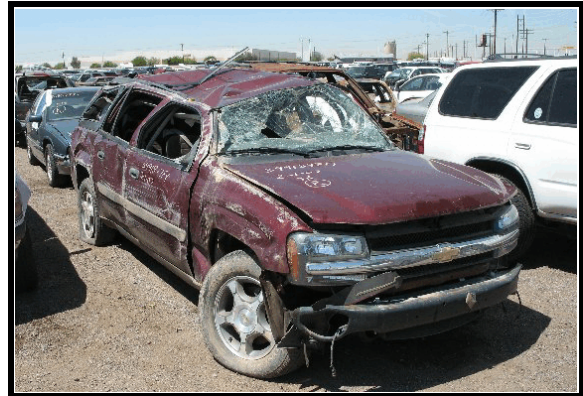
This single vehicle rollover crash occurred in January 2007 at 1246 hours. The crash occurred in Arizona. The 2005 Chevrolet Trailblazer (**Figure 1**) was being driven by a restrained 49-year-old male. There were six additional occupants in the vehicle. All the occupants were restrained.

Figure 1. Case vehicle, 2005 Chevrolet Trailblazer

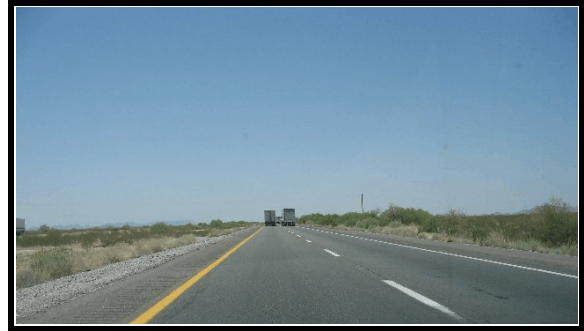
The crash occurred at 1246 hours in January 2007. This single vehicle crash occurred on an east/west divided interstate highway (**Figure 2**). The westbound and eastbound lanes were divided by a depressed median. The westbound lanes were separated by a dashed white line. The left lane edge was bordered by a solid yellow line, followed by an asphalt shoulder with a rumble strip. The right lane edge was bordered by a solid white line, followed by an asphalt shoulder with a rumble strip. The interstate was level at this location. The asphalt roadway was clear of debris and dry with no obstructions present. The weather was clear. The posted speed limit was 121 km/h (75 mph).

Figure 2. Path of travel (west)

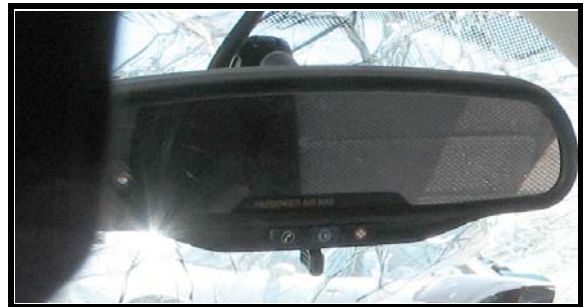
The 2005 Chevrolet was equipped with advanced occupant protection systems including multi-stage Certified Advanced 208-Compliant driver and front right passenger air bags. The multi-stage air bags were certified by the manufacturer to meet the advanced air bag requirements of Federal Motor Vehicle Safety Standard (FMVSS) No. 208. The driver's air bag was mounted in the center of the steering wheel hub and front right passenger air bag was a mid instrument mount. The vehicle was equipped with a front right Passenger Sensing System (PSS). The PSS works with sensors located in the front right passenger seat and safety belt. These sensors are designed to detect the presence of a properly seated occupant and under certain conditions, the PSS will turn off the passenger front air bag. There is a passenger air bag status indicator located in the rear view mirror which displays ON or OFF when the vehicle is running (**Figure 8**). Whenever the PSS has turned off the front right air bag, the OFF indicator located on the rearview mirror will illuminate. This vehicle was not equipped with any other air bags. There were no air bag deployments in this crash.

Figure 8. Passenger Air Bag On/Off indicator on rearview mirror

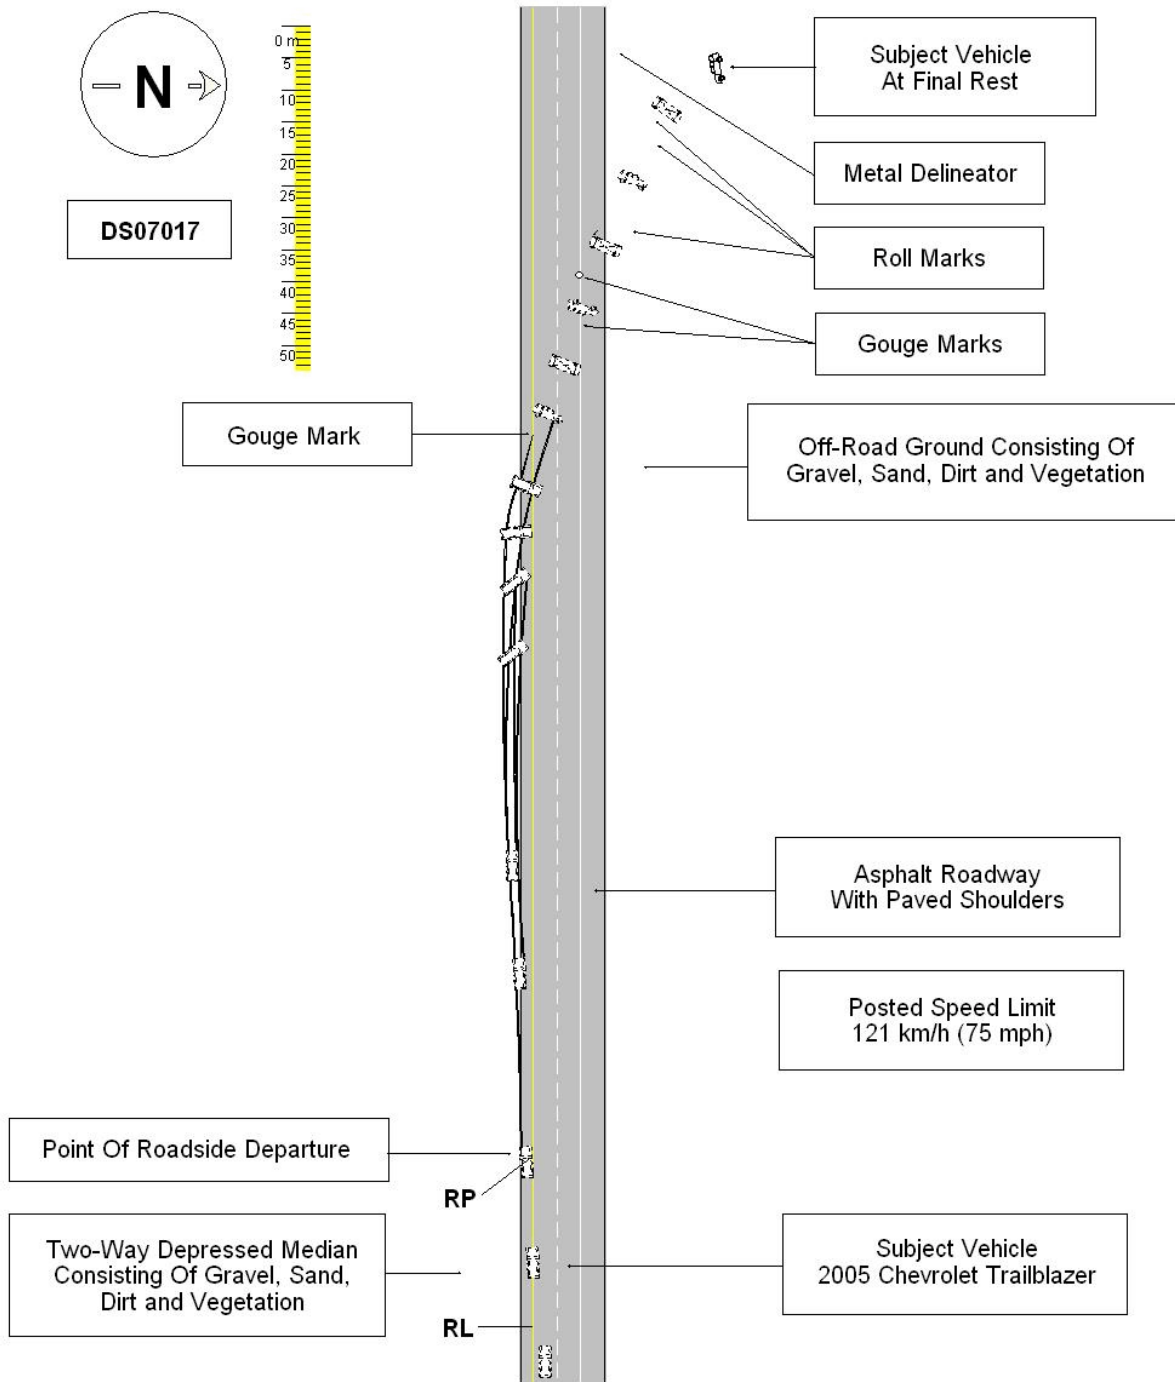
Attachment 1. Scene Diagram

The Chevrolet Trailblazer was traveling westbound at a driver-reported speed of 113 km/h (70 mph) on a two-lane divided interstate highway. The driver fell asleep. The case vehicle drifted to the left into the median. Upon waking, the driver steered to the right but over-corrected. The case vehicle began a clockwise motion on the dirt median onto the shoulder. Upon entering the shoulder, the left side tires dug into the asphalt surface causing the vehicle to begin rolling onto its left side. The case vehicle continued to roll over across both lanes of travel, the emergency shoulder and the dirt shoulder. The case vehicle rolled six quarter turns. The case vehicle came to rest on its roof facing northeast on the dirt shoulder. The driver sustained minor contusions and abrasions. He was transported to a local hospital where he was treated and released. The front right occupant sustained multiple minor lacerations. The second row left occupant sustained minor contusions and abrasions and a neck strain. He was transported to a local hospital where he was treated and released. The second row middle occupant sustained no injuries. She was evaluated at the scene. The second row right occupant sustained multiple contusions and abrasions. She was evaluated at the scene and then transported by air ambulance to an area trauma center where she was admitted. The third row left occupant complained of pain to his left shoulder. He was transported to a local hospital for evaluation. The third row right occupant sustained a skull fracture, as well as miscellaneous lacerations, contusions and abrasions. He was evaluated at the scene. He was then transported by air ambulance to an area trauma center where he was admitted. The Chevrolet Trailblazer was towed from the scene and later declared a total loss by the insurance company.
