NOT-IN-TRAFFIC SURVEILLANCE

CALSPAN REMOTE POWER WINDOW INVESTIGATION

SCI CASE NO.: CA 07-019

VEHICLE: 1998 TOYOTA CAMRY

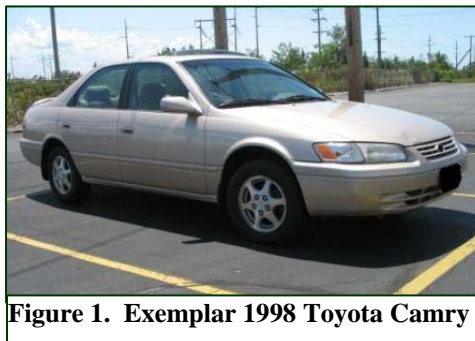
This remote investigation focused on the power window switch configuration and the closing force of the rear door windows of a 1998 Toyota Camry (**Figure 1**). A 2-year old male seated in the rear right position of the vehicle extended his head out of the window opening as the 25-year old female driver closed the window without knowledge of the child's position. The child's neck was trapped between the window and the top of the window frame which resulted in police

Figure 1. Exemplar 1998 Toyota Camry
