Remote Not In Traffic Surveillance Back Over Investigation
Dynamic Science, Inc. (DSI), Case Number (DS07020)
2007 Hyundai Sonata
Colorado
February 2007

1. Report No. DS07020	2. Government Accession No.		3. Recipient Catalog No.	
4. Title and Subtitle Remote Not In Traffic Surveillance Back Over Investigation			5. Report Date February 11, 2008

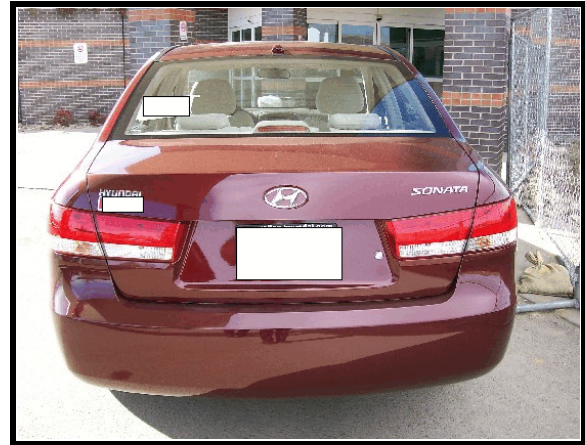
Figure 1. 2007 Hyundai Sonata.

This single vehicle incident occurred in February 2007 at 1350 hours. The case vehicle is a 2007 Hyundai Sonata four-door sedan (see Figure 1) that was being driven by a 27-year-old female. The Sonata had been recently purchased by the driver and had a temporary license affixed to the left side of the backlight. This incident occurred in a parking area on private property. The parking area is behind a private building. Access to the parking area is through a south to north driveway. The driver was cleaning a building located adjacent to the parking area. She arrived at 1200 hours and was cleaning until shortly before the incident. The Sonata was initially parked facing west. The driver's 3-year-old daughter was in the parking area. The driver stated that she had told her daughter to stand next to the building and to stay there while she turned the Sonata around. The driver began backing east and then turned the wheel to continue backing to the north. As the backing motion began, she heard her daughter screaming. She saw her daughter on the ground and went to her. She picked up her daughter and put her in the vehicle. She drove her daughter directly to the hospital. The 3-year-old child sustained a right tibia fracture, as well as a number of contusions and abrasions.

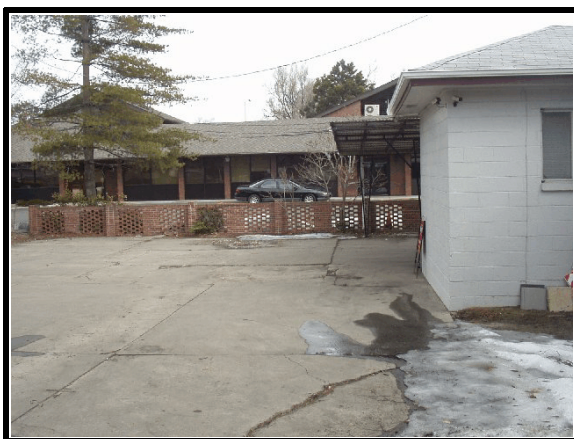
The Hyundai was being driven by a 27-year-old female. The involved child was the 3-year-old daughter of the driver. The 3-year-old was wearing a shiny pink jacket and blue jeans. The driver was cleaning a building located adjacent to the parking area. She arrived at 1200 hours and was cleaning until shortly before the incident. The Sonata was initially parked facing west (see Figure 3). The driver and her daughter exited from the east side of the building (see Figure 4). The driver stated that she had told her daughter to stand next to the building on the sidewalk and to stay there while she turned the Sonata around. The driver began backing east and then turned the wheel to continue backing to the north. It is believed that the 3-year-old left the sidewalk and began walking northwest toward the Sonata.

Figure 3. Path of Sonata, backing (east)

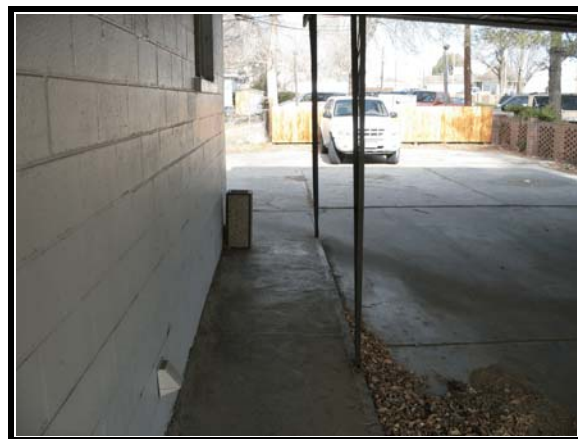
Figure 4. Path from door to parking area (north)

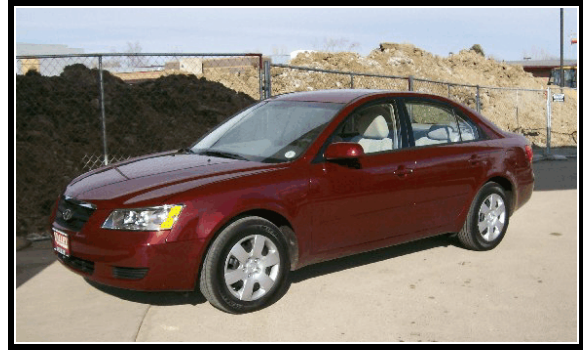
Figure 7. 2007 Hyundai Sonata (police photo of subject vehicle)

There was no damage to the Hyundai Sonata.
