CRASH DATA RESEARCH CENTER

**CALSPAN ON-SITE ROLLOVER CRASH INVESTIGATION
SCI CASE NO: CA07-021**

**VEHICLE: 2007 CHEVROLET HHR
LOCATION: FLORIDA
CRASH DATE: MAY, 2007**

Contract No. DTNH22-07-C-00043

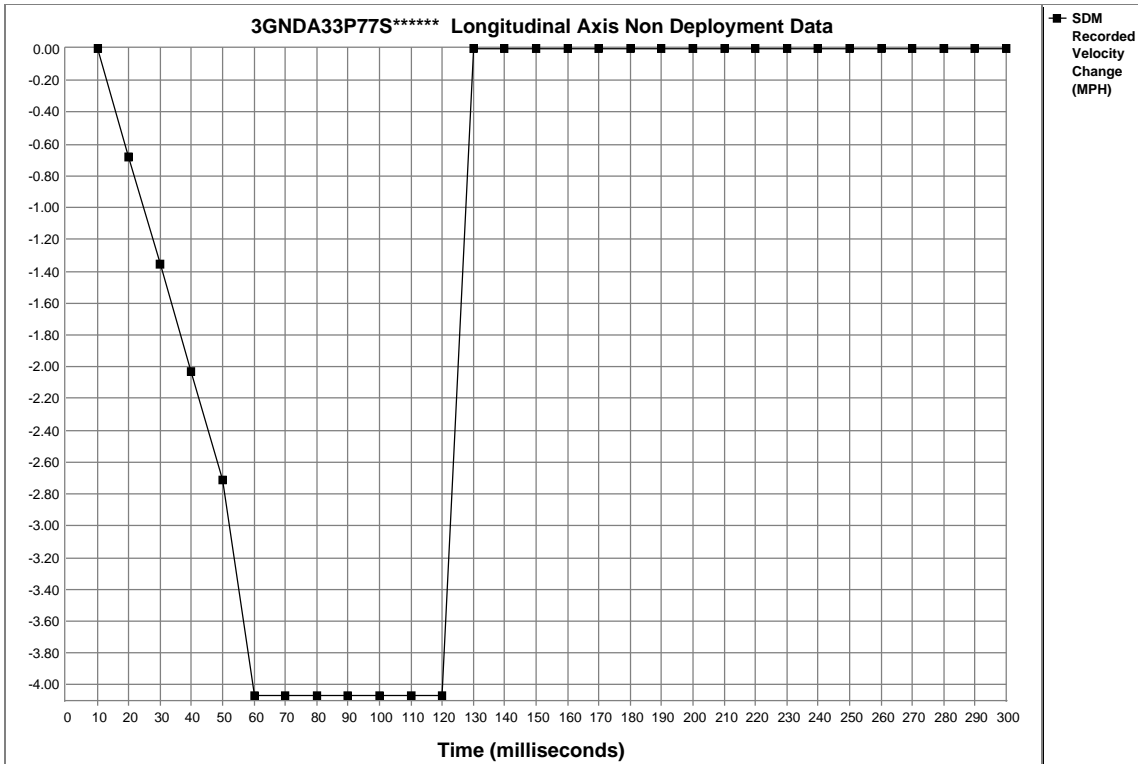
Time (milliseconds)	10	20	30	40	50	60	70	80	90	100	110	120	130	140	150
Longitudinal Axis Recorded Velocity	0.00	-0.68	-1.36	-2.03	-2.71	-4.07	-4.07	-4.07	-4.07	-4.07	-4.07	-4.07	0.00	0.00	0.00
Time (milliseconds)	160	170	180	190	200	210	220	230	240	250	260	270	280	290	300
Longitudinal Axis Recorded Velocity	0.00	0.00	0.00	0.00	0.00	0.00	0.00	0.00	0.00	0.00	0.00	0.00	0.00	0.00	0.00

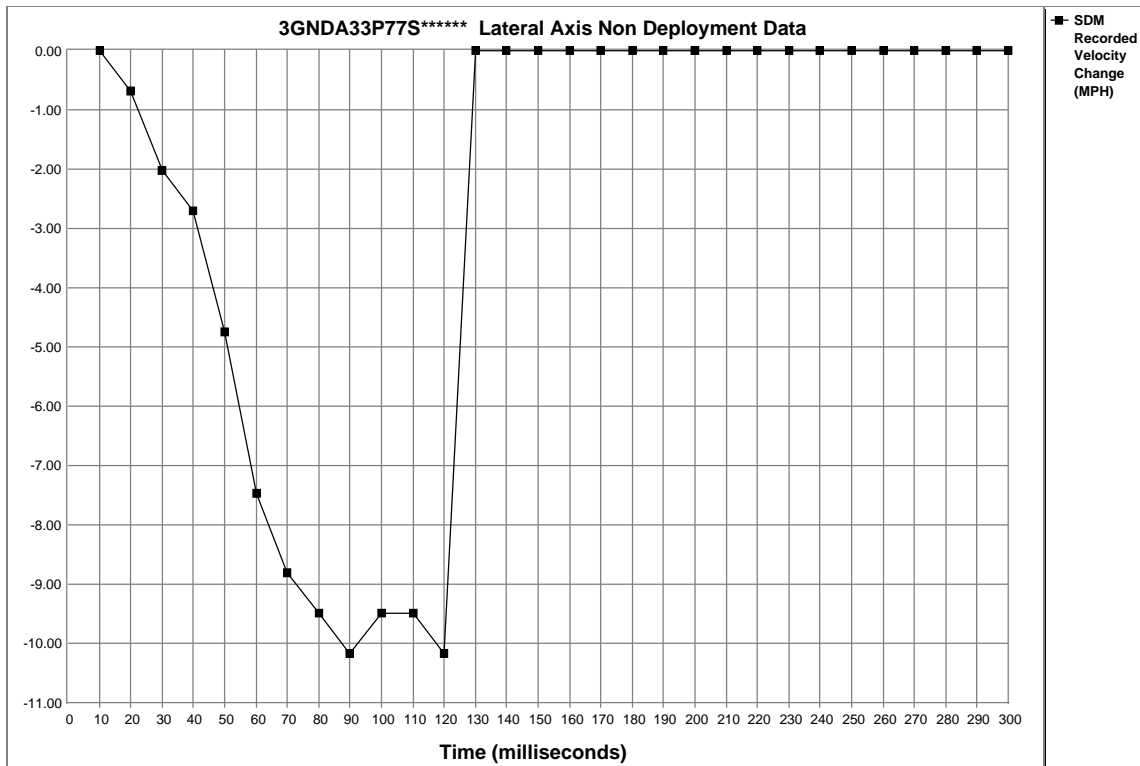
Time (milliseconds)	10	20	30	40	50	60	70	80	90	100	110	120	130	140	150
Lateral Axis Recorded Velocity Change (MPH)	0.00	-0.68	-2.03	-2.71	-4.74	-7.46	-8.81	-9.49	-10.17	-9.49	-9.49	-10.17	0.00	0.00	0.00
Time (milliseconds)	160	170	180	190	200	210	220	230	240	250	260	270	280	290	300
Lateral Axis Recorded Velocity Change (MPH)	0.00	0.00	0.00	0.00	0.00	0.00	0.00	0.00	0.00	0.00	0.00	0.00	0.00	0.00	0.00
