CALSPAN ON-SITE CHILD SAFETY SEAT CRASH INVESTIGATION

CASE NO: CA07-031

VEHICLE: 2006 KIA OPTIMA

CRASH DATE: SEPTEMBER 2007

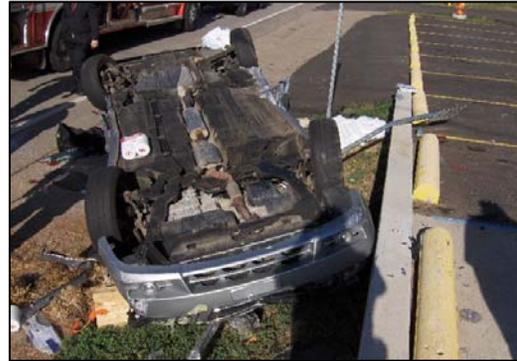
This on-site investigation focused on a rear-facing infant Child Safety Seat (CSS) and the fatal injury sources of a 2-month old male child restrained within the CSS. The CSS was installed without the detachable base in the second row right position of a 2006 Kia Optima (**Figure 1**). The Kia was struck on the left side by the front of a 1999 Dodge Neon in an intersection crash. The Kia then departed the right side of the road and impacted multiple fixed objects and overturned. The Kia was equipped with dual stage frontal air bags and seat back mounted side impact air bags for the driver and front right passenger positions, all of which deployed during the crash. The Kia was occupied by a 47-year old male driver, a 49-year old female front right passenger, a 26-year old female second row middle passenger, and the 2-month old male child passenger, who was placed within the CSS. The 2-month old child and the CSS were ejected from the vehicle through the right rear side as integrity was lost between the window frame and roof side rail. The child and CSS came to rest approximately

Figure 1 - 2006 Kia Optima at final rest.

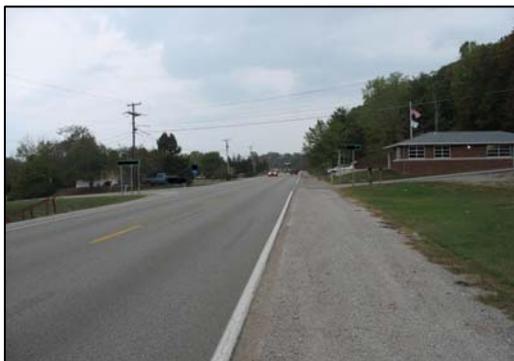
The 47-year old male driver of the Kia was traveling in a westerly direction on the two-lane roadway and was approaching the four-leg intersection (**Figure 3**). The driver of the Kia was intending to continue straight through the intersection. The Dodge was traveling north approaching the same intersection, disregarded a stop sign and attempted to turn left (**Figure 4**). The driver of the Kia reacted to the impending crash by applying and locking the brakes, which was evidenced by a 6 m (20') skid mark on the roadway. The skid mark was attributed to the front right tire.

Figure 3 - Westbound approach of the Kia.

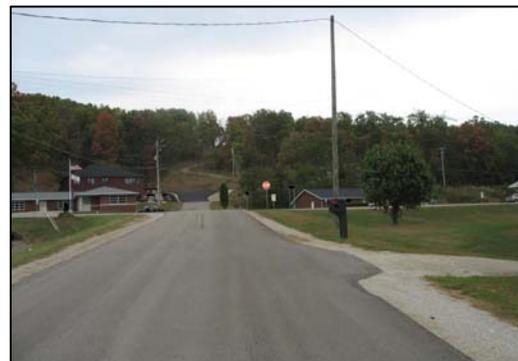
Figure 4 - Northbound approach of the Dodge Neon.

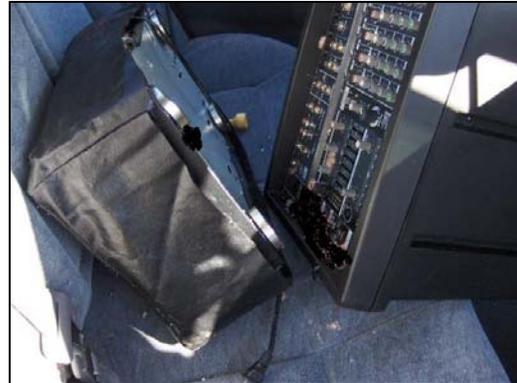
The roof and interior in general exhibited large areas of body fluid transfers attributable to the head injuries sustained by the right rear child passenger. The body fluid and matter transfers were present in every region of the vehicle and were particularly heavy on the roof liner. Musical production equipment consisting of a sound system and turn table [estimated to weigh 23 kg (50 lb)] was placed on the seat cushion in the second row left seating position (**Figure 13**). An 11 x 10 cm (4.5 x 4") gouge was present on the roof slightly aft of the dome light, and the dome light cover was missing. The gouge occurred during the rollover as a result of contact from the musical equipment. An extensive amount of body fluids pooled within the equipment post-crash.

Figure 13 - Musical equipment inside of the Kia Optima.

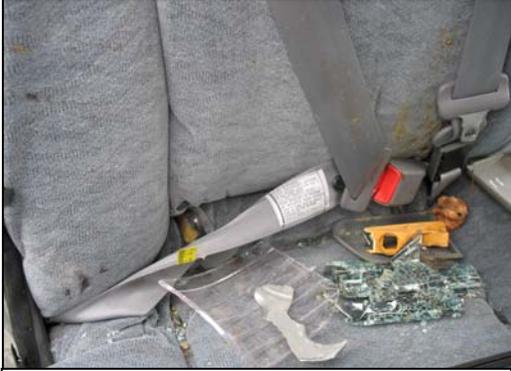
The second row belts were configured with sliding latch plates. The right rear lap belt was used to install the CSS without the attachable base in the right rear seating position. The lap belt was routed across the belt paths on the forward aspect of the CSS. Post-crash, the right rear belt remained buckled with the latch plate still engaged with the receiver (**Figure 17**). The investigating police officer advised that since the CSS was completely ejected from the vehicle there was no need to unlatch the belt system post-crash. In this position, the slack in the lap belt from the anchor point to the latch plate engaged in the buckle measured 71 cm (28"). The full length of the right rear belt webbing was 220 cm (90"). The switchable retractor was fully operational and in the ELR mode at the time of the SCI inspection. Body fluid transfers were present along the lower half aspect of the belt webbing, which began at the anchor point and extended upwards 104 cm (41"). A small tear was also present on the webbing; it was located 15 cm (6") above the anchor point and measured 1 cm (0.5") in length (**Figure 18**).

Figure 17 - Engaged right rear lap and shoulder belt.

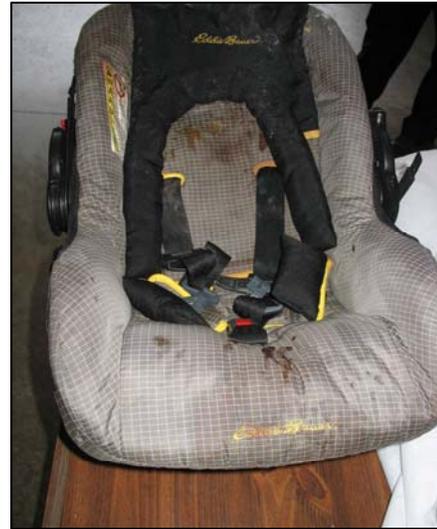
A Dorel/Eddie Bauer Designer 22 infant CSS was installed rear-facing in the second row right side position of the 2006 Kia Optima (**Figure 19**). The CSS was installed inside the vehicle with the manual shoulder belt and without the detachable base. The CSS was ejected from the vehicle during the crash and was inspected at the police department during the on-site SCI investigation. The CSS model number was 22-625 GDC and the date of manufacture was 01/18/2005. The CSS was configured with a 5-point internal harness system and a two-piece chest retainer clip. The CSS was rated for infants weighing between 2.3 km (5 lb) and 10 km (22 lb) and between 48 cm (19”) and 74 cm (29”) in height.

Figure 19 - Dorel/Eddie Bauer Designer 22 Infant CSS.

The CSS sustained severe damage as a result of becoming unrestrained and struck by the vehicle during the rollover sequence. Damage consisted of multiple fractures to all sides of the CSS shell as well as torn fabric and a fractured right belt path. The CSS had four slots to adjust the internal harness straps and the investigation revealed that the harness straps were routed through the slots at the third level from the top. Based on police images, the retainer chest clip was adjusted to slightly below the armpit level of the child.
