**CALSPAN ON-SITE SIDE IMPACT INFLATABLE  
OCCUPANT PROTECTION CRASH INVESTIGATION**

**CASE NO: CA07-032**

**VEHICLE: 2007 ACURA MDX**

**CRASH DATE: OCTOBER 2007**

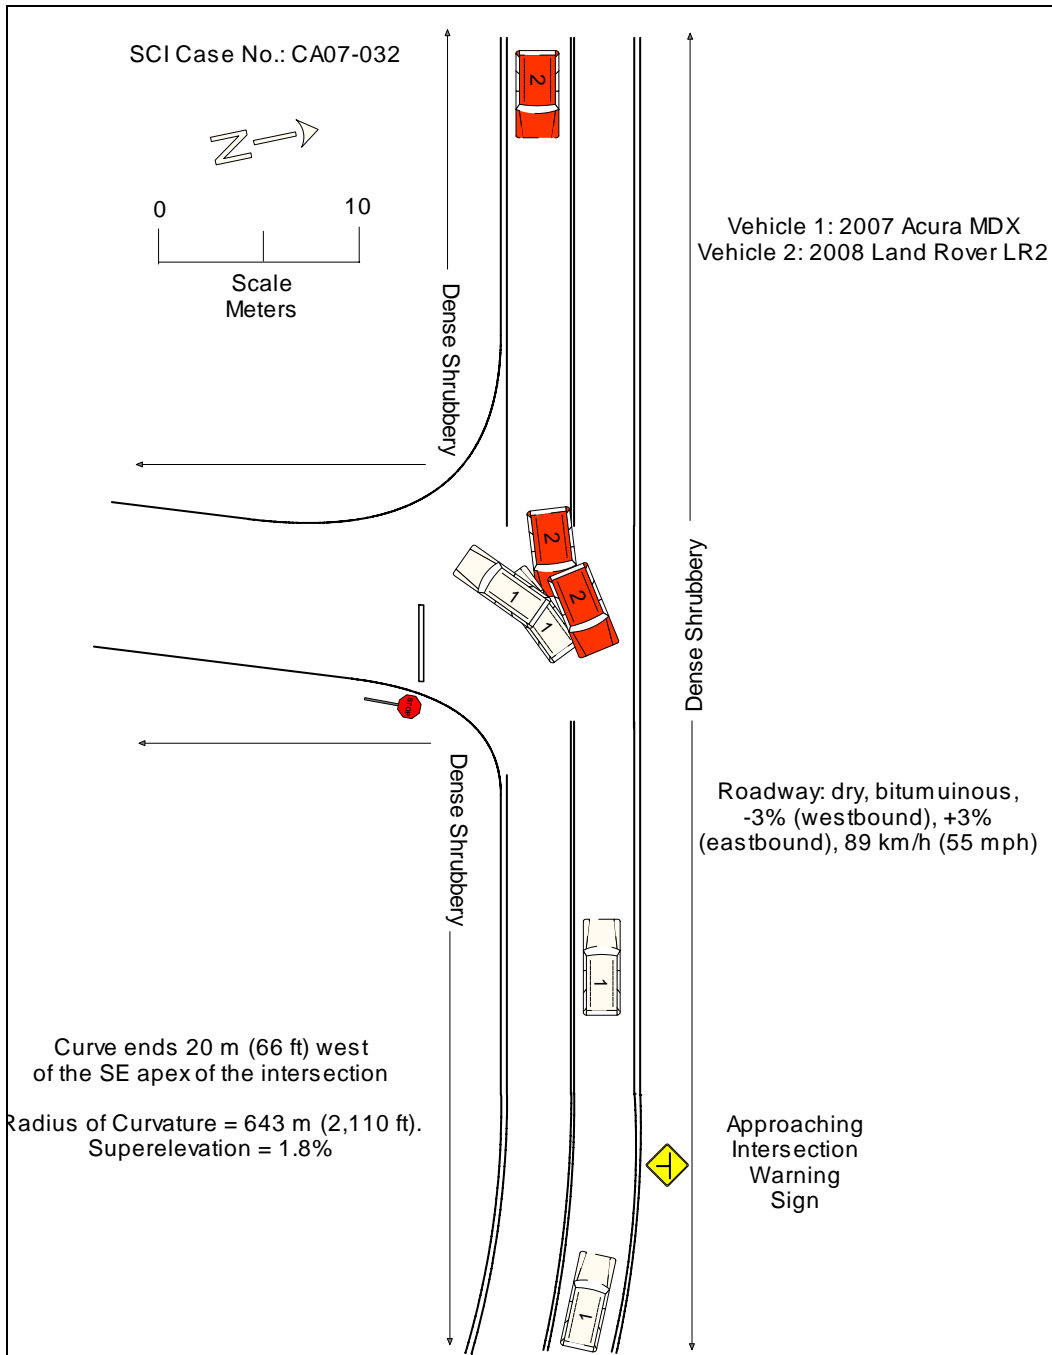
**Figure 11 – SCI Crash Schematic**

The front right area of the Land Rover struck the right passenger area of the Acura. The directions of force were in the 1 o’clock and 12 o’clock sectors for the Acura and Land Rover, respectively. The impact was sufficient to deploy the Acura’s right seat back mounted side air bag and the right side IC air bag. The air bags in the Land Rover did not deploy. The damage algorithm of the WinSMASH program computed a total delta-V of 13 km/h (8.1 mph) for the Acura and 15 km/h (9.3 mph) for the Land Rover. The specific longitudinal and lateral velocity changes were -10 km/h (-6.2 mph) and -8 km/h (-5 mph) for the Acura and -15 km/h (-9.3 mph) and 0 km/h for the Land Rover. The Acura was displaced slightly to the left of the point of impact. The Land Rover came to rest at the point of impact.
