CALSPAN ON-SITE CHILD SAFETY SEAT FATALITY INVESTIGATION
GRACO SNUG RIDE CHILD SAFETY SEAT
SCI CASE NO: CA07-033

VEHICLE: 1998 FORD EXPLORER
LOCATION: TENNESSEE
CRASH DATE: OCTOBER 2007

**CALSPAN ON-SITE CHILD SAFETY SEAT FATALITY INVESTIGATION
SCI CASE NO.: CA07-033**

**VEHICLE: 1998 FORD EXPLORER
LOCATION: TENNESSEE
CRASH DATE: OCTOBER, 2007**

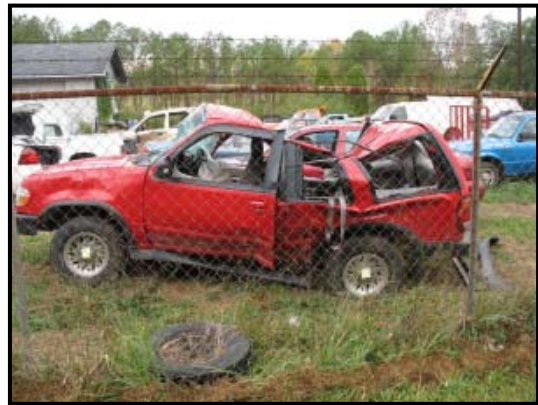
The subject vehicle was a 1998 Ford Explorer Sport 4x2, two-door model identified by the Vehicle Identification Number (VIN): 1FMYU22E7WU (production sequence deleted). The Explorer was manufactured in December 1997. **Figure 2** is a left side view of the vehicle. The rear-wheel drive sport utility vehicle was manufactured with a 258 cm (101.7 in) wheelbase. The power train consisted of a 4.0 liter/V6 engine linked to a four-speed automatic transmission. The service brakes were a four-wheel disc system with ABS. The vehicle seating was configured for four passengers (2/2). The front row consisted of cloth upholstered bucket seats. The second row seat system consisted of a 60/40 split bench seat with folding backs. The manual restraint system consisted of three-point lap and shoulder belts for the four seat positions. The Ford Explorer was also equipped with redesigned driver and front right passenger air bags that deployed during the crash. The vehicle was not equipped with side impact protection. The odometer read 299,340 km (186,001 miles) at the time of the SCI inspection. The vehicle manufacturer’s recommended tire size was P235/75R15 with a recommended cold inflation pressure of 179 kPa (26 PSI). The subject vehicle was equipped with a Goodyear Eagle P225/70R15 tire at the left front position, Champiro GT Radial P235/75R15 tires at the right front and left rear positions and a Goodyear Wrangler P235/75R15 tire at the right rear position. All four tires were mounted on OEM alloy rims. The specific tire data measured at the time of the SCI inspection was as follows:

Figure 2: Left side view of the Explorer.
