ODI Unintended Acceleration Investigation / Vehicle to Vehicle  
Dynamic Science, Inc. / Case Number: DS07035  
2007 Toyota Camry  
California  
July 2007

1. Report No. DS07035		2. Government Accession No.		3. Recipient Catalog No.	
4. Title and Subtitle ODI Unintended Acceleration Investigation				5. Report Date May 15, 2008

**Dynamic Science, Inc.**  
**Crash Investigation**  
**Case Number: DS07035**

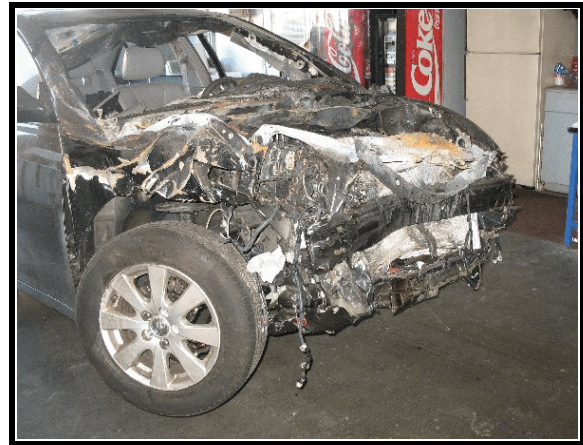
This three-vehicle crash occurred at 0735 hours in July 2007. The crash took place on an interstate highway. The subject vehicle was a 2007 Toyota Camry that was being driven by a 68-year-old male (**Figures 1-2**). The first other vehicle was a 2002 Mazda 626 that was being driven by a 27-year-old male. The second other vehicle was a 1993 Honda Accord that was being driven by a 39-year-old male. The 2007 Toyota Camry was traveling southbound on the interstate at speeds reported to be in excess of 161 km/h (100 mph). Witnesses reported seeing the Camry traveling southbound on the interstate and using both roadway shoulders to pass other vehicles for at least 13 km (8 miles). The driver indicated that he tried to brake and also tried to put the vehicle into neutral. Some witnesses reported seeing smoke coming from the Camry. They also noted that the Camry had the emergency flashers on and they could see the brake lights flashing. The Camry struck two barriers/walls while avoiding traffic before becoming involved in the subsequent collision. The Camry rear-ended the Mazda, displacing it into the median. The Camry then struck the Honda Accord, causing the Accord to rotate CCW. Both the Toyota and Honda caught fire at final rest. The driver of the Honda Accord was fatally injured. The driver of the Camry sustained head lacerations and a fractured/dislocated right ulna. The driver of the Mazda sustained minor facial lacerations. The vehicles were towed from the scene due to damage and were placed on a police hold.

**Figure 1.** Subject vehicle, 2007 Toyota Camry

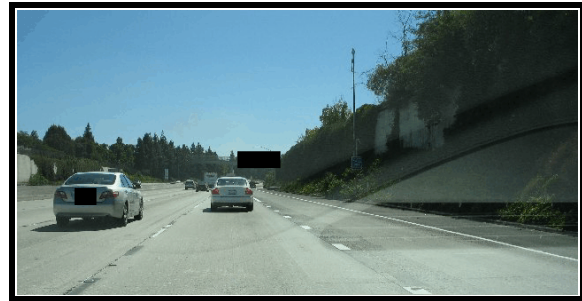
This crash took place on a 5-lane interstate highway (**Figure 3**). The 2007 Toyota Camry was involved in several vehicle to object impacts before reaching the scene of this crash. The locations of these impacts are not known. The locations of the vehicle to vehicle impacts were on the southbound interstate highway (see the attached satellite image and the scene diagram). The roadway at this location was comprised of five asphalt travel lanes that were separated from northbound traffic lanes by a concrete center divider. The east/west roadway was curved slightly to the left. The northernmost lane was bordered by a solid painted yellow line, an asphalt shoulder and a concrete center divider. The southernmost lane was bordered by a solid painted white edge line, an asphalt shoulder, and an ascending dirt embankment. The roadway was dry and level. The temperature at the nearest reporting station was 17 degrees C (62 degrees F). The speed limit was 105 km/h (65 mph).

**Figure 3.** Southbound travel lanes

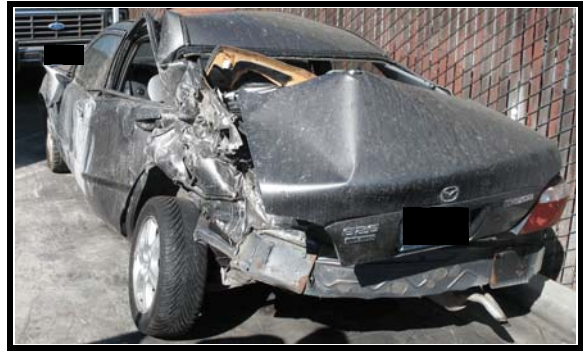
**Figure 4.** Mazda 626

The 2007 Toyota Camry was traveling southbound on the interstate at speeds in excess of 161 km/h (100 mph). The first other vehicle was a Honda Accord. The second other vehicle was a 2002 Mazda 626 (**Figure 4**). All three vehicles were traveling southbound and witnesses reported seeing the Camry traveling on the interstate and using both roadway shoulders to pass other vehicles for at least 13 km (8 miles). The driver indicated that he tried to brake and also tried to put the vehicle into neutral. There was evidence that the driver was braking for an extended period of time (see Service Brake Inspection discussion later in this report). There was also evidence that the driver tried to stop the vehicle by applying the parking brake (see Parking Brake Inspection section). The driver reported that he attempted to turn off the vehicle by pushing the power button several times. The vehicle was equipped with a Smart Key system<sup>1</sup>. In order to turn off the power while moving at speed requires the driver to press and hold the power button down for three seconds. The driver was unaware of this feature.

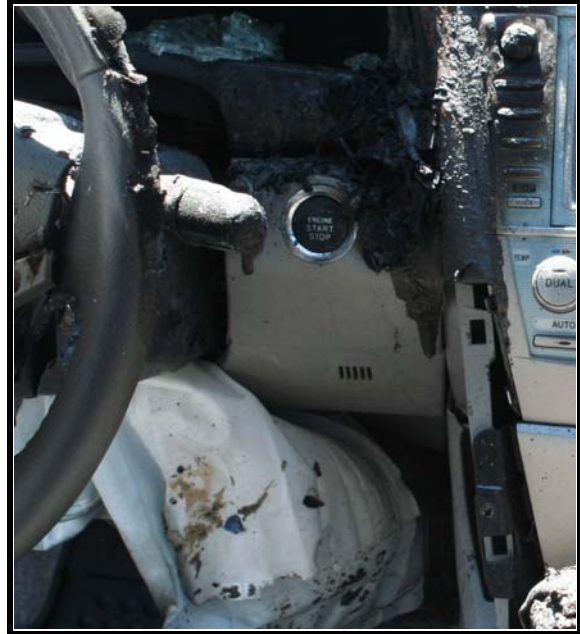
**Figure 5.** Push start button

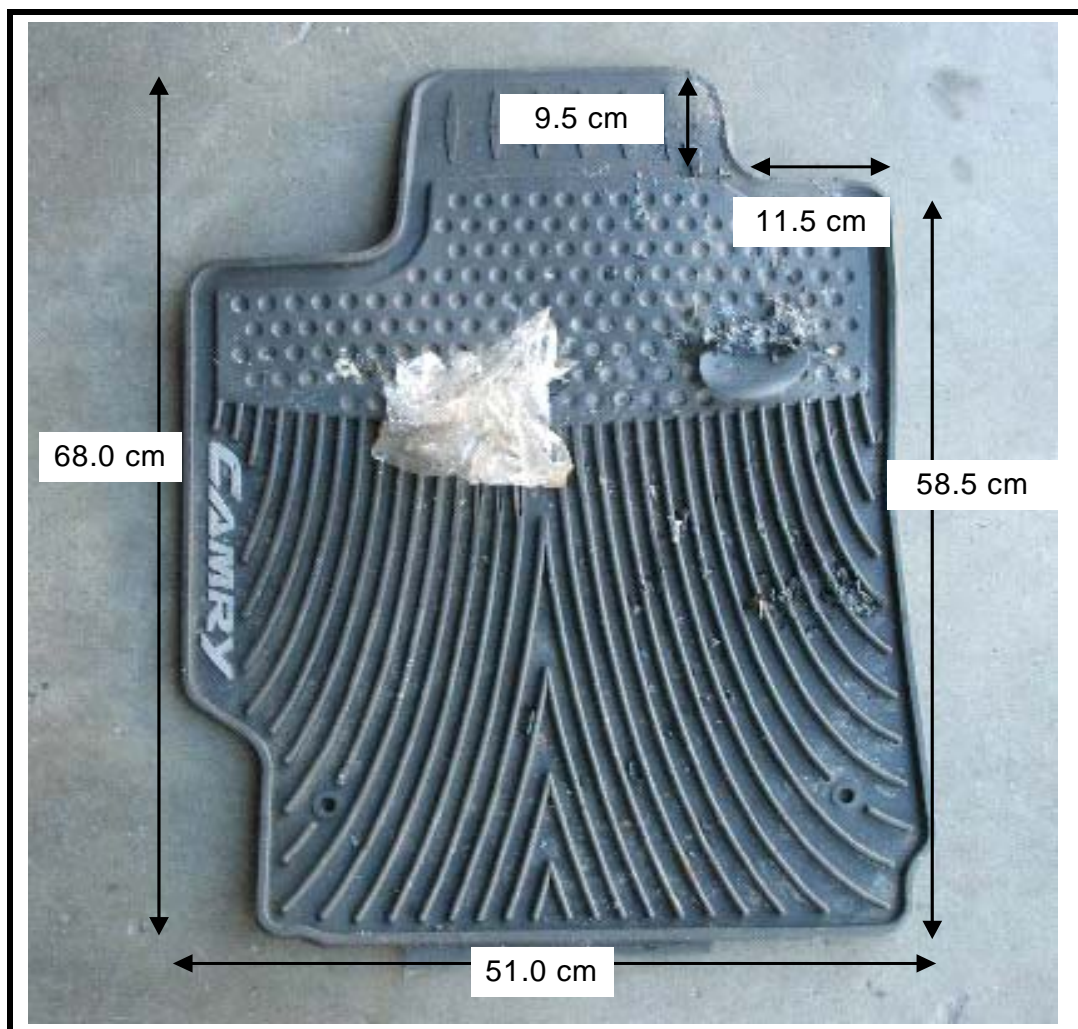
Figure 32. All-weather mat dimensions

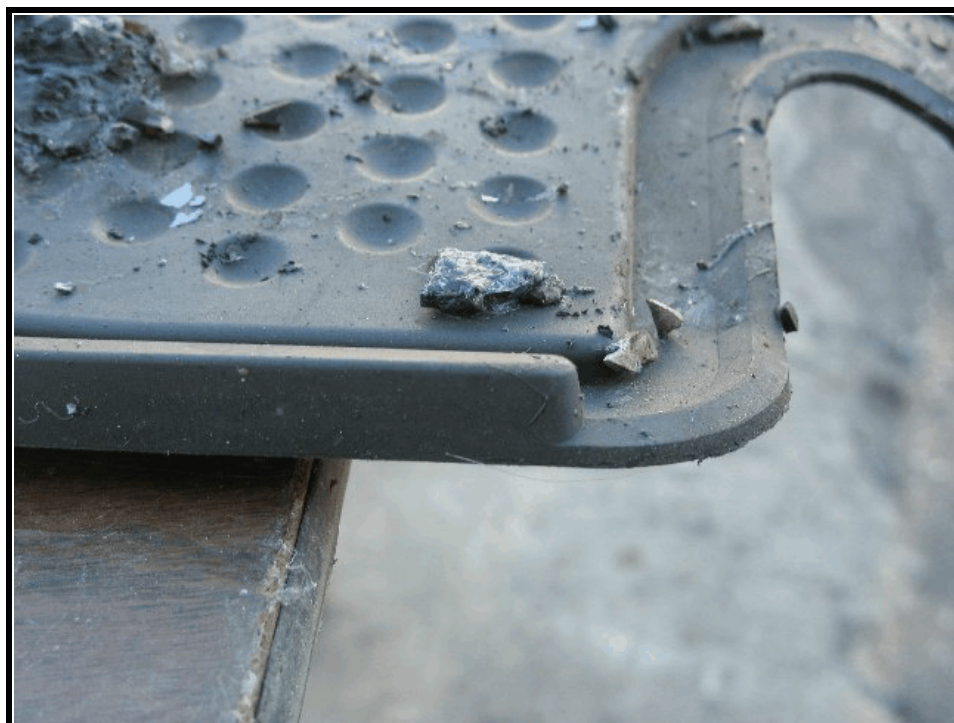
The rubberized mat and the accelerator assembly had been removed prior to the vehicle inspection. The investigating officer had, however, taken photos of the mat and the accelerator assembly prior to their removal. The mat in the police photos appeared to be shifted forward and to the right of its designed location (**Figure 30**). There was some scuffing found on the bottom right of the accelerator pedal that was possibly due to pedal/mat interaction. There was also some scuffing found on the top right portion of the mat. The distance from the rear of the mat to the top right cutout was 58.5 cm (23 in). The distance from the front seat mounting bolt to the bottom of the accelerator pedal in the depressed position was 64 cm (25.2 in). For the accelerator pedal to engage the floor mat, the mat would have to be at least 5.5 cm (2.2 in) forward of the seat mounting bolt. Based on the police image in **Figure 31**, this would appear to be the case.

**Figure 34.** Top right corner of mat

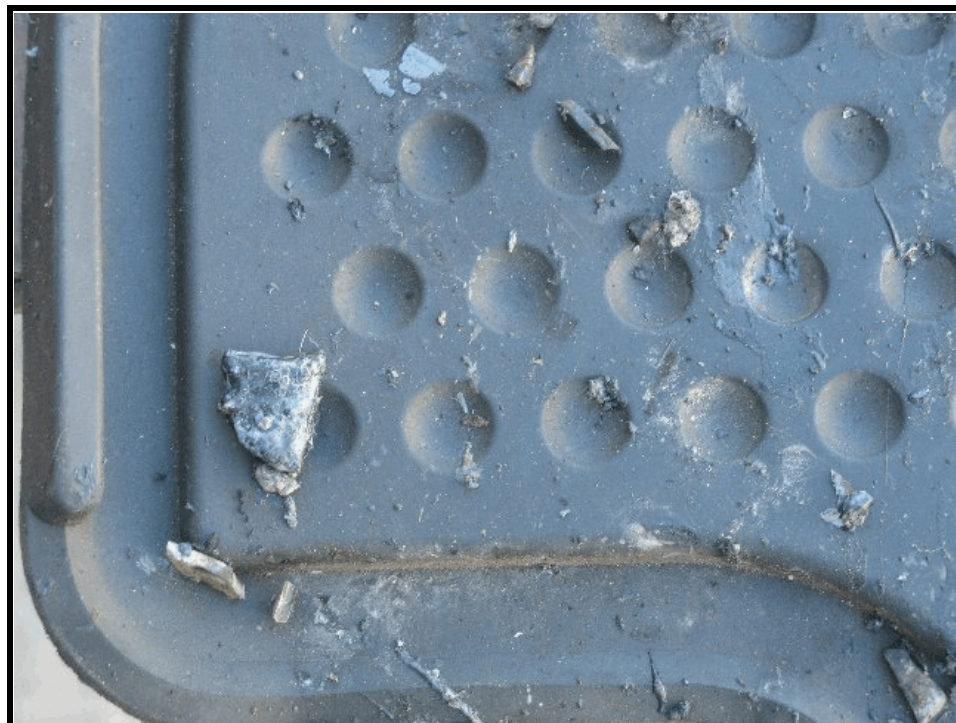
**Figure 35.** Top right corner of mat

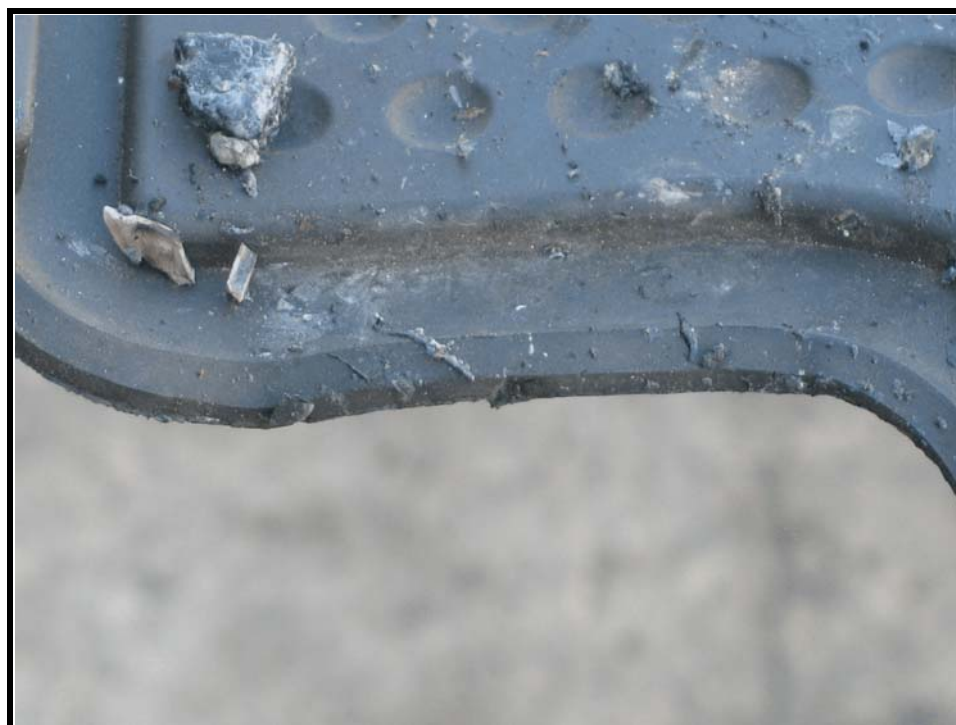
**Figure 36.** Top right corner of mat
