Child Safety Seat Investigation  
Dynamic Science, Inc. (DSI), Case Number DS07036  
1996 Jeep Grand Cherokee  
Arizona  
August 2007

1. Report No. DS07036	2. Government Accession No.	3. Recipient Catalog No.	
4. Title and Subtitle Child Safety Seat Investigation		5. Report Date November 18, 2008

**Dynamic Science, Inc.**  
**Crash Investigation**  
**Case Number: DS07036**

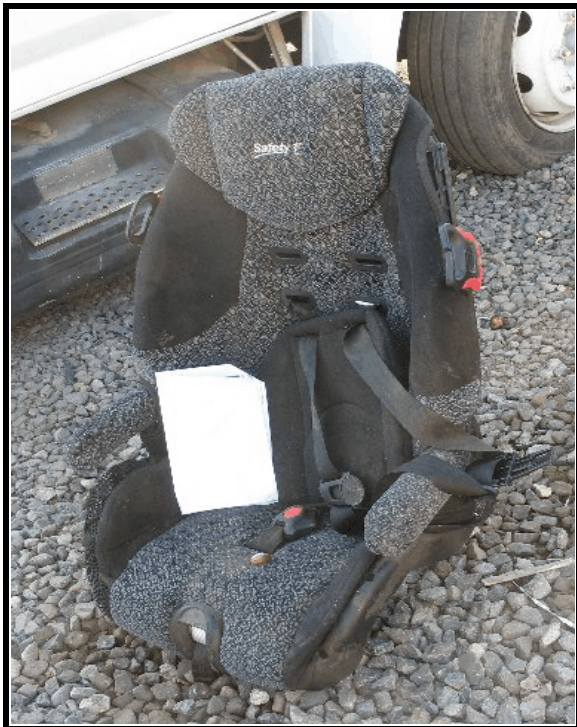
**Figure 9.** Cosco Safety 1<sup>st</sup> child safety seat

A Cosco Safety 1st Vantage Point SE forward facing Child Safety Seat (CSS) was used to restrain the second row left occupant. The model number was 22-561-WAL and the date of manufacture was October 18, 2006. The child seat was configured with a 5-point harness and a 2-piece harness retainer clip. The seat was designed with three harness positions. At the time of the crash, the harness was in the middle set of slots (**Figure 9**). The CSS was designed to be used as a forward facing CSS or a booster seat. The CSS was configured with a top tether and Lower Anchors and Tethers for Children (LATCH) hardware. The child seat was designed to be secured by a lap belt, lap and shoulder belt, or LATCH. When anchored by a safety belt, the belt was to be routed through a set of forward facing slots.

The Cosco Safety 1<sup>st</sup> instructions specified that the child must be 10.1-18 kg (22-40 lb) in weight, 85.1-110 cm (34-43 in) in height, and greater than 1 year of age. The child in this seat position met the age criteria, but it is not known if she met the height and weight guidelines.
