CRASH DATA RESEARCH CENTER
Calspan Corporation
Buffalo, NY 14225

OFFICE OF DEFECTS INVESTIGATION

**2005 FORD CROWN VICTORIA POLICE INTERCEPTOR
REAR IMPACT CRASH AND FIRE INVESTIGATION**

CALSPAN CASE NO: CA07-037
LOCATION: OHIO
CRASH DATE: NOVEMBER, 2007

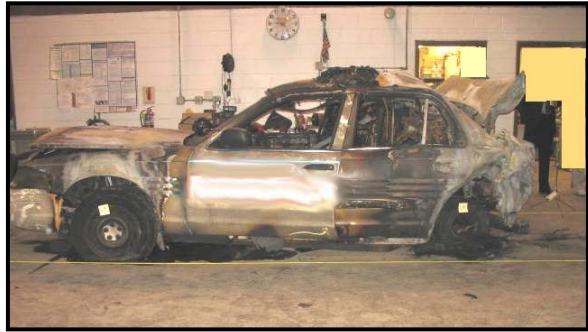
This on-site investigation focused on the crash severity and the source of the fuel leak that contributed to a post-crash fire that consumed a 2005 Ford Crown Victoria Police Interceptor (CVPI), **Figure 1**. This CVPI was not equipped with a Fire Panel or the Ford Fire Suppression System. The Ford was driven by a 48 year old on-duty police officer. The Ford was traveling at a driver estimated speed of 48 km/h (30 mph) when its back plane was impacted by a 1995 Cadillac DeVille. The Cadillac was operated by an intoxicated 22 year old female driver at a reconstructed speed of approximately 145 to 161 km/h (90 to 100 mph). The crash resulted in severe rear impact damage to the Ford and a fuel-fed fire. The impact displaced the CVPI approximately 119 m (390 ft) forward of the point of impact to its final rest location. The police officer driver of the Ford was able to open the driver's door post-crash and exited the vehicle unassisted; however, he sustained thermal burns over approximately 40 percent of his body and was admitted to a burn unit for treatment.

Figure 1: Left side view of the Ford.

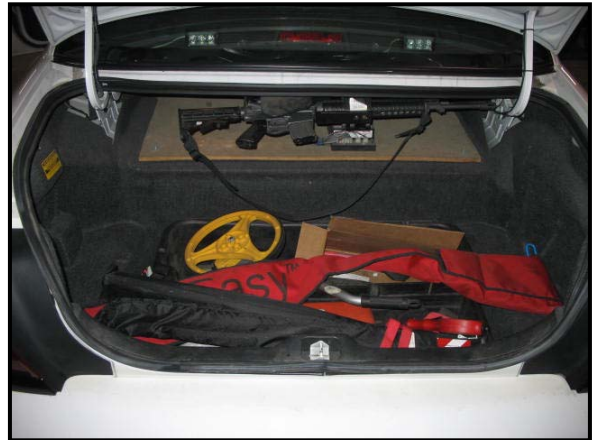
This police agency did not use the Kevlar-shielded trunk pack in their vehicles that was developed by Ford. A 91 cm x 61 cm (36 in x 24 in) molded plastic organizer was used to arrange the trunk contents in a lateral direction. The trunk contents included: Measuring Wheel, First Aid Kit, Sharps Container, “Big Easy” Lock-out Tool, 91 cm (36 in) long Stop Sticks, 10 cm (4 in) diameter Fire Extinguisher, Box of Flares, 61 cm (24 in) Crow Bar, Lug Wrench, Slim Jim, Flexible Cuffs, Ammunition Belt and an Assault Rifle. A single radio unit was mounted to plywood backing on the forward shelf of the trunk. **Figure 2** is a view of the trunk contents in an exemplar police vehicle.

Figure 2: Exemplar trunk contents.

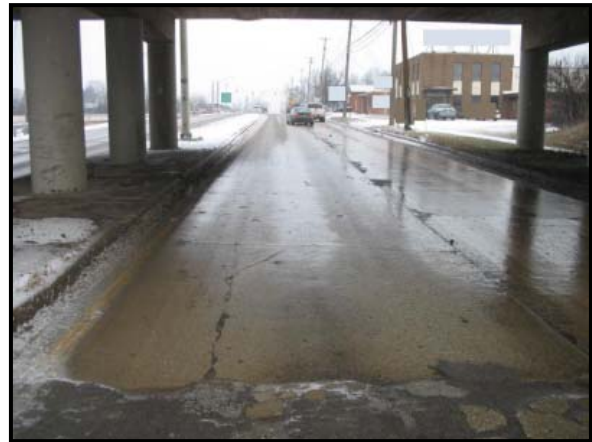
This two-vehicle front-to-rear crash occurred during the nighttime hours of November 2007. At the time of the crash, it was dark with overhead street lighting. The weather was police reported as fog. There was no precipitation and the concrete road surface was dry. The crash occurred on a two-lane divided north/south road in a suburban commercial setting. The traffic flow in the respective directions was separated by a 15 cm (6 in) high curbed concrete median. There was an overpass in the area of the impact. North of the overpass, the road grade was a positive two percent. The speed limit in the area of the crash was 56 km/h (35 mph). **Figure 3** is a northward view along the roadway at the point of impact.

Figure 3: Northbound trajectory view at the POI.

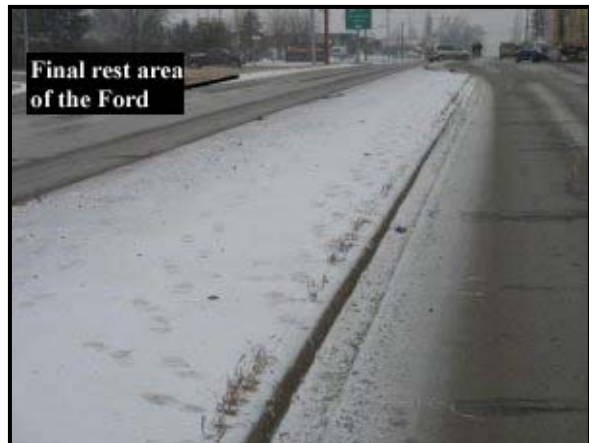
The fire started immediately after the impact. The police investigation documented burn marks on the inboard northbound lane 24 m (80 ft) north of the impact location. The northbound momentum of the Cadillac displaced the Ford forward in continuous engagement until the vehicles reached a common velocity. The Ford was deflected to the left and separated from the Cadillac with a counterclockwise (CCW) rotation. The Ford mounted the center median approximately 43 m (140 ft) north of the impact, crossed into the southbound traffic lanes and came to final rest on the west shoulder of the roadway. **Figure 4** is a post-impact trajectory view of the Ford. The vehicle came to rest facing eastward approximately 119 m (390 ft) north of the impact. The total rotation of the Ford measured 280 degrees.

Figure 4: Post-impact trajectory of the Ford.

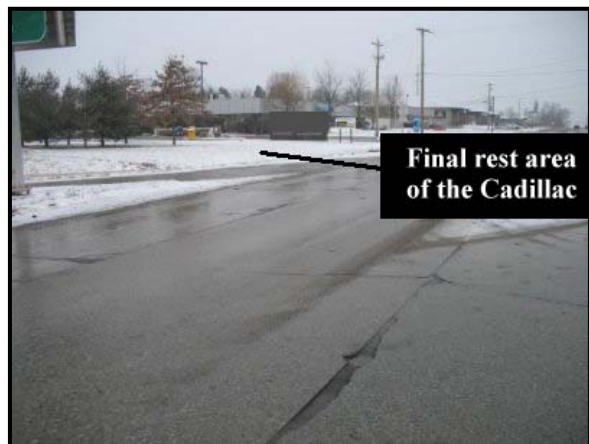
The Cadillac continued northward after the separation of the Ford. The left front tire of the Cadillac became restricted due to the impact damage and induced a left steer to the vehicle. The police documented the post-impact trajectory of the Cadillac as it contacted the center median several times but did not mount it. The center median terminated at the intersection of the roadway with an interstate on-ramp. The Cadillac traversed through the intersection with a northwest trajectory as a result of the induced steer and began to rotate CCW. Refer to **Figure 5**. A fluid trail evidenced the vehicle's trajectory across the intersection. The Cadillac traveled into the northwest intersection quadrant and came to rest in the grass facing southward. The Cadillac came to rest approximately 204 m (670 ft) from the point of impact. A schematic of the crash developed by the police during their investigation is included at the end of this report as **Figure 23**.

Figure 5: Post-impact trajectory view of the Cadillac.

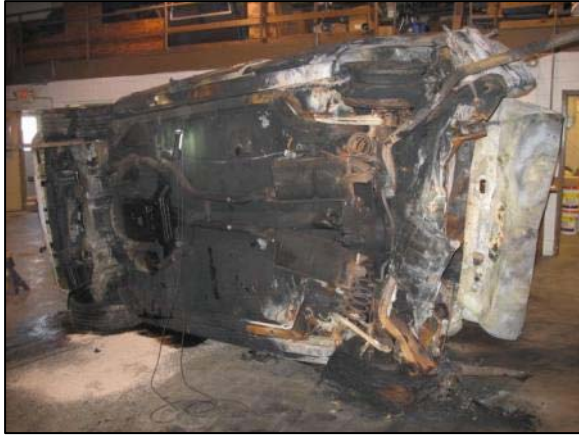
The initial inspection of the undercarriage revealed that the back wall of the fuel tank was crushed by the forward wall of the trunk and against the differential housing. The tank was intact, held in place by the tank straps. The filler tube remained intact and positioned in the tank and at the filler-door location. A positioning bracket attached to the inner fender held the tube in place. No visible punctures of the tank were visible. The fuel pump sending unit was dislodged from the tank and rotated 180 degrees. Refer to **Figure 15**. The unit was held in place by the external braided stainless steel fuel lines. The retainer ring was secured to the pump/sending unit flange by the six bolts.

Figure 14: CVPI positioned on its right side.

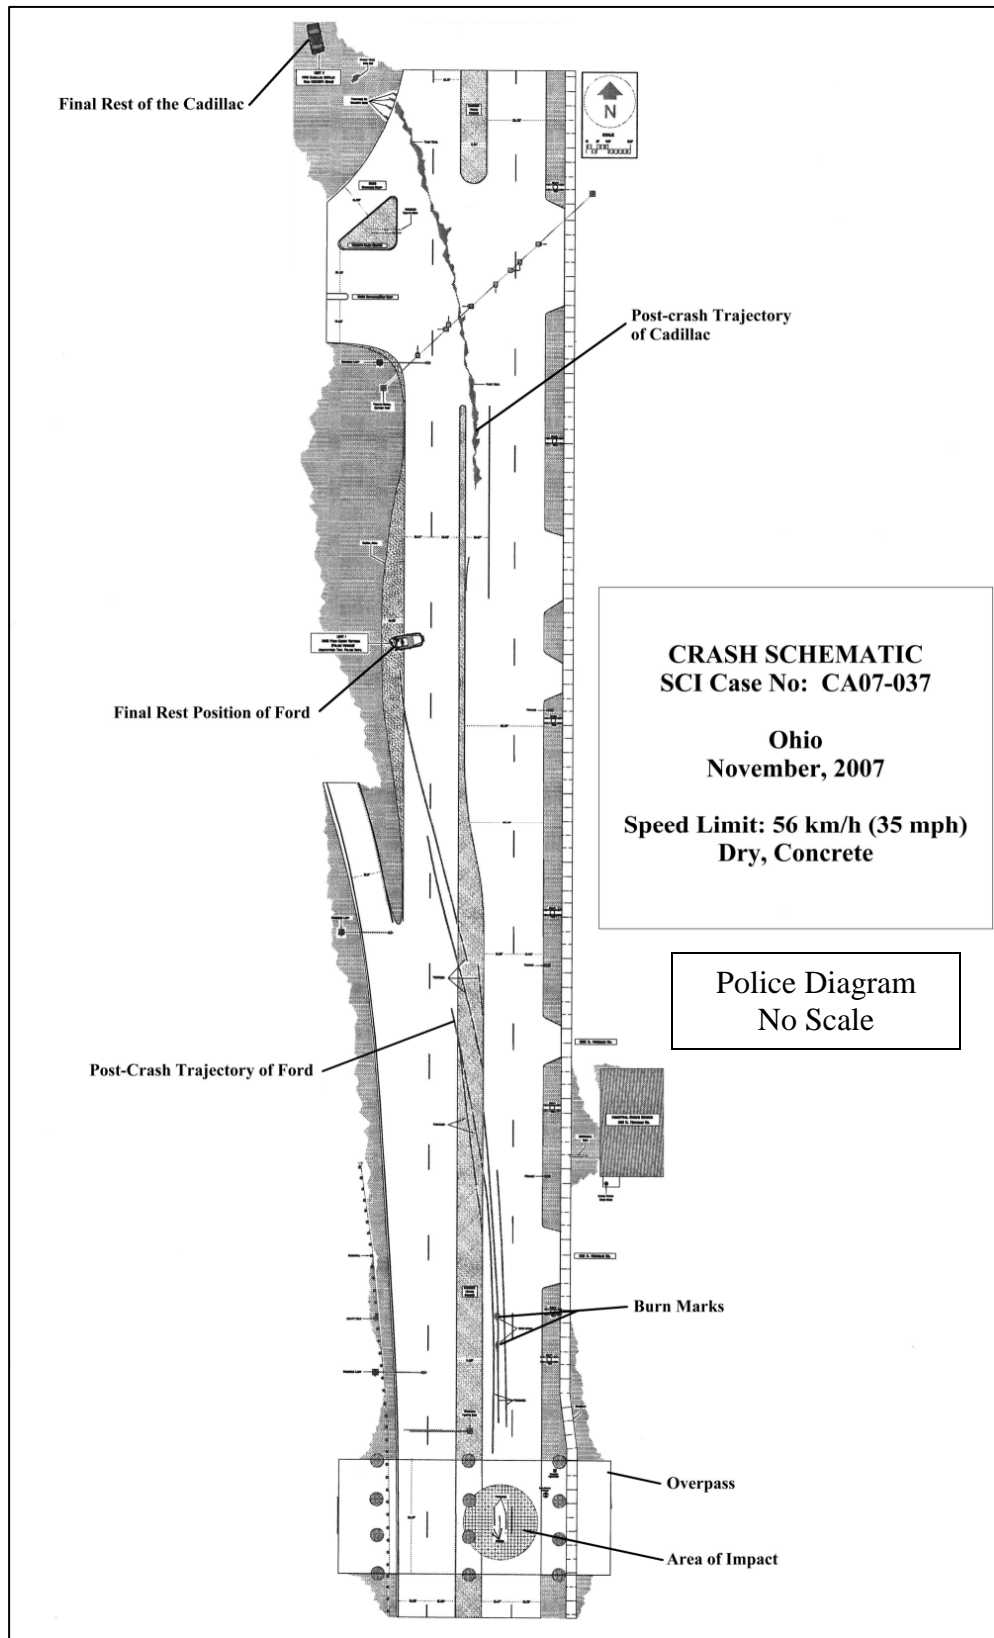
Figure 23: Crash schematic.
