ON-SITE NOT IN TRAFFIC SURVEILLANCE BACK OVER INVESTIGATION

CASE NUMBER - IN08001
LOCATION - ARKANSAS
VEHICLE - 2007 HYUNDAI ELANTRA
CRASH DATE - November 2007

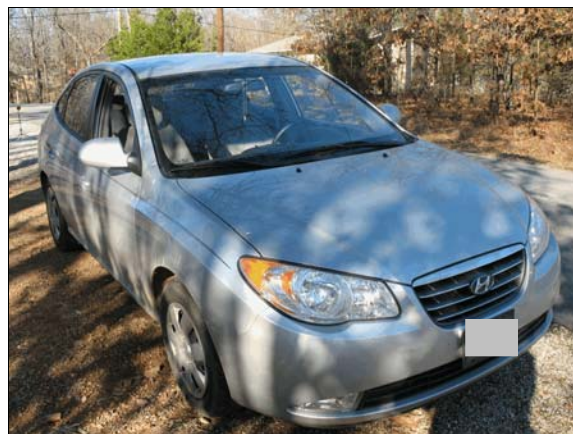
Figure 5: Front right view of subject Hyundai Elantra

The 2007 Hyundai Elantra (**Figures 5 and 6** below) was a front wheel drive, four-door sedan (VIN: KMHDU46D57U-----) equipped with a 2.0L, I-4 engine and automatic transmission. Its back bumper was covered with a plastic bumper fascia with energy absorbing material between the bumper fascia and bumper bar. None of the Hyundai's glazing was tinted. The Hyundai was not equipped with any after market equipment and was not equipped with a back up/parking aid. The Hyundai's specified wheelbase was 265 centimeters (104.3 inches), the specified rear overhang was 99 centimeters (38.9 inches), and the specified overall length was 451 centimeters (177.4 inches). The measured distance from the ground to the bottom of the back bumper fascia
