Child Safety Seat Investigation
Dynamic Science, Inc. / Case Number: DS08001
1985 Mercedes-Benz 190E
California
January 2008

1. Report No. DS08001		2. Government Accession No.		3. Recipient Catalog No.	
4. Title and Subtitle Child Safety Seat Investigation				5. Report Date February 15, 2009

14. Sponsoring Agency Code	
15. Supplemental Notes					
16. Abstract <p>This on-site investigation focused on a child safety seat that was positioned in the left rear seat position in a 1985 Mercedes-Benz 190E. The Mercedes was being driven by a restrained 33-year-old female and a 3-year-old female was seated in the second row left position in a child safety seat. The Mercedes was traveling northbound at a witness reported speed of 72 km/h (45 mph) and was weaving through slower moving traffic. The other vehicle in this crash was a 2003 Honda Odyssey minivan. There were three occupants in this vehicle. The Odyssey was stopped at the intersection and was facing north. As the Mercedes approached the intersection, the driver lost control of her vehicle. The left side of the Mercedes struck the right rear of the Odyssey. The Mercedes continued past the Odyssey through the intersection, over the n

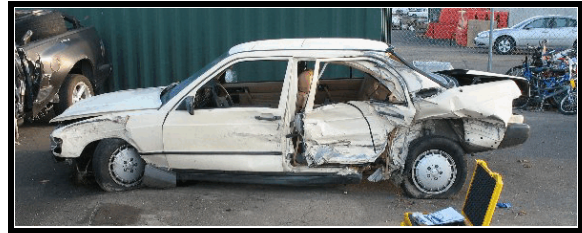
Figure 1. 1985 Mercedes-Benz 190E

This on-site investigation focused on a Child Safety Seat (CSS) that was positioned in the left rear seat position in a 1985 Mercedes-Benz 190E (**Figure 1**). The Mercedes was being driven by a restrained 33-year-old female and a 3-year-old female was seated in the second row left position in the CSS. The Mercedes was traveling northbound at a witness reported speed of 72 km/h (45 mph) and was weaving through slower moving traffic. The other vehicle in this crash was a 2003 Honda Odyssey minivan. There were three occupants in the vehicle. The Odyssey was stopped at an intersection and was facing north. As the Mercedes neared the intersection, the driver lost control of her vehicle. The left side of the Mercedes struck the right rear of the Odyssey. The Mercedes continued past the Odyssey through the intersection, over the northeast corner of the intersection, and struck several off-road objects. The driver of the Mercedes sustained severe injuries according to the police report. She was transported to a local hospital. She was later arrested for driving under the influence alcohol. The 3-year-old female left rear passenger sustained facial lacerations, a right globe rupture, a pulmonary contusion, displaced rib fractures, and bilateral hip contusions. She was transported by air to an area trauma center where she was hospitalized for five days. The occupants of the Odyssey reported minor injuries. The Mercedes was towed from the scene due to damage and was placed on a police hold.

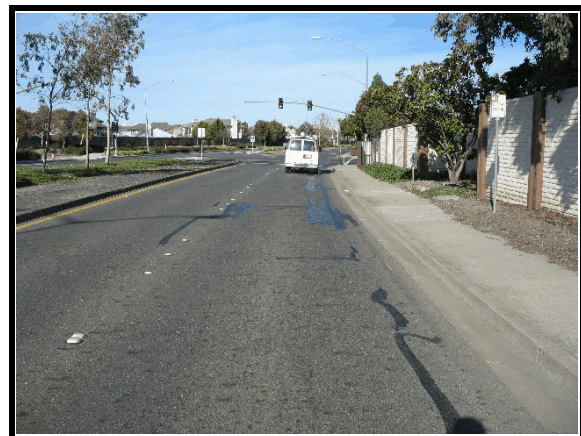
Figure 2. Approach to area of impact (North)

This two-vehicle crash occurred in the approach to a four-leg intersection (**Figure 2**). At the time of crash, there were no adverse weather conditions and the asphalt roadway was dry. The curved north/south roadway was configured with two lanes in each direction that were separated by a raised median. The northbound travel lanes were separated by raised pavement markers. The intersection was controlled by a tri-color traffic signal. The posted speed limit was 72 km/h (45 mph).
