**CALSPAN ON-SITE CHILD SAFETY SEAT
CRASH INVESTIGATION**

CASE NO: CA08002

VEHICLE: 2000 HONDA CIVIC LX

CRASH DATE: JANUARY 2008

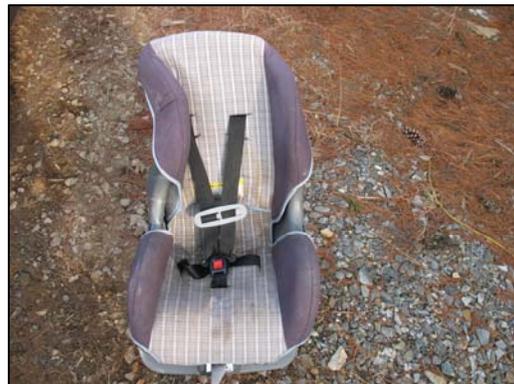
Figure 9 - Overhead view of CSS.

The CSS was configured with a 5-point harness system. The harness was routed through the top slots and the harness straps were in good condition. The length of the right and left straps was 24 cm (9.5") and 23 cm (9.25"), respectively. The CSS was designed with a 13 x 5 cm (5.5 x 2") chest retainer clip. The right harness strap was threaded through the clip. The left harness strap was not threaded at the time of the inspection, refer to **Figure 10**. There was no loading evidence on the harness straps or retainer clip.
