**CALSPAN ON-SITE CERTIFIED ADVANCED 208-COMPLIANT VEHICLE
CRASH INVESTIGATION**

SCI CASE NO. – CA08007

VEHICLE – 2007 HONDA CIVIC

CRASH DATE – DECEMBER 2007

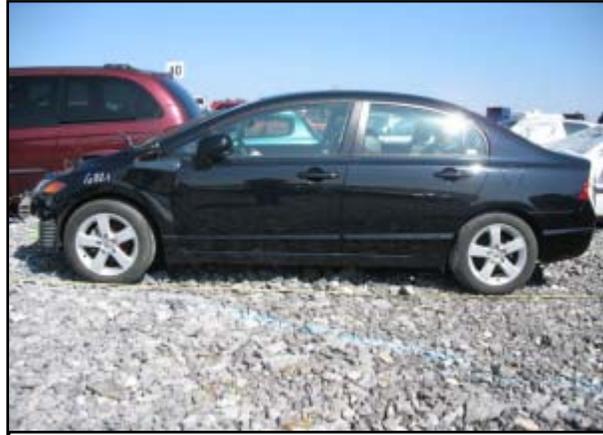
Figure 1. 2007 Honda Civic.

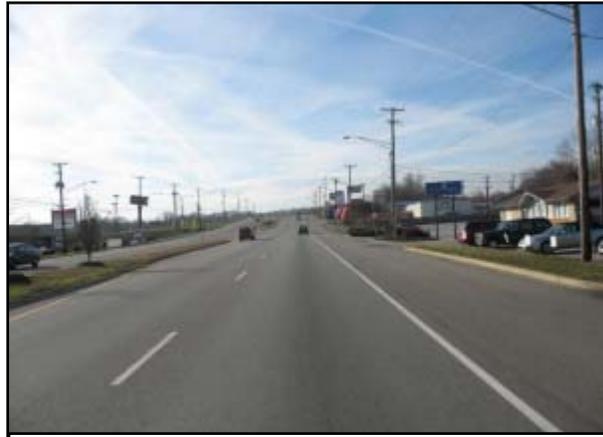
The driver of the Honda was operating the vehicle northbound in the inboard lane. A 42-year-old male was operating the 2006 Ford F550. The Ford was entering the travel lanes from the shoulder. The driver of the Honda stated during the interview that as she neared the intersection, the Ford began to change lanes from right to left into the inboard lane. A witness to the crash reported to the police investigator that he followed the Honda and noted that he did not observe any avoidance actions (i.e. brake lights). The crash scene images were taken in the inboard lane based on the police reported information at the time of the SCI investigation. **Figure 2** is a northbound view of the roadway.

Figure 2. Northbound view of the roadway from the outboard lane.

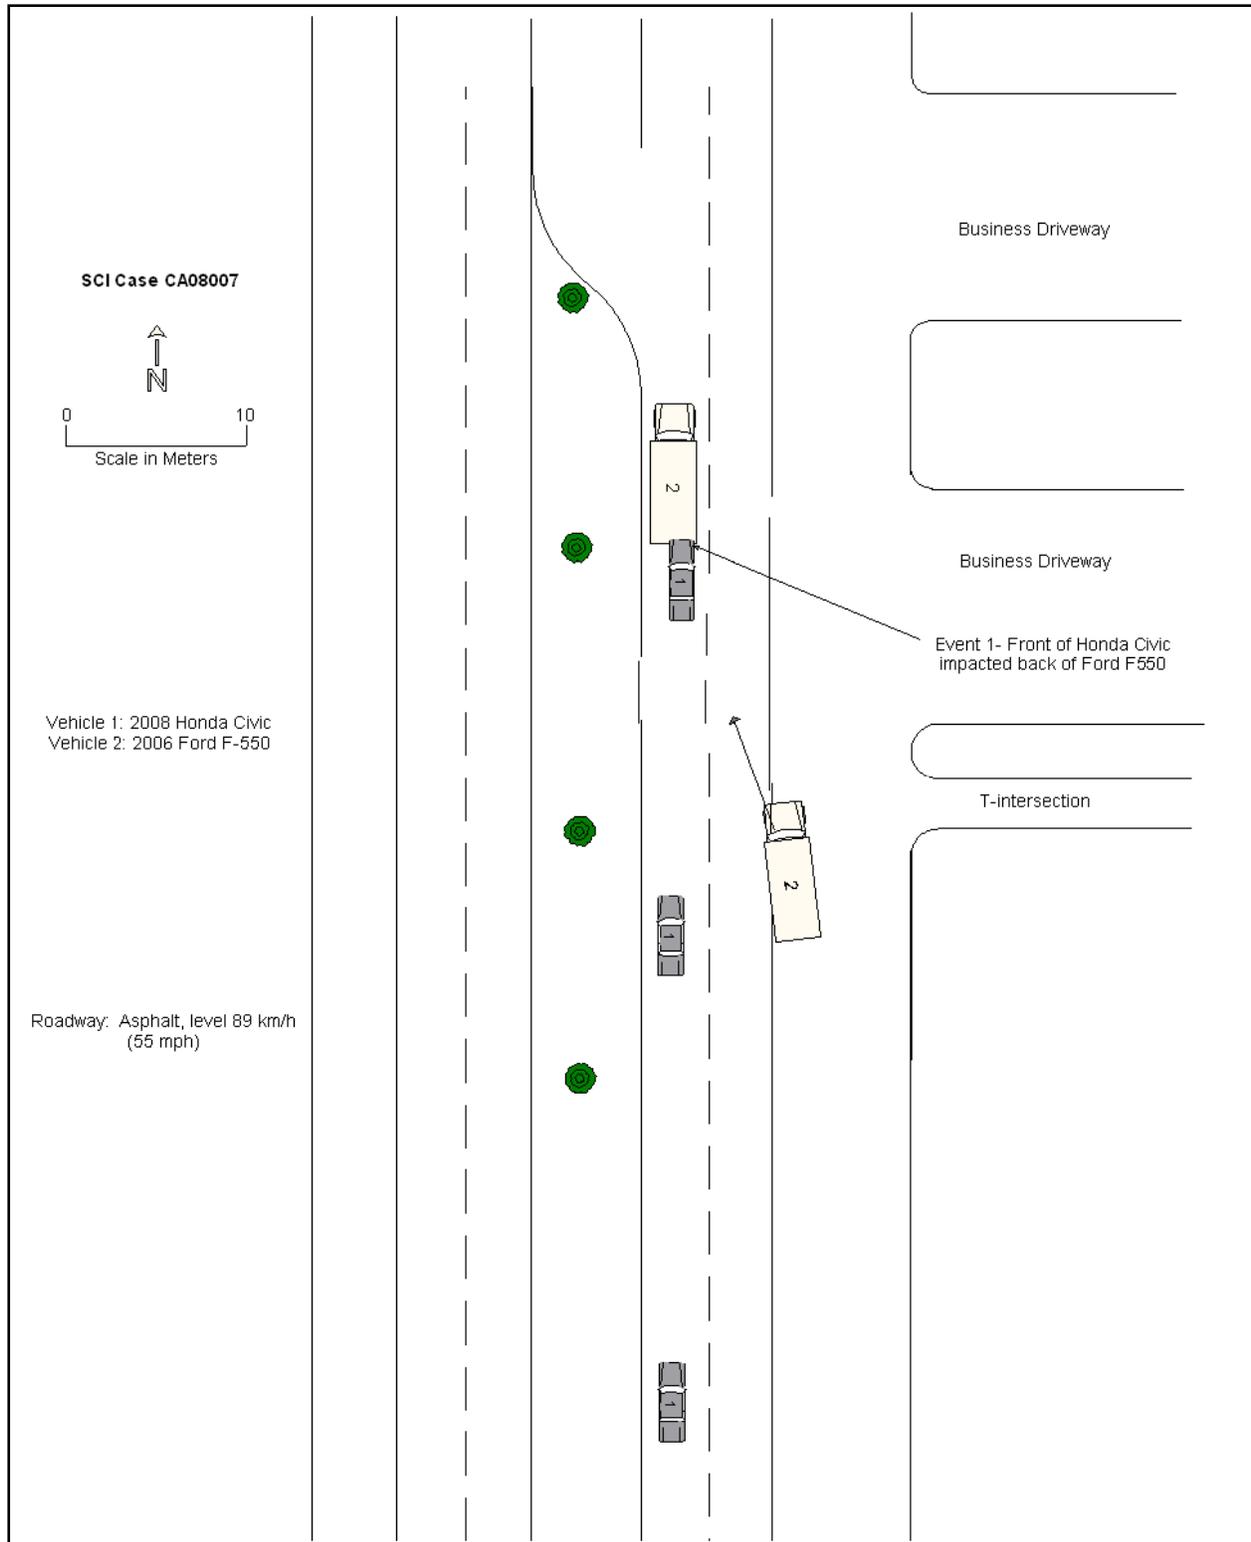
Figure 11. Scene schematic

This front-to-rear crash occurred during the nighttime hours of December 2007. At the time of the crash it was cloudy and the asphalt road surface was dry. The crash occurred north of a T-intersection. The north and south legs of the intersection were configured with two travel lanes in each direction that were delineated by a grass median. Immediately north of the crash site, a left turn lane was available for turning traffic. The east and westbound lanes were configured with one travel lane in each direction that were not separated. The posted speed limit for the north/southbound roadway was 72 km/h (45 mph). The scene schematic is included as **Figure 11** of this report.
