Child Safety Seat Investigation
Dynamic Science, Inc. / Case Number: DS08008
2001 Jeep Grand Cherokee
California
February 2008

14. Sponsoring Agency Code	
15. Supplemental Notes				
16. Abstract This on-site investigation focused on a booster seat that was installed in the second row left position of a 2001 Jeep Grand Cherokee. The Jeep was occupied by an unrestrained 27-year-old female and a 2-year-old female second row left passenger, restrained in the child seat. This two-vehicle crash occurred in February 2008 at 1140 hours in a rural area of California. The Jeep was traveling westbound. The other vehicle was a 2007 Chevrolet Silverado that was being driven by an unrestrained 41-year-old female. The Chevrolet was traveling eastbound and traveled partially onto the south gravel shoulder. The driver of the Chevrolet overcorrected in an attempt to get back in her lane and the vehicle began a counterclockwise rotation. The Chevrolet traveled into the westbound lane of travel. The Chevrolet and the Jeep collided in an angled head-on configuration. The Jeep subsequently struck a barbed wire fence, rolled over onto it left side, and caught fire. Both drivers were fatally injured. The

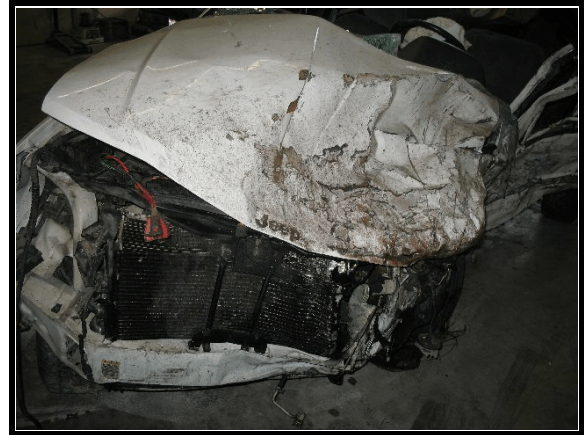
Figure 1. 2001 Jeep Grand Cherokee

This on-site investigation focused on a forward facing child safety seat (CSS) that was installed in the second row left position of a 2001 Jeep Grand Cherokee (Figure 1). The Jeep was occupied by an unrestrained 27-year-old female and a 2-year-old female rear left passenger, restrained in the CSS. This two-vehicle crash occurred in February 2008 at 1140 hours in a rural area of California. The Jeep was traveling westbound. The other vehicle was a 2007 Chevrolet Silverado that was being driven by an unrestrained 41-year-old female (Figure 2). The Silverado was traveling eastbound and traveled partially onto the south gravel shoulder. The driver of the Silverado overcorrected in an attempt to get back in her lane. The Chevrolet traveled into the westbound lane of travel. The Chevrolet and the Jeep collided in a head-on configuration. The driver of the Chevrolet was ejected. Both drivers were fatally injured. The second row seated child occupant of the Jeep was transported by air to an area trauma center. She sustained a skull fracture, right leg and ankle fractures, a lung contusion, and a concussion.

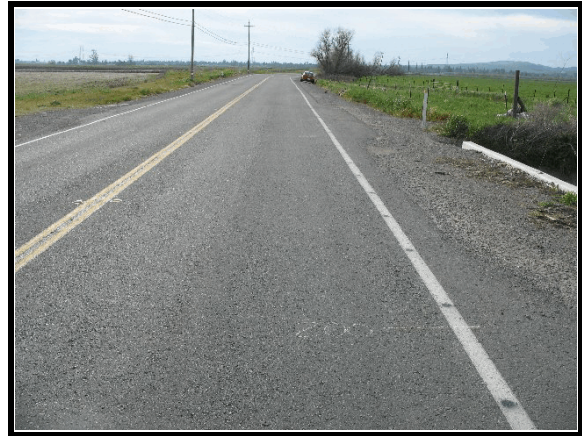
Figure 3. Approach to area of impact (west)

The 2001 Jeep Grand Cherokee was traveling westbound at an unknown speed (**Figure 3**). The 2007 Chevrolet Silverado was traveling eastbound (**Figure 4**). The EDR reported the vehicle's speed five seconds prior to impact as 143 km/h (89 mph). As the Silverado entered the left hand curve, the right side tires went off the roadway and onto the gravel shoulder. The driver began steering to the left and braking. The Silverado returned to the roadway and began a counterclockwise rotation. The EDR-reported the speed one second prior to impact as 122 km/h (76 mph). Brake application was based on the EDR pre-crash data, which showed the brake switch status as "on" two seconds prior to impact.

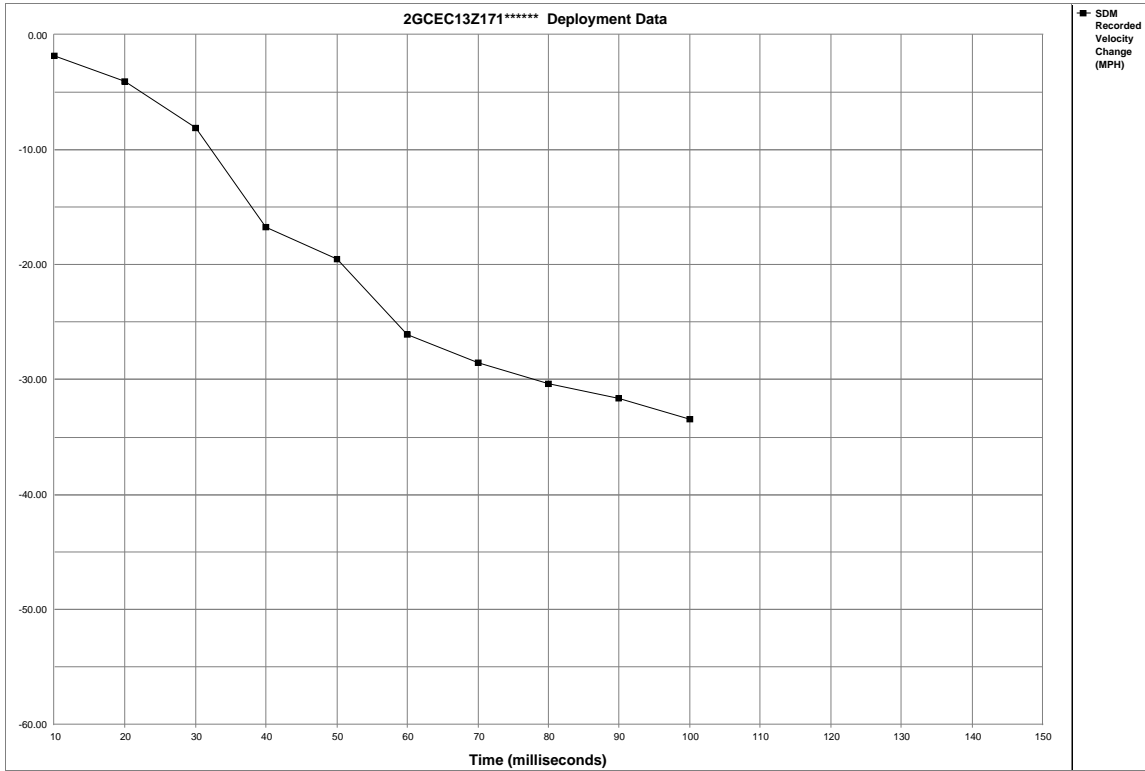
Time (milliseconds)	10	20	30	40	50	60	70	80	90	100	110	120	130	140	150
Recorded Velocity Change (MPH)	-1.86	-4.03	-8.06	-16.74	-19.53	-26.04	-28.52	-30.38	-31.62	-33.48	N/A	N/A	N/A	N/A	N/A

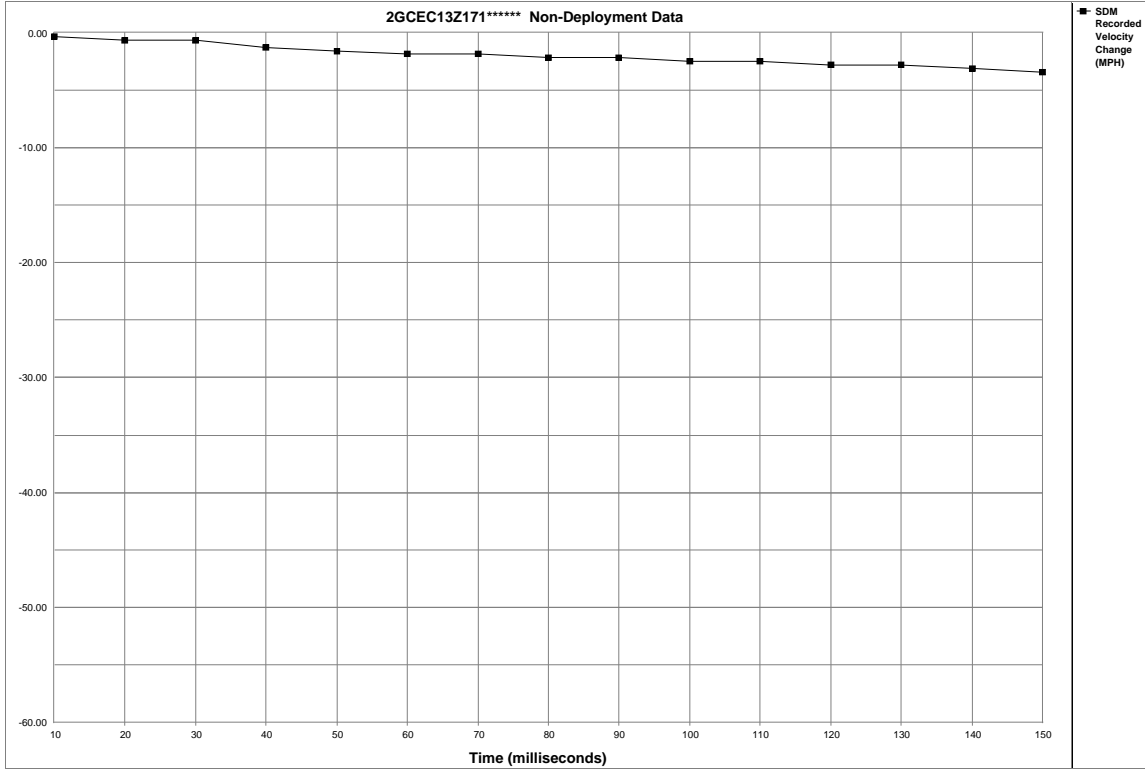
Time (milliseconds)	10	20	30	40	50	60	70	80	90	100	110	120	130	140	150
Recorded Velocity Change (MPH)	-0.31	-0.62	-0.62	-1.24	-1.55	-1.86	-1.86	-2.17	-2.17	-2.48	-2.48	-2.79	-2.79	-3.10	-3.41
