**CALSPAN ON-SITE SIDE IMPACT INFLATABLE OCCUPANT PROTECTION
CRASH INVESTIGATION**

SCI CASE NO. – CA08012

VEHICLE – 2007 HYUNDAI SONATA

CRASH DATE – FEBRUARY 2008

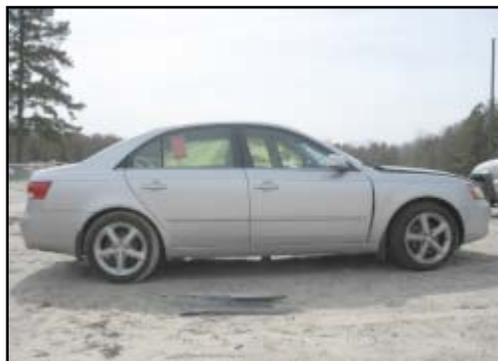
Figure 1. 2007 Hyundai Sonata.

This on-site investigative effort focused on the side impact inflatable occupant protection system in a 2007 Hyundai Sonata (**Figure 1**) and the injury sources of the restrained 31-year-old female driver. The Hyundai was equipped with seat back mounted side impact air bags for the front seat positions and curtain air bags for the four outboard positions. In addition to the side impact air bags, the Hyundai was equipped with a Certified Advanced 208-Compliant frontal air bag system. The Hyundai was involved in an intersection crash with a 2005

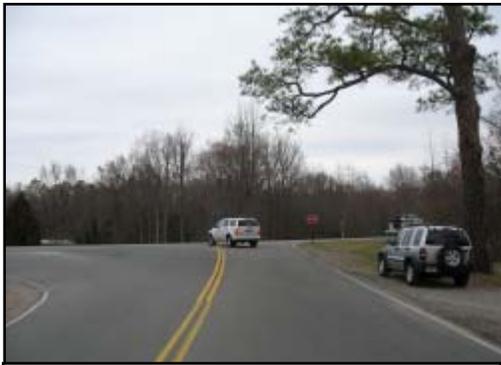
Figure 2. Hyundai's approach to the intersection.

The restrained 31-year-old female driver of the Hyundai Sonata was traveling north approaching the intersection where her intention was to turn left (**Figure 2**). She was decelerating for a regulatory stop sign and stopped at the three-leg intersection.

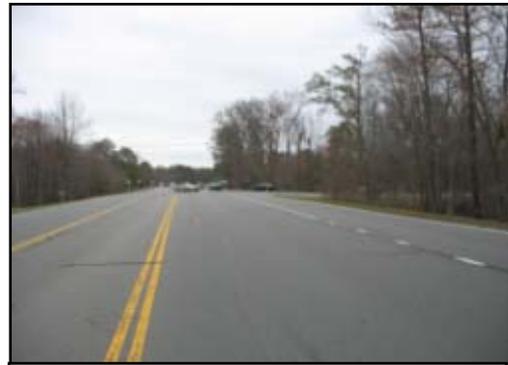
Figure 3. Ford Explorer and Ford Focus eastbound travel paths.

A 72-year-old male was operating the 2005 Ford Explorer eastbound approaching the intersection. The 2004 Ford Focus was operated by 50-year-old female eastbound behind the Explorer. **Figure 3** is a view of the eastbound travel path for the Explorer and Focus.

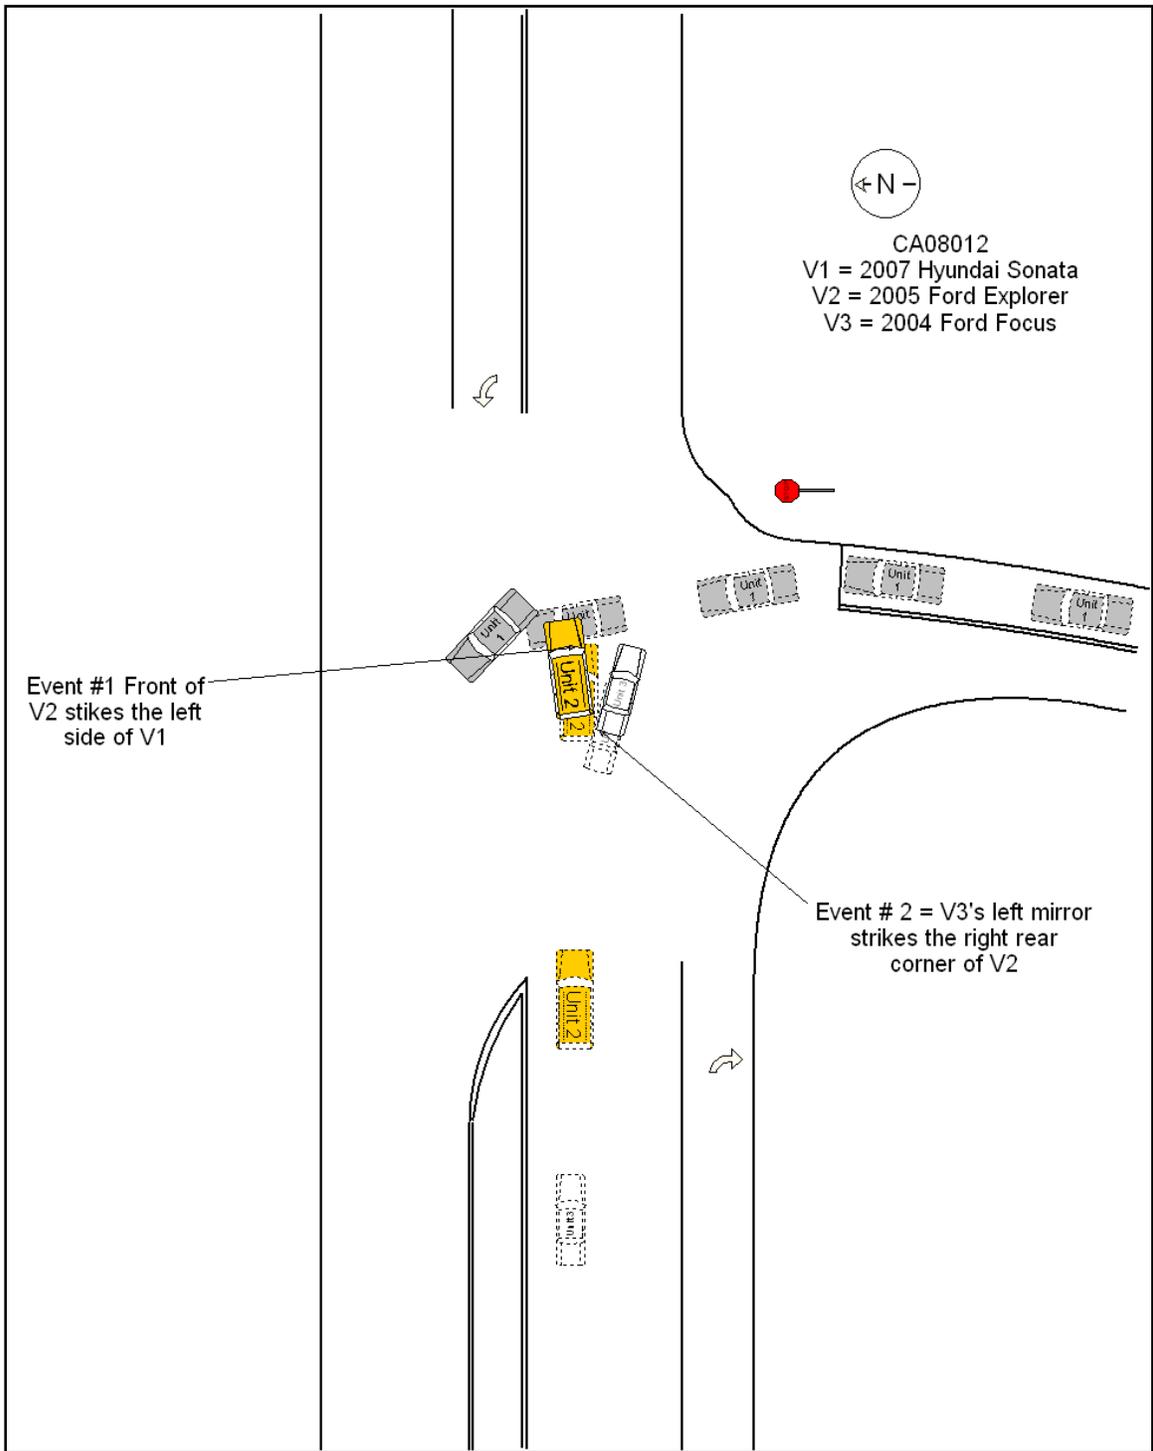
Figure 14: Scene Schematic

center left turn lane. The travel lanes on the east leg were separated by double yellow center lines. The west leg of the intersection measured 20.6 meters (67.6 feet) in width and contained a right turn only lane. There was a positive grade in the eastbound and northbound directions. The traffic lanes on the west leg were separated by a painted flush median. The intersection was controlled by stop signs for the northbound traffic. The posted speed limit for the north/south roadway was 56 km/h (35 mph) and 89 km/h (55 mph) for the east/west roadway. The scene schematic is included as **Figure 14** of this report.
