TRANSPORTATION RESEARCH CENTER

ON-SITE CHILD SAFETY SEAT INVESTIGATION

CASE NUMBER - IN08014
LOCATION - MINNESOTA
VEHICLE - 2004 TOYOTA CAMRY LE
CRASH DATE - March 2008

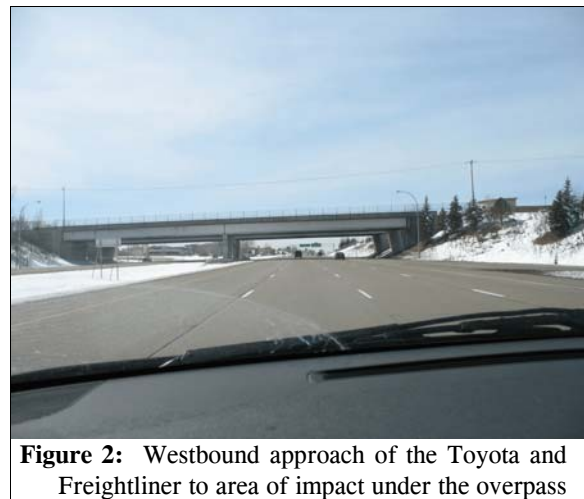
Crash Environment: This crash occurred on a 9-lane, divided Interstate highway, that traversed in an east-west direction (**Figure 2**). Both the Toyota and Freightliner were traveling west, and the crash occurred within an interchange area. The roadway had four through lanes, an entrance lane, and wide bituminous shoulders. The trafficway was divided by a grass median and the eastbound side of the Interstate highway had three through lanes, an entrance lane and wide bituminous shoulders. Each lane of the trafficway was nominally 3.5 meters (11.5 feet) in width and the pavement markings consisted of dashed white lane lines, yellow median lines and solid white edge lines. The posted speed limit for both vehicles was 88 km/h (55 mph). At the time of the crash, the light condition was daylight, the atmospheric condition was cloudy, and the roadway pavement was level, dry bituminous. Traffic density was moderate to heavy and the site of the crash was a rural/suburban area. See the Crash Diagram on page 8 of this report

Figure 2: Westbound approach of the Toyota and Freightliner to area of impact under the overpass

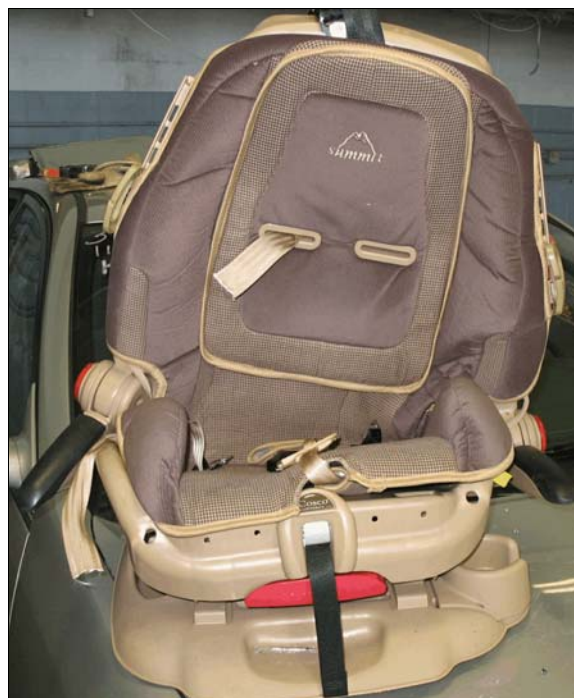
The Toyota's back right passenger 19-month-old, female; 89 centimeters and 11 kilograms (35 inches, 24 pounds)] was seated in a Cosco/Dorel Juvenile Group Summit High-Back Belt Positioning Booster seat (**Figure 6**) that was being used in the forward facing position. The CSS was manufactured on February 20, 2004 and its model number was 22-260-HOU. The CSS was designed for children who weigh 14-40 kilograms (30-100 pounds) and who's height is 73-102 centimeters (29-40 inches).

The CSS was secured in the second row right seat position by the CSS LATCH anchor straps, which were secured to the lower anchors. The tether strap was not used. Due to the intrusion of the Toyota's seat back, the CSS was held tightly in place by the LATCH anchor straps and had to be cut in order to remove the CSS for inspection. The CSS was deformed as a result of the seat back intrusion, which bent the back of the CSS forward as well as to the left 10 degrees. The right arm rest was also displaced outward, and the lower left side of the seat back sustained a crack in the shell 13 centimeters (5.1 inches) in length (**Figure 7**). The left harness strap was broken (**Figure 8**) due to loading on the harness slot as the seat back was bent forward. The harness retainer clip was also broken and the right harness strap was cut by rescue personnel.

Figure 6: Front view of CSS
