# INDIANA UNIVERSITY

## **ON-SITE CERTIFIED ADVANCED 208-COMPLIANT VEHICLE INVESTIGATION**

CASE NUMBER - IN08017

VEHICLE - 2007 CHEVROLET TRAILBLAZER LS

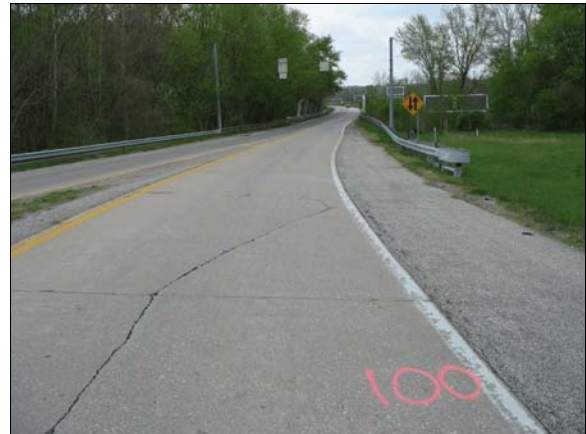
Figure 2: South approach of Chevrolet; number on pavement designates meters to impact area

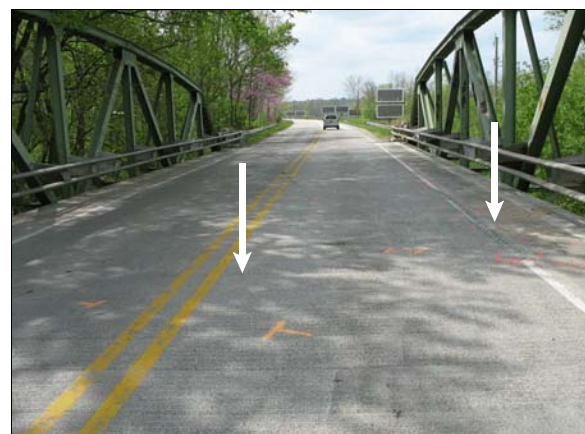
**Figure 8:** View south from Chevrolet's approach to area of impact between the Chevrolet and Pontiac; arrow on left shows final rest location of the Chevrolet; arrow on right shows final rest location of the Pontiac

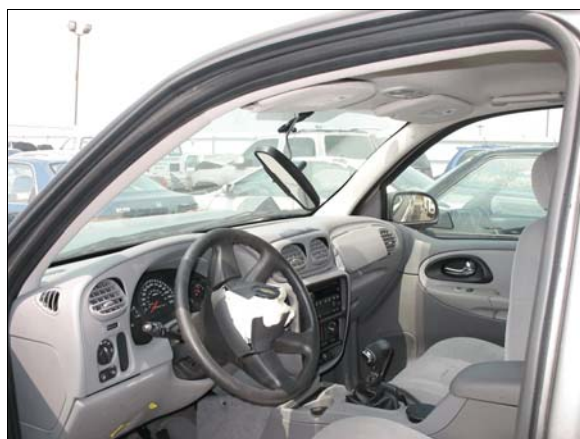
**Vehicle Interior:** The inspection of the Chevrolet's interior (**Figure 9**) revealed numerous areas of occupant contact evidence. Scuff marks from loading by the driver's knees were located on the knee bolster on each side of the steering column. The right half of the steering wheel rim was deformed 1 cm (0.4 in) as a result of the driver riding down the air bag and loading the steering wheel. The glove box door was cracked and scuffed due to loading by the front right passenger's knees. The front right seat back was displaced forward (**Figure 10**) due to loading by the unrestrained second row right passenger, and the second row right seat cushion was scuffed. All of the doors remained closed and operational and there was no damage or occupant contact to any of the window glazing. The passenger compartment sustained no intrusion.

**Figure 9:** View of the front row from the left front door

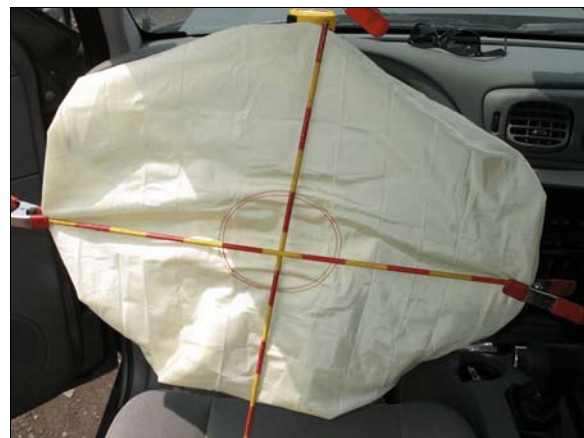
The Chevrolet's driver air bag was located in the steering wheel hub. The air bag module cover flaps (**Figure 11**) were constructed of vinyl, and the tear seams were configured horizontally across the top, bottom, and vertically down the middle. Each module flap was 7.5 cm (3 in) in width at the top, 4.3 cm (1.7 in) in width at the bottom and 13 cm (5.1 in) in height at the vertical tear seam. The cover flaps separated at the designated tear points during the deployment and there was no evidence of damage or occupant contact on the cover flaps or the air bag fabric. The deployed driver's air bag (**Figure 12**) was round with a diameter of 68 cm (26.8 in). The air bag was designed with four tethers and two vent ports.

**Figure 12:** Driver's air bag

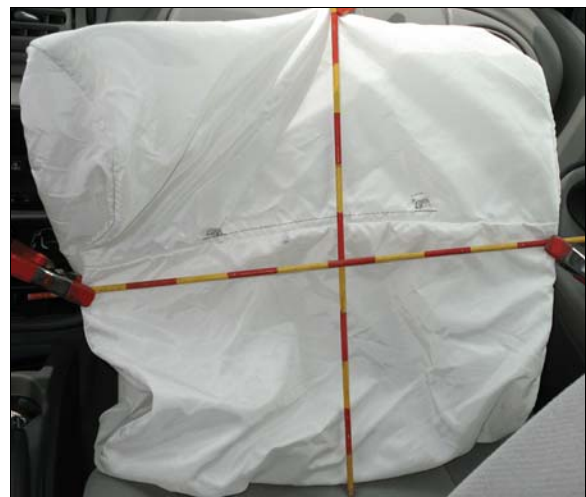
The front right passenger air bag was located in the middle of the instrument panel. The air bag module cover flap (**Figure 13**) was constructed of vinyl and hinged at the top. The cover flap was 33 cm (13 in) in width and 13 cm (5.1 in) in height. There was no evidence of damage or occupant contact on the cover flap or the air bag fabric. The deployed front right passenger air bag (**Figure 14**) was square with a length and width of 50 cm (19.7 in). The air bag was designed with one tether and two vent ports.

**Figure 14:** Front right passenger air bag

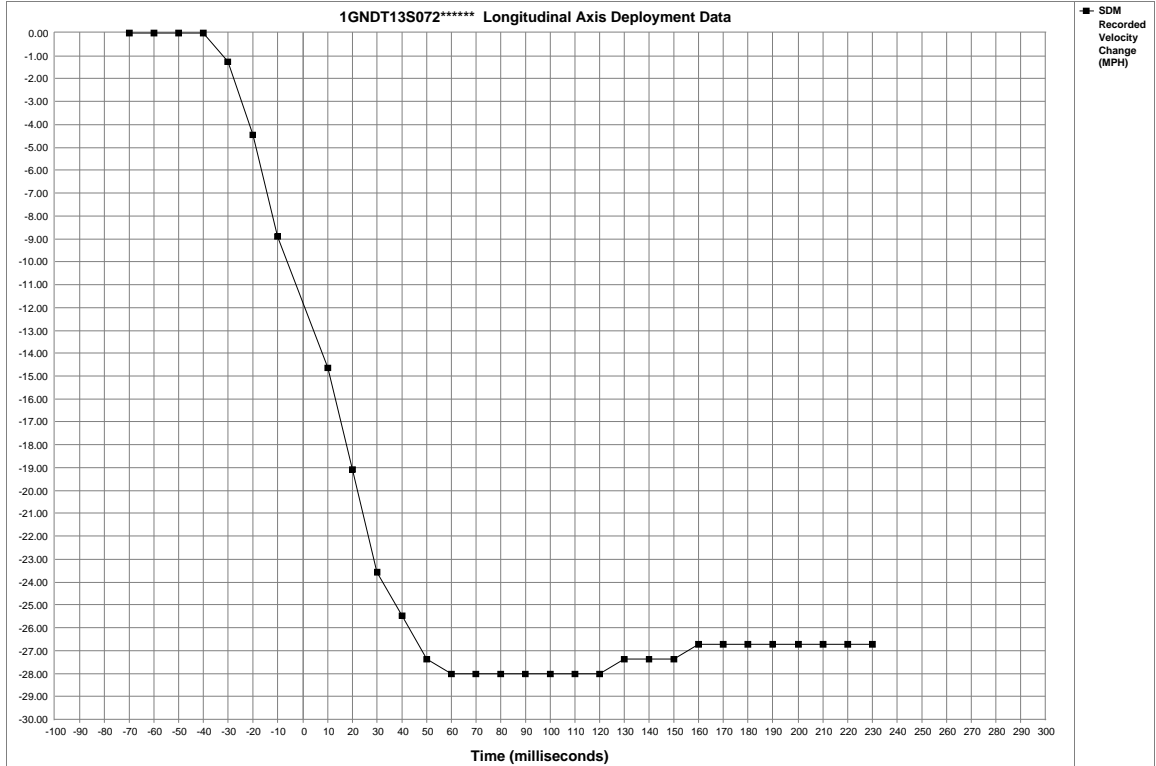
**Damage Classification:** The Chevrolet's Collision Deformation Classifications (CDC) were **12-FDEW-1 (0 degrees)** for the front impact and **03-RPEW-1 (90 degrees)** for the right front door impact. The Missing Vehicle algorithm of the WinSMASH program calculated the Chevrolet's total Delta V for the front impact as 23 km/h (14.3 mph). The longitudinal and lateral velocity changes were -23 km/h (-14.3 mph) and 0 km/h. The Missing Vehicle algorithm of the WinSMASH program calculated the Chevrolet's total Delta V for the right front door impact as 5 km/h (3.1 mph). The longitudinal and lateral velocity changes were 0 km/h and -5 km/h (-3.1 mph). The results for both runs were borderline because they are based only on the Chevrolet's crush profiles. The EDR recorded a maximum longitudinal velocity change for the front impact of -45.09 km/h (-28.02 mph).

Time (milliseconds)	-70	-60	-50	-40	-30	-20	-10	10	20	30	40	50	60	70	80
SDM Longitudinal Axis Recorded Velocity Change (MPH)	0.00	0.00	0.00	0.00	-1.27	-4.46	-8.91	-14.64	-19.10	-23.56	-25.47	-27.38	-28.02	-28.02	-28.02
Time (milliseconds)	90	100	110	120	130	140	150	160	170	180	190	200	210	220	230
SDM Longitudinal Axis Recorded Velocity Change (MPH)	-28.02	-28.02	-28.02	-28.02	-27.38	-27.38	-27.38	-26.74	-26.74	-26.74	-26.74	-26.74	-26.74	-26.74	-26.74

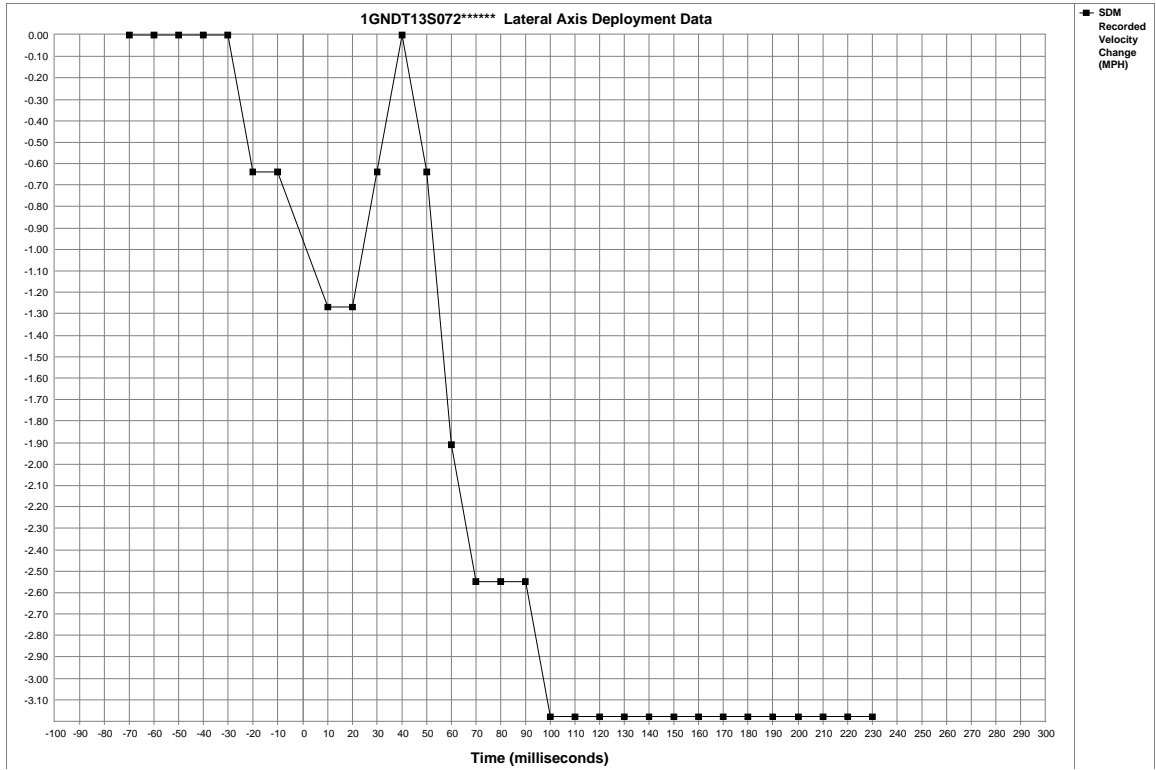
Time (milliseconds)	-70	-60	-50	-40	-30	-20	-10	10	20	30	40	50	60	70	80
SDM Lateral Axis Recorded Velocity Change (MPH)	0.00	0.00	0.00	0.00	0.00	-0.64	-0.64	-1.27	-1.27	-0.64	0.00	-0.64	-1.91	-2.55	-2.55
Time (milliseconds)	90	100	110	120	130	140	150	160	170	180	190	200	210	220	230
SDM Lateral Axis Recorded Velocity Change (MPH)	-2.55	-3.18	-3.18	-3.18	-3.18	-3.18	-3.18	-3.18	-3.18	-3.18	-3.18	-3.18	-3.18	-3.18	-3.18
