CALSPAN ON-SITE CERTIFIED ADVANCED 208-COMPLIANT VEHICLE

SCI CASE NO.: CA08018

VEHICLE: 2007 HONDA ACCORD

CRASH DATE: MARCH 2008

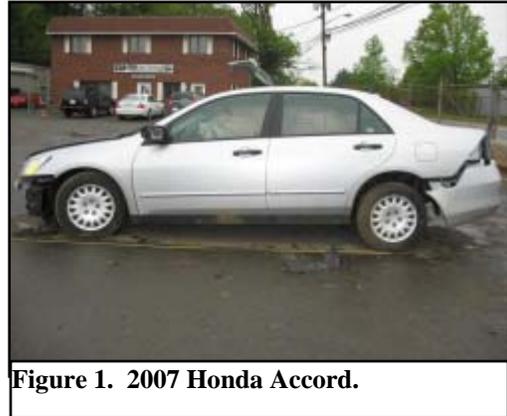
Figure 1. 2007 Honda Accord.

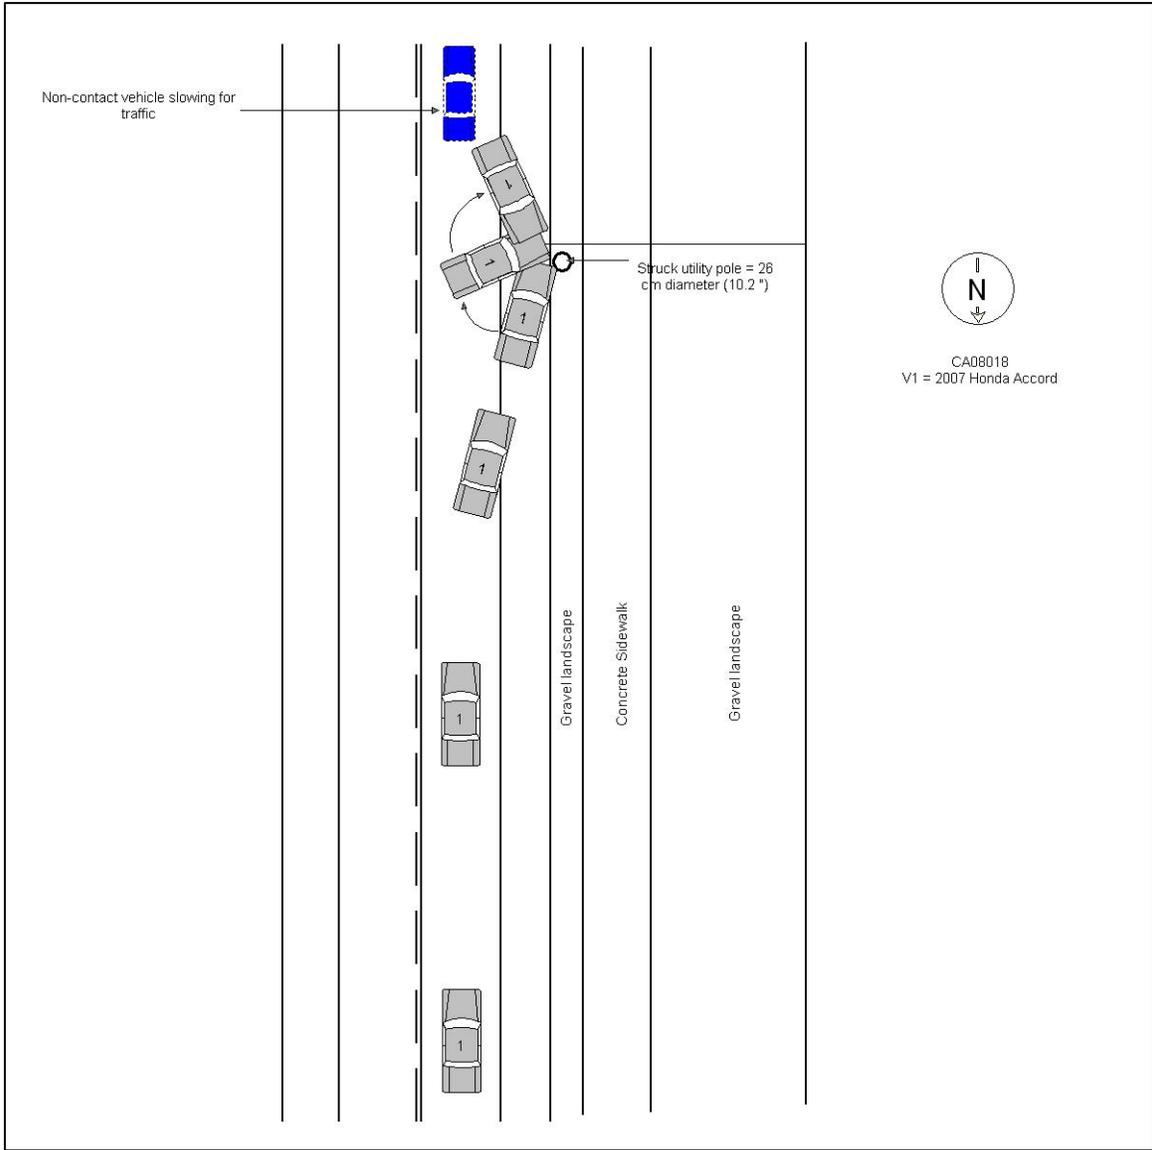
Figure 11: Scene Schematic

shoulder and mounted the west curb and entered the gravel landscaped area. The Scene Schematic is included as **Figure 11** of this report.
