Side Curtain Air Bag Investigation
Dynamic Science, Inc. (DSI), Case Number DS08021
2006 Ford Explorer
Washington
June 2008

1. Report No. DS08021	2. Government Accession No.		3. Recipient Catalog No.	
4. Title and Subtitle Side Curtain Air Bag Investigation			5. Report Date May 19, 2009

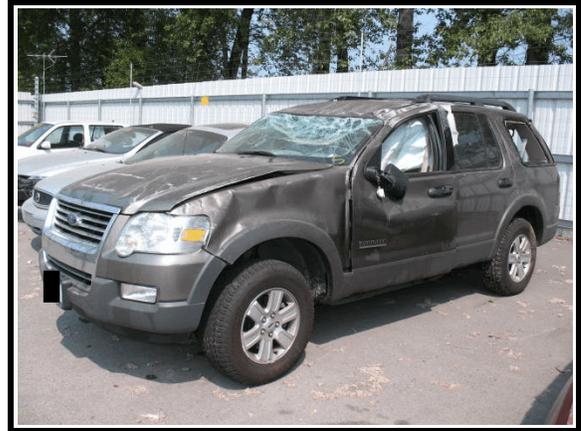
This on-site investigation focused on the deployment of the side curtain air bags in a 2006 Ford Explorer (**Figure 1**) that was involved in a two vehicle crash and subsequent two quarter turn rollover. The crash occurred within a four-leg intersection. The Ford was being driven by a restrained 47-year-old male. The Ford was struck on the right side while making a left turn by a 1998 BMW 740 sedan. The subject vehicle was displaced in a counterclockwise rotation, tripped, and overturned with its left side leading. The vehicle rolled two quarter turns and came to rest on its roof. The driver sustained a laceration to his left wrist. The Ford was towed from the scene due to damage and was later declared to be a total loss by the insurance company.

Figure 1. 2006 Ford Explorer

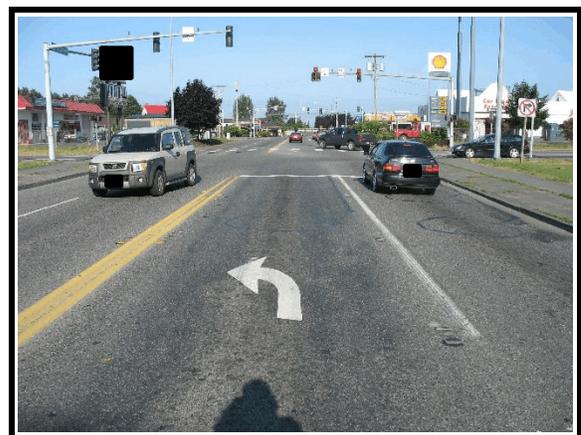
Figure 2. Westbound approach for the Ford

The Ford was stopped in the left turn lane, heading west; the driver was waiting for through traffic to clear, and was intending to turn left and proceed south onto the interstate on-ramp (**Figure 2**). The 1998 BMW 740 sedan was being driven by a restrained 30-year-old male who was traveling eastbound in the outboard lane at an unknown speed (**Figure 3**).

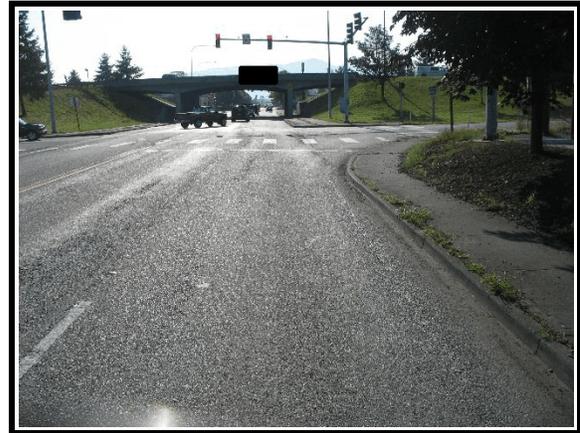
Figure 3. Eastbound approach of the BMW
