Child Safety Seat Investigation
Dynamic Science, Inc. (DSI), Case Number DS08025
1997 Honda Accord SE
California
June 2008

1. Report No. DS08025	2. Government Accession No.	3. Recipient Catalog No.	
4. Title and Subtitle Child Safety Seat Investigation		5. Report Date June 12, 2009

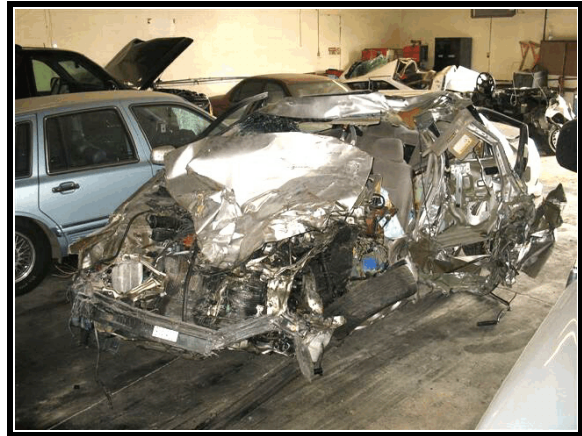
This investigation focused on a child occupant and child restraint in a 1997 Honda Accord (**Figure 1**), which was involved in a crash with a 2006 Ford F250 Super Duty pickup. A 4-month-old male child was seated in a Baby Trend Flex-Loc rear facing infant safety seat in the second row center position of the subject vehicle (**Figure 2**).

Figure 1. Subject vehicle, 1997 Honda Accord SE

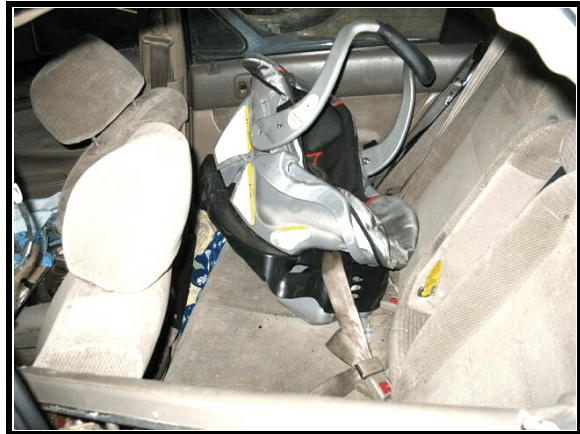
Figure 2. Baby Trend Flex-Loc infant safety seat

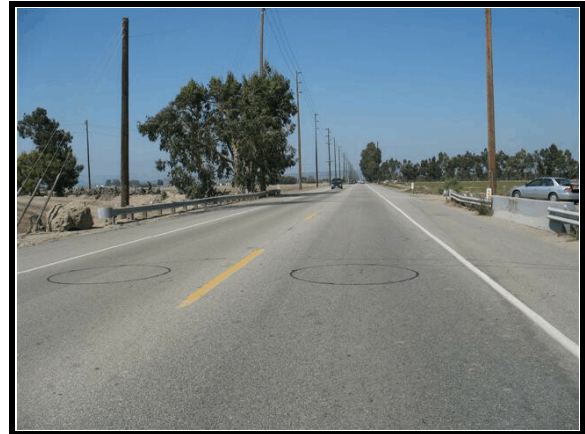
The Honda was being driven eastbound by a 21-year-old female and the second row center seat position was occupied by a 4-month-old male child who was seated in a rear-facing child safety seat. As the Honda approached the crash area, the vehicle traveled across the centerline and entered the westbound travel lane (**Figure 4**). Based on the post-crash position of the speedometer needle, the Honda was traveling approximately 97 km/h (60 mph). Based on the scene inspection, it was determined that the vehicle was tracking to the point of impact, and there was no braking.

Figure 3. Pre crash approach, subject vehicle

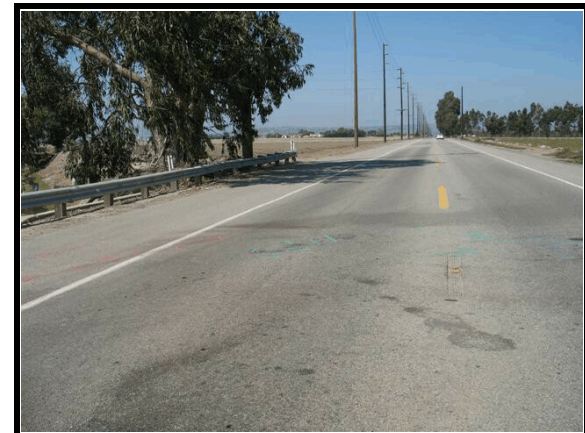
Figure 4. Area of impact, subject vehicle
