**NOT-IN-TRAFFIC SURVEILLANCE  
CALSPAN REMOTE HYPERTHERMIA DEATH INVESTIGATION  
SCI CASE NO.: CA08027**

**VEHICLE: 2001 GMC YUKON XLT**

**LOCATION: VIRGINIA**

**DATE OF INCIDENT: JULY 2008**

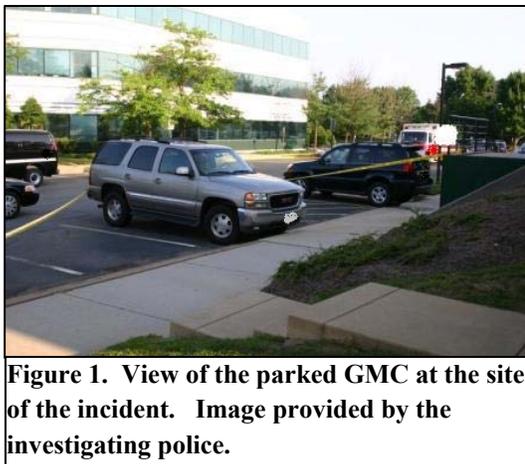
This remote investigation focused on the hyperthermia death of a 21-month-old male non-motorist who was left unattended in a closed vehicle for an extended period of time during daylight summer hours. The vehicle was a 2001 GMC Yukon sport utility vehicle that was pewter in color with a beige leather interior. The rear door, quarter windows, and backlight utilized OEM deep tint glazing. All the windows were closed during the incident. The non-motorist was restrained the full duration of the incident in a forward-facing Child Restraint System (CRS) that was secured in the second row left position of the GMC. He was found by a co-worker approximately 9.5 hours after the 49-year-old male driver had parked his vehicle at his work place (**Figure 1**). The child was pronounced deceased at the scene.
