## ON-SITE SIDE IMPACT INFLATABLE OCCUPANT PROTECTION INVESTIGATION

CASE NUMBER - IN08030  
LOCATION - TEXAS  
VEHICLE - 2007 CHEVROLET IMPALA LT  
CRASH DATE - May 2008

1. <i>Report No.</i> IN08030		2. <i>Government Accession No.</i>		3. <i>Recipient's Catalog No.</i>	
4. <i>Title and Subtitle</i> On-Site Side Impact Inflatable Occupant Protection Investigation Vehicle - 2007 Chevrolet Impala Location - Texas			5. <i>Report Date:</i> April 6, 2009

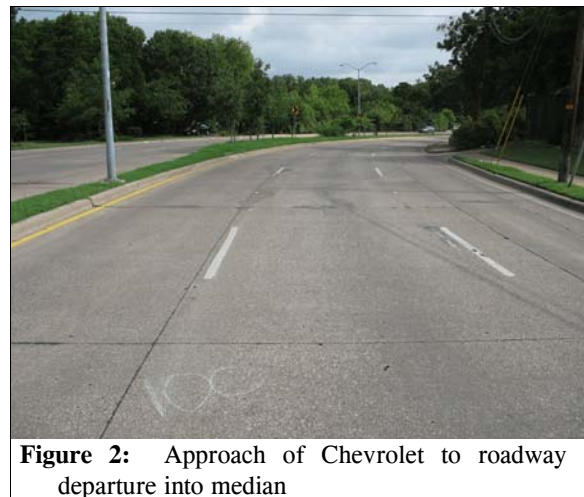
**Pre-Crash:** The Chevrolet was occupied by a restrained 18-year-old male driver, restrained 19-year-old male front right passenger, and a 19-year-old female second row right passenger (unknown if restrained). The driver was traveling north in the center lane (**Figure 2**) and negotiating a right curve. The Event Data Recorder's (EDR) pre-crash data indicated that the vehicle was traveling 142 km/h (88 mph) at 20 percent throttle 2.5 seconds prior to Algorithm Enable (AE). The

**Figure 2:** Approach of Chevrolet to roadway departure into median

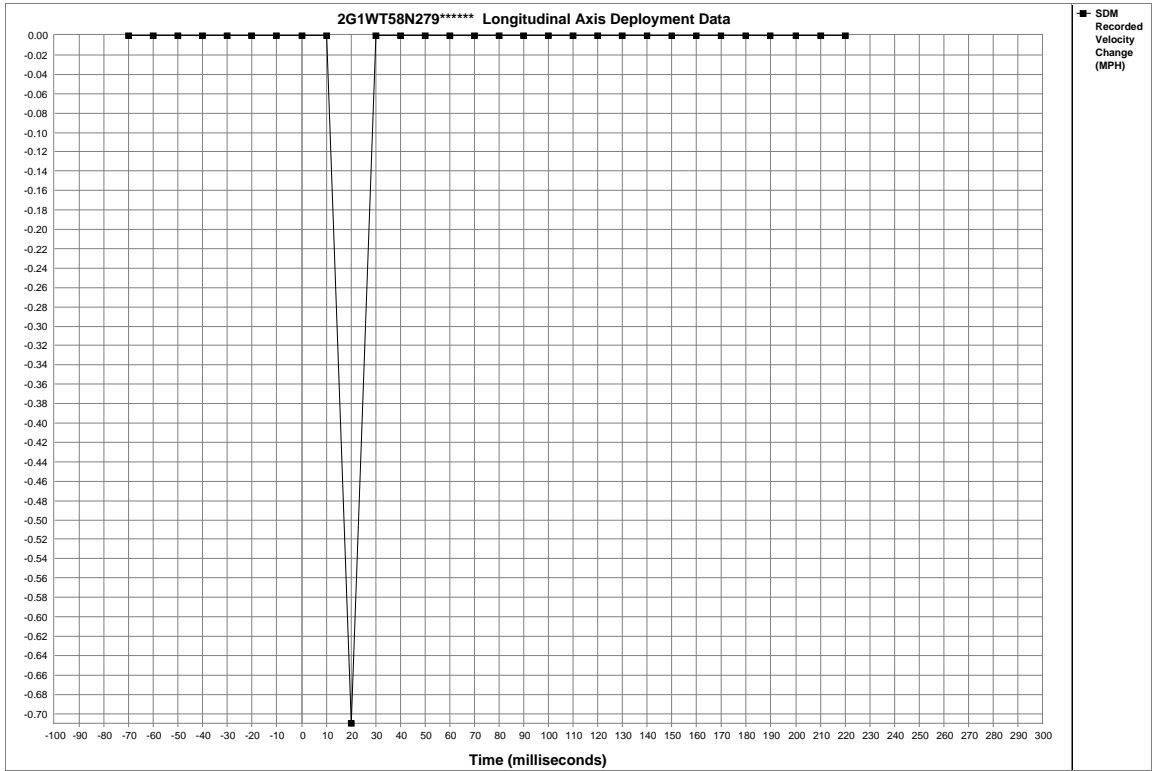
Time (milliseconds)	-70	-60	-50	-40	-30	-20	-10	0	10	20	30	40	50	60	70
SDM Longitudinal Axis Recorded Velocity Change (MPH)	0.00	0.00	0.00	0.00	0.00	0.00	0.00	0.00	0.00	-0.71	0.00	0.00	0.00	0.00	0.00
Time (milliseconds)	80	90	100	110	120	130	140	150	160	170	180	190	200	210	220
SDM Longitudinal Axis Recorded Velocity Change (MPH)	0.00	0.00	0.00	0.00	0.00	0.00	0.00	0.00	0.00	0.00	0.00	0.00	0.00	0.00	0.00

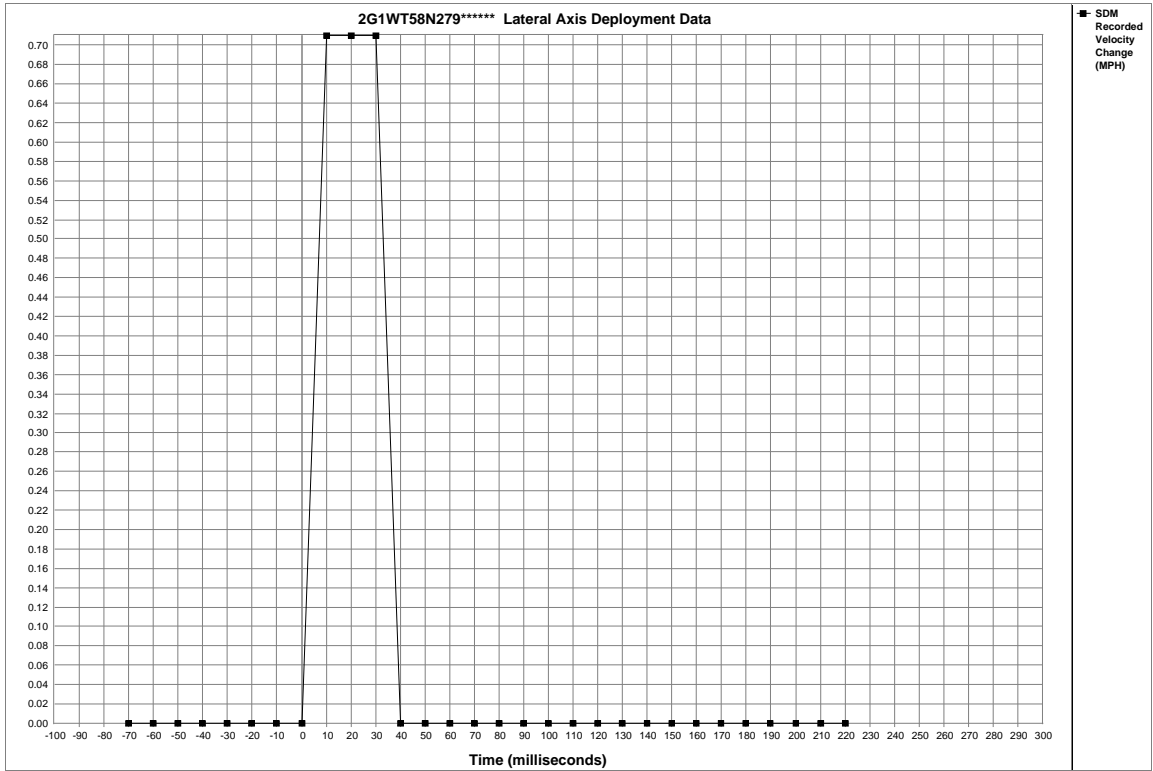
Time (milliseconds)	-70	-60	-50	-40	-30	-20	-10	0	10	20	30	40	50	60	70
SDM Lateral Axis Recorded Velocity Change (MPH)	0.00	0.00	0.00	0.00	0.00	0.00	0.00	0.00	0.71	0.71	0.71	0.00	0.00	0.00	0.00
Time (milliseconds)	80	90	100	110	120	130	140	150	160	170	180	190	200	210	220
SDM Lateral Axis Recorded Velocity Change (MPH)	0.00	0.00	0.00	0.00	0.00	0.00	0.00	0.00	0.00	0.00	0.00	0.00	0.00	0.00	0.00

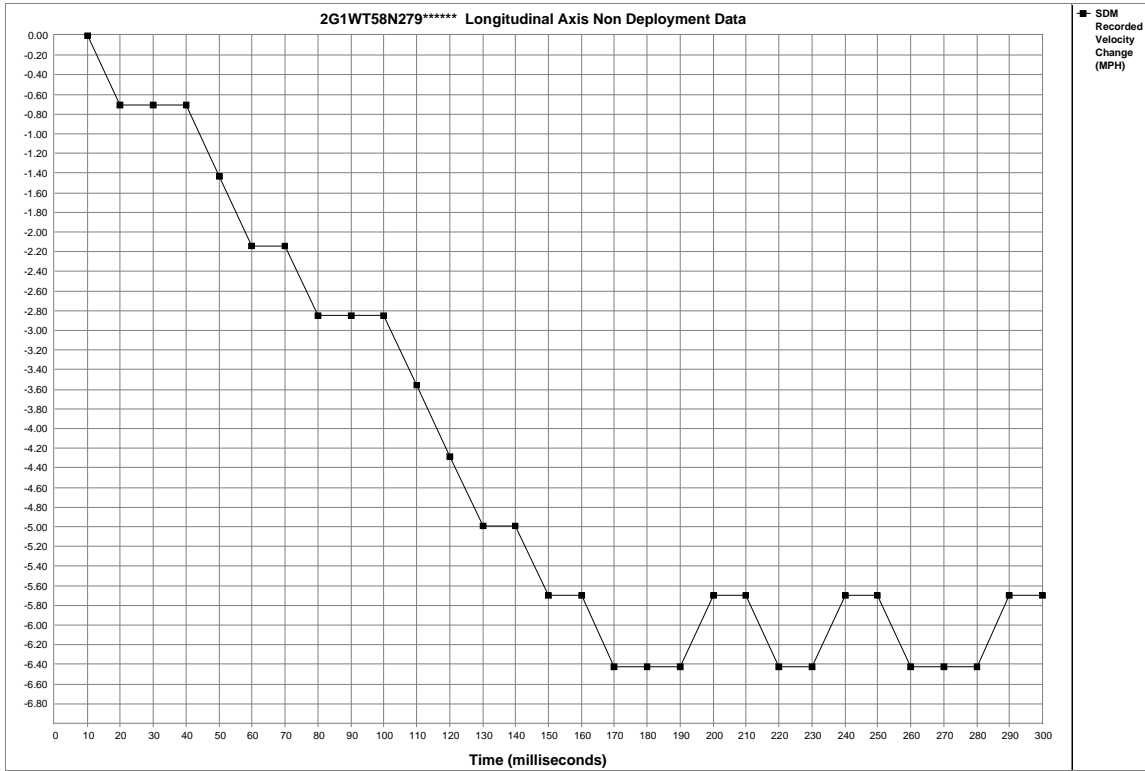
Time (milliseconds)	10	20	30	40	50	60	70	80	90	100	110	120	130	140	150
SDM Longitudinal Axis Recorded Velocity Change (MPH)	0.00	-0.71	-0.71	-0.71	-1.43	-2.14	-2.14	-2.85	-2.85	-2.85	-3.56	-4.28	-4.99	-4.99	-5.70
Time (milliseconds)	160	170	180	190	200	210	220	230	240	250	260	270	280	290	300
SDM Longitudinal Axis Recorded Velocity Change (MPH)	-5.70	-6.42	-6.42	-6.42	-5.70	-5.70	-6.42	-6.42	-5.70	-5.70	-6.42	-6.42	-6.42	-5.70	-5.70

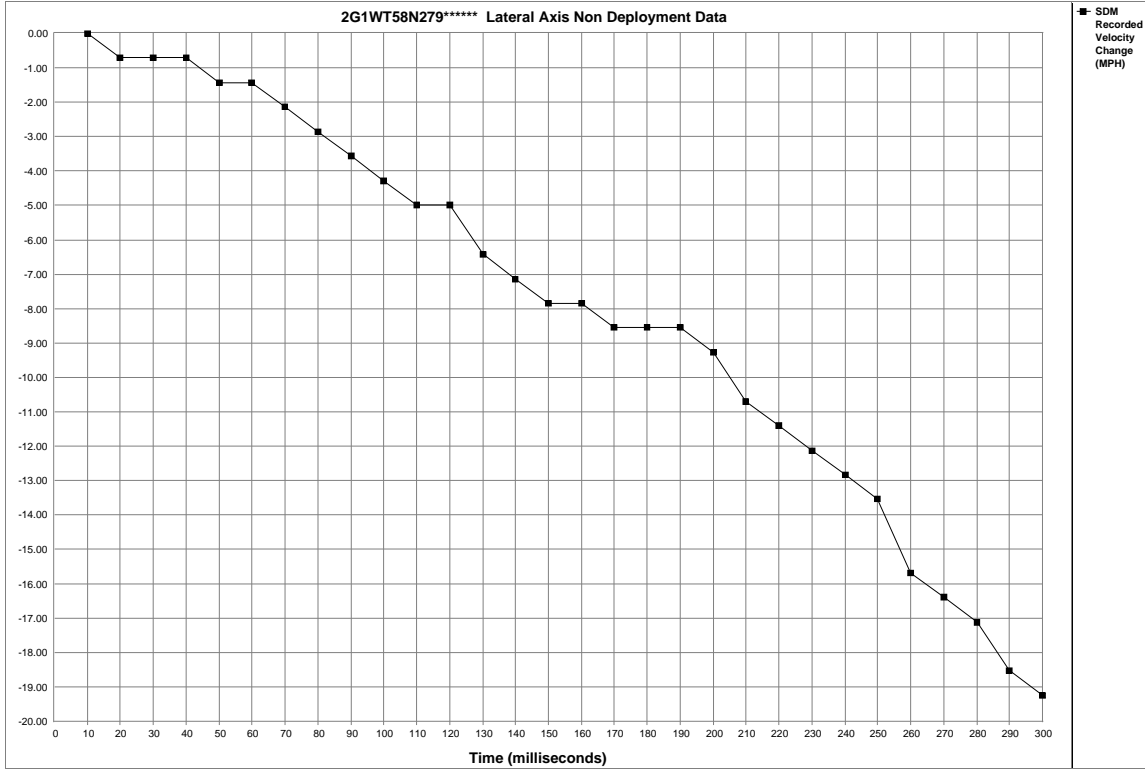
Time (milliseconds)	10	20	30	40	50	60	70	80	90	100	110	120	130	140	150
SDM Lateral Axis Recorded Velocity Change (MPH)	0.00	-0.71	-0.71	-0.71	-1.43	-1.43	-2.14	-2.85	-3.56	-4.28	-4.99	-4.99	-6.42	-7.13	-7.84
Time (milliseconds)	160	170	180	190	200	210	220	230	240	250	260	270	280	290	300
SDM Lateral Axis Recorded Velocity Change (MPH)	-7.84	-8.55	-8.55	-8.55	-9.27	-10.69	-11.41	-12.12	-12.83	-13.54	-15.68	-16.40	-17.11	-18.53	-19.25
