## ON-SITE ROLLOVER INVESTIGATION

CASE NUMBER - IN08039

VEHICLE - 2008 CHEVROLET K1500 SILVERADO Z71 4X4 CREW CAB

CRASH DATE - September 2009

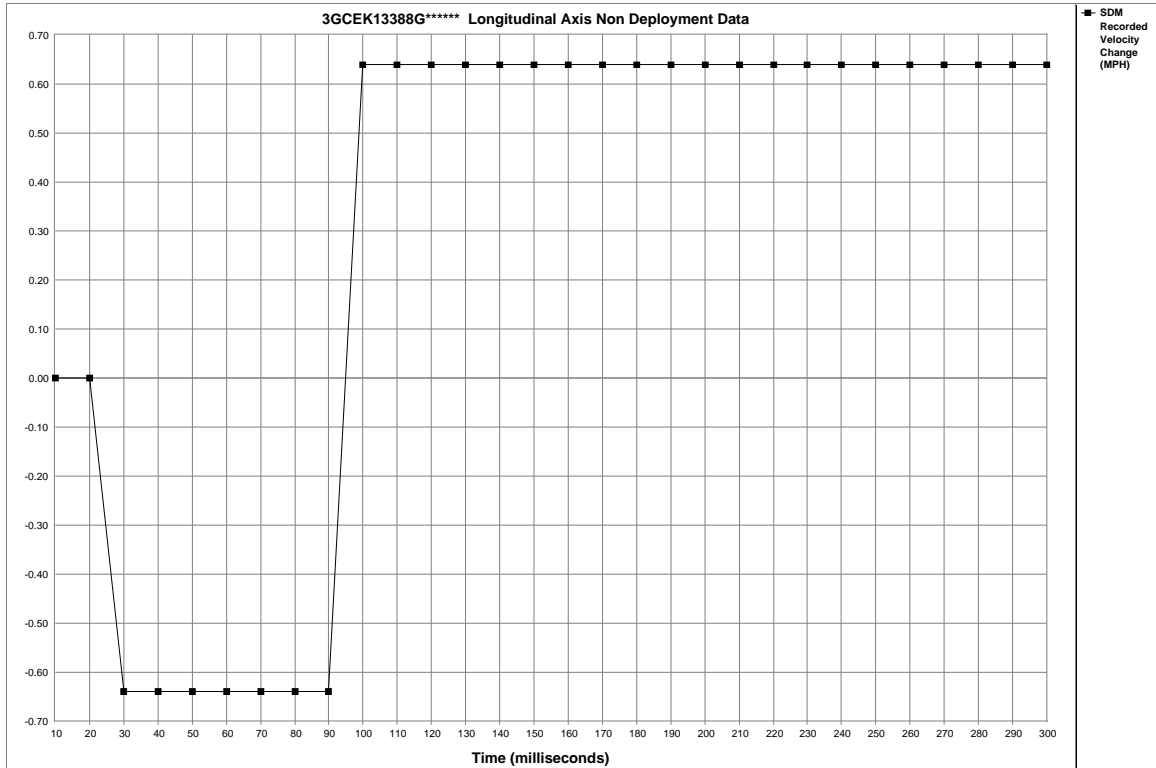
Time (milliseconds)	10	20	30	40	50	60	70	80	90	100	110	120	130	140	150
SDM Longitudinal Axis Recorded Velocity Change (MPH)	0.00	0.00	-0.64	-0.64	-0.64	-0.64	-0.64	-0.64	-0.64	0.64	0.64	0.64	0.64	0.64	0.64
Time (milliseconds)	160	170	180	190	200	210	220	230	240	250	260	270	280	290	300
SDM Longitudinal Axis Recorded Velocity Change (MPH)	0.64	0.64	0.64	0.64	0.64	0.64	0.64	0.64	0.64	0.64	0.64	0.64	0.64	0.64	0.64

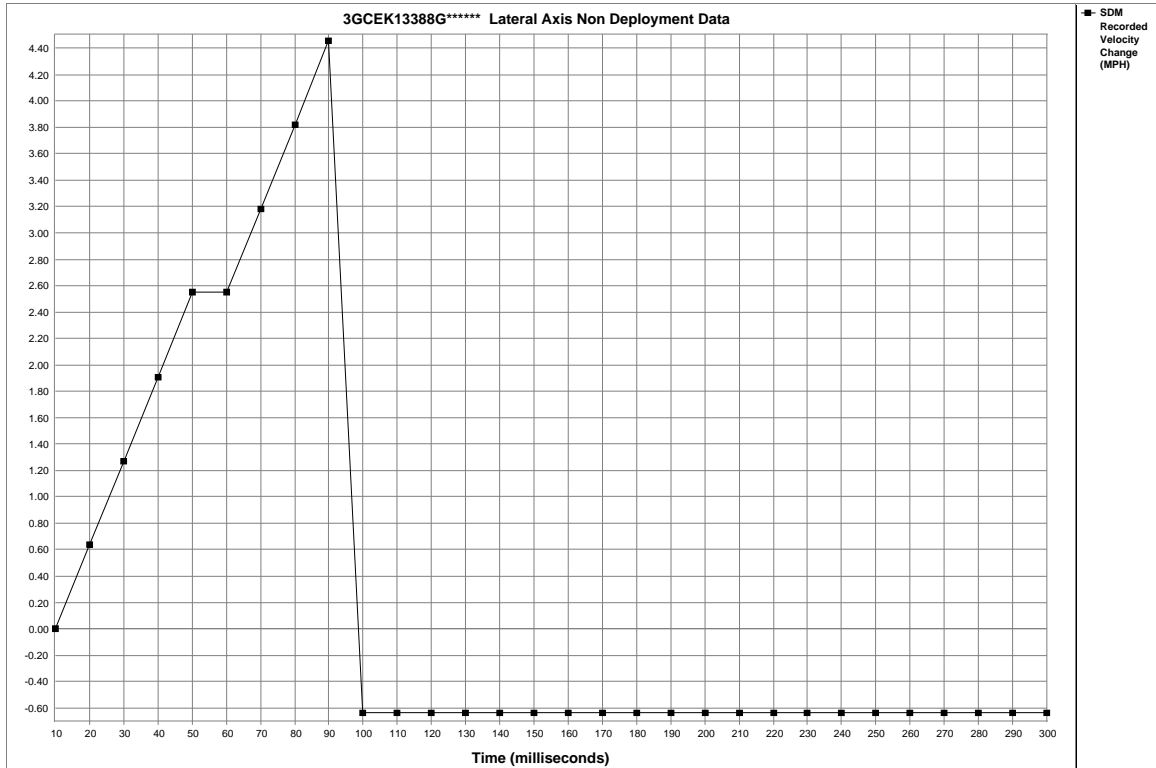
Time (milliseconds)	10	20	30	40	50	60	70	80	90	100	110	120	130	140	150
SDM Lateral Axis Recorded Velocity Change (MPH)	0.00	0.64	1.27	1.91	2.55	2.55	3.18	3.82	4.46	-0.64	-0.64	-0.64	-0.64	-0.64	-0.64
Time (milliseconds)	160	170	180	190	200	210	220	230	240	250	260	270	280	290	300
SDM Lateral Axis Recorded Velocity Change (MPH)	-0.64	-0.64	-0.64	-0.64	-0.64	-0.64	-0.64	-0.64	-0.64	-0.64	-0.64	-0.64	-0.64	-0.64	-0.64
