**CALSPAN ON-SITE INFLATABLE SIDE IMPACT
OCCUPANT PROTECTION INVESTIGATION
CALSPAN CASE NO: CA08042**

**VEHICLE: 2007 HONDA ACCORD
LOCATION: TENNESSEE
CRASH DATE: MAY, 2008**

Contract No. DTNH22-07-C-00043

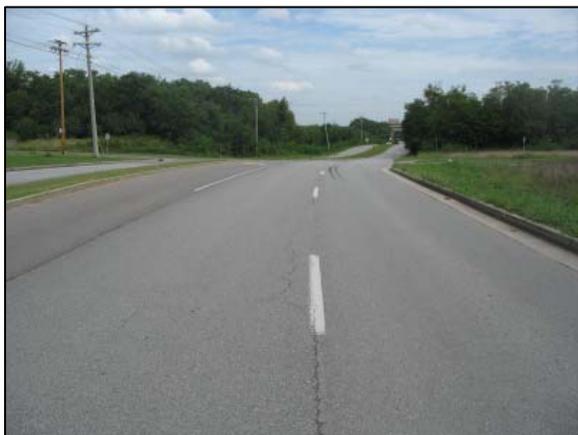
Figure 2: Eastbound trajectory view of the Honda Accord approaching the intersection.

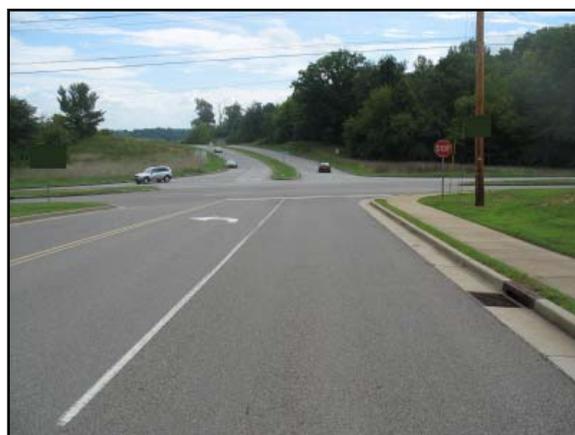
This two-vehicle crash occurred during the daylight hours of May 2008. At the time of the crash, the weather was not a factor. The crash occurred at the four-leg intersection of a five-lane east/west road and a three-lane north/south road in an urban setting. There was a shallow right curve and slight down grade eastbound leading into the intersection. **Figure 2** is an eastbound trajectory view of the Honda Accord on the approach to the intersection. The eastbound traffic lanes were configured with two through lanes and a left turn only lane. The east/west speed limit was 64 km/h (40 mph). The southbound traffic lanes were configured with a single through lane and a left turn only lane. **Figure 3** is a southbound trajectory view of the Honda CR-V. The

Figure 3: Southbound trajectory view of the Honda CR-V.
