ON-SITE OTHER INFLATABLE OCCUPANT PROTECTION INVESTIGATION

CASE NUMBER - IN08044
LOCATION - TEXAS
VEHICLE - 2006 MAZDA 5
CRASH DATE - October 2008

1. <i>Report No.</i> IN08044		2. <i>Government Accession No.</i>		3. <i>Recipient's Catalog No.</i>	
4. <i>Title and Subtitle</i> On-Site Other Inflatable Occupant Protection Investigation Vehicle - 2006 Mazda 5 station wagon Location - Texas			5. <i>Report Date:</i> September 28, 2009

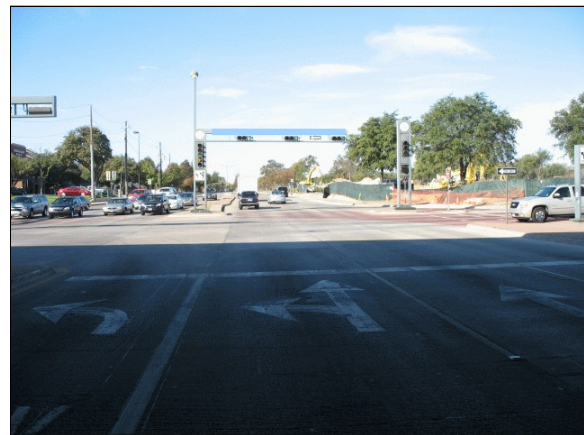
Crash Environment: The traffic-way on which the Mazda was traveling was an 8-lane, divided, city street, traversing in an east-west direction, and the Mazda was approaching a 4-leg intersection (**Figure 1**). On the eastern leg of the intersection the east roadway had 2 through lanes, 1 combination through/left turn lane, and 1 left-hand turn lane. The west roadway had 3 through lanes and 1 left-hand turn lane. The trafficway on which the Chevrolet was traveling was a 6-lane, undivided, one-way, service road to a U.S. highway, traversing in a north-south direction, and the Chevrolet was approaching the same 4-leg intersection (**Figure 2**). On the northern leg of the intersection, the southbound service road had 2 through lanes, 1 combination through/left turn lane, 1 left turn lane, 1 channelized right turn lane, and 1 U-turn lane.

Figure 1: Mazda's westbound path of travel toward intersection in inside through lane

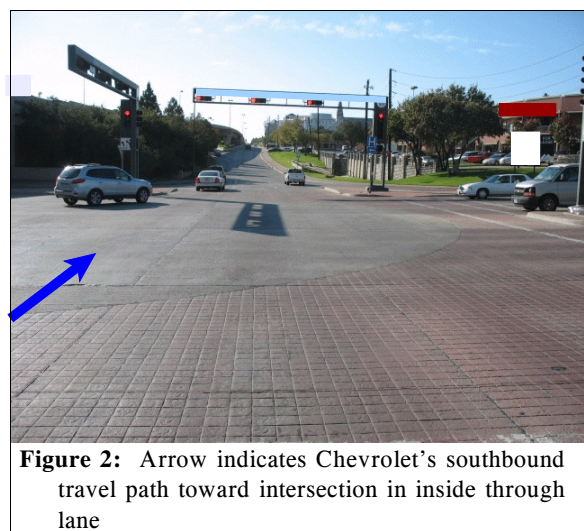
Figure 2: Arrow indicates Chevrolet's southbound travel path toward intersection in inside through lane

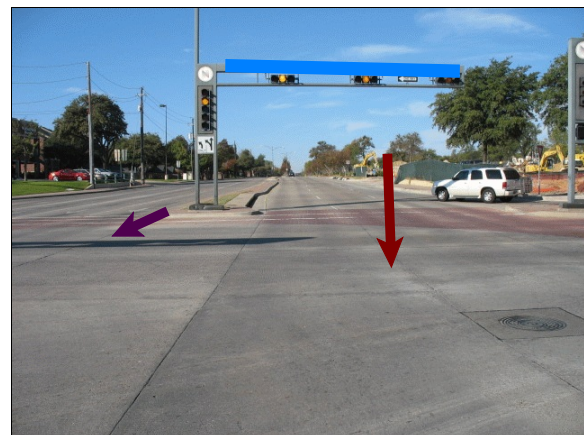
Pre-Crash: The Mazda was traveling west in the inside through lane, and the driver intended to continue straight through the intersection (**Figure 3**). The Chevrolet was traveling south in the inside through lane, and the driver intended to continue straight through the intersection. It is unknown if the Mazda's driver made any avoidance maneuvers prior to the crash. The crash occurred within the 4-leg intersection of the 2 trafficways.

Figure 3: Mazda's westbound travel path into intersection; foreground arrow indicates approximate impact location with Chevrolet; background arrow shows Mazda approximate final rest position
