CALSPAN ON-SITE ROLLOVER CRASH INVESTIGATION

SCI CASE NO.: CA08050

VEHICLE: 2006 FORD ESCAPE

CRASH DATE: AUGUST 2008

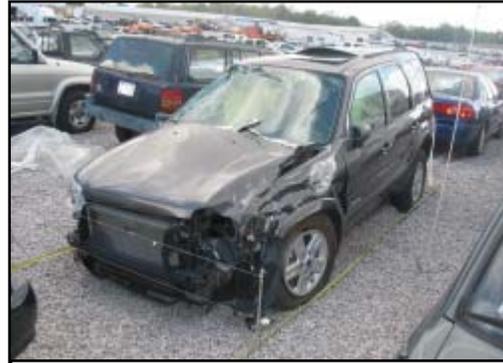
This on-site investigation focused on the rollover crash of a hybrid-powered 2006 Ford Escape (**Figure 1**). The Ford was occupied by a 19-year-old male driver and a 14-year-old female front right passenger. The Escape was equipped with a high-voltage nickel-metal hydride battery pack with a total output rating of 300-volts. The hybrid battery was used for low-speed vehicle movement and to assist the 2.3-liter gasoline engine in higher speed movement. This battery pack was

Figure 1. 2006 Ford Escape.

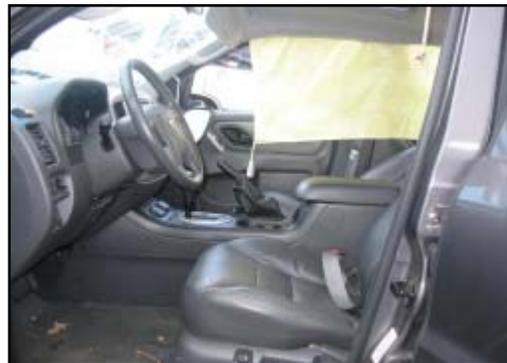
Figure 6. Overall view of the front row.

The interior of the Ford sustained minor severity damage as a result of passenger compartment intrusion and occupant contact points. A single contact point was present which consisted of an 8 cm x 3 cm (3 in x 1 in) scuff mark on the left aspect of
