**CALSPAN ON-SITE OFFICE OF DEFECTS INVESTIGATION
ROLLOVER CRASH INVESTIGATION**

SCI CASE NO. – CA08052

VEHICLE – 2007 FORD ESCAPE XLT

CRASH DATE – OCTOBER 2008

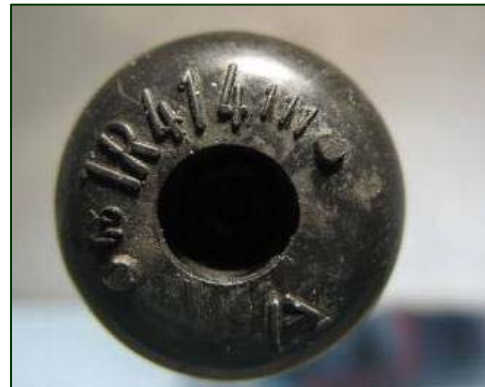
Figure 10. Close-up view of the LF tire valve identification.

The OEM tire valves in the left front and rear wheels were presumed to have been manufactured by Topseal. These valve stems were closely inspected for signs of cracking during the SCI investigation. None of the valves appeared to have cracks. The SCI investigator proceeded to remove the valves from the alloy wheels. All four tires were flat and de-beaded from the wheels, thus the inner bulb of the valve was visible on the inside surface of the wheel. A silicone lubricant was applied to both surfaces of the stems at the wheel bore. A valve stem installation tool was threaded onto the stem and slight pressure was applied to stretch the stem away from the wheel to check for further cracking. None was visible. A small pry tool was used to push the bulb of the stem outward through the wheel bore as a slight pulling force was applied to the valve stem tool. All three valve stems were removed from the vehicle without difficulty and without further damage to the valves (**Figure 9**). This removal process facilitated a close and thorough inspection of the valve stems.

The identification numbers on the bottom of the stems (**Figure 10**) were as follows:

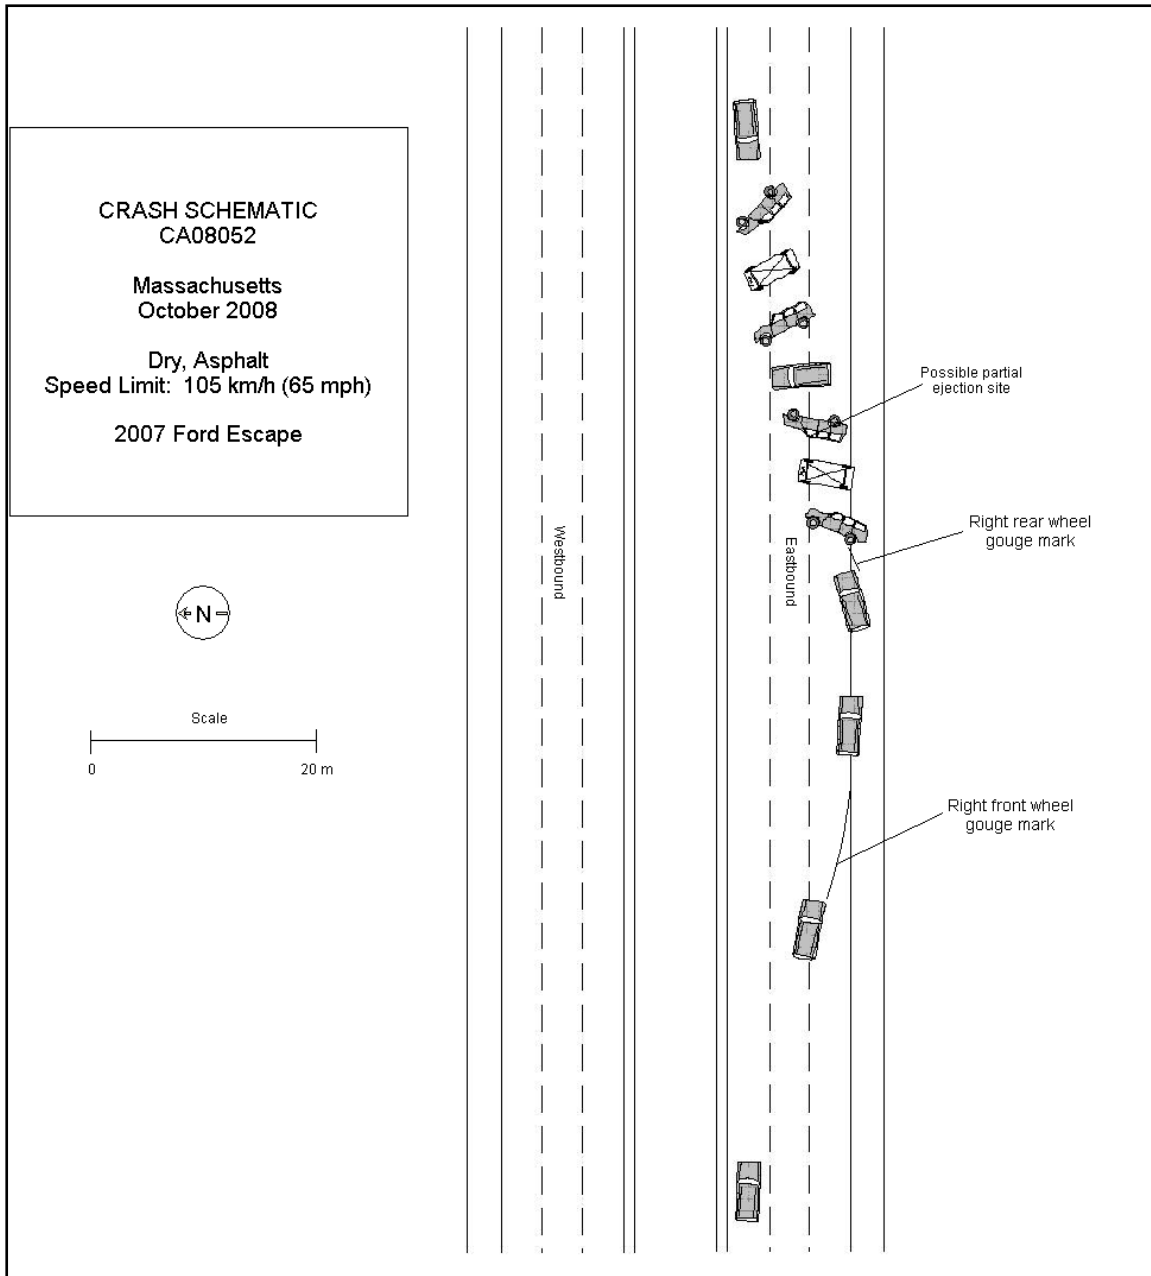
Figure 16. Crash Schematic.

The crash occurred on a divided interstate roadway during nighttime hours. At the time of the crash, the conditions were clear, dry and dark. The roadway was not illuminated. The driver of the Ford Escape was traveling in an easterly direction. The eastbound lanes consisted of three travel lanes that were surfaced with asphalt and posted with a 105 km/h (65 mph) speed limit. A three-beam median barrier separated the east and west bound lanes. The travel lanes were 3.7 m (12') in width and were bordered by asphalt surfaced shoulders with curbs located at the outboard aspect of the shoulders. Rumble strips were cut into the inboard shoulder. The travel lanes were delineated by broken white lane lines with solid lines marking the edges of the inboard and outboard travel lanes. On the distant approach to the crash site, the eastbound lanes curved to the left with an uphill grade. In the vicinity of the crash site, the lanes transitioned to a straight segment with a slight positive grade of less than two-percent. **Figure 2** is a look-back view of the Ford's trajectory to the crash site. The Crash Schematic is attached as **Figure 16**, Page 12 of this report.
